TITLE: Seismic Damages in Masonry Structural Walls and Solution Suggestions

Academic Platform Journal of Natural Hazards and Disaster Management

4(2) 2023: 49-64, DOI: 10.52114/apjhad.1400644

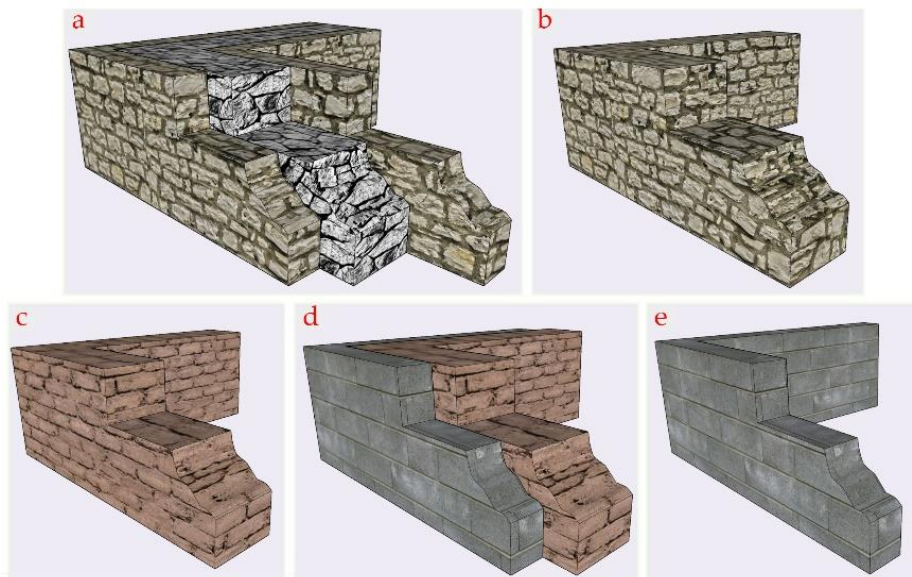
**Figure 5.** Observed wall and material types a)double-layered stone b)stone c)adobe d)briquette+adobe e)briquette

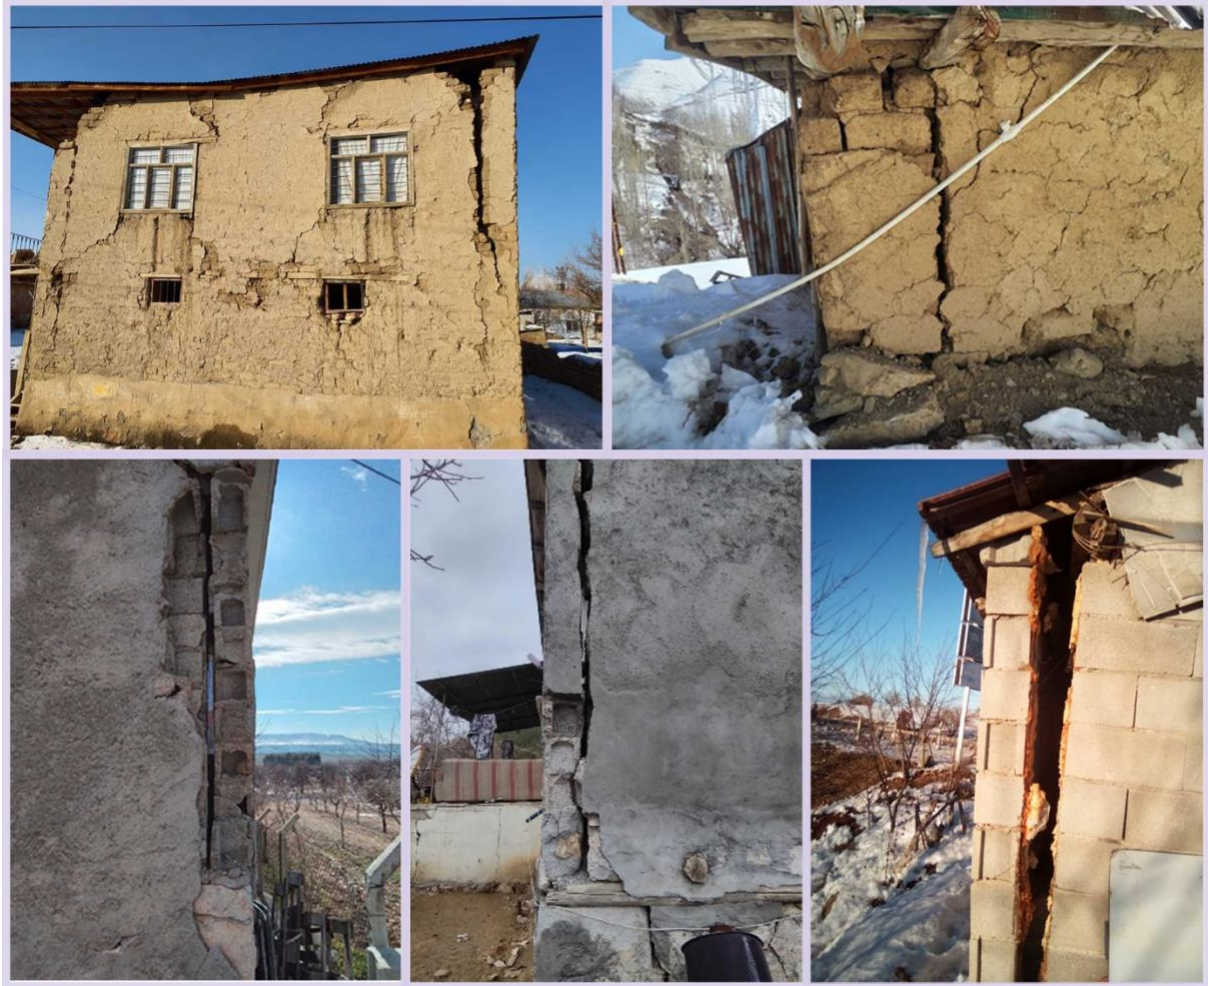
One of the elements that will affect the earthquake performance of masonry structures is forming the corner connections rigid and strong. One of the damages observed after earthquakes, especially in rural areas, is separation damage in the wall-corner joint areas. The level of damage was negatively affected by the lateral stresses resulting from heavy earthen use

in the masonry structures built in these regions. Additionally, during earthquakes, forces are exerted on structures in both principal directions. Under this two-way loading, the condition of the corner of the masonry structure shows different movements and pushes each other. If the walls are not well connected at the corner and there is no bond beam or roof slab, the walls will push each other at the corner, causing wall separation damage [4, 58]. Examples of such damage are shown in Figure 6.

**Figure 6.** Wall separation at corners of the structures

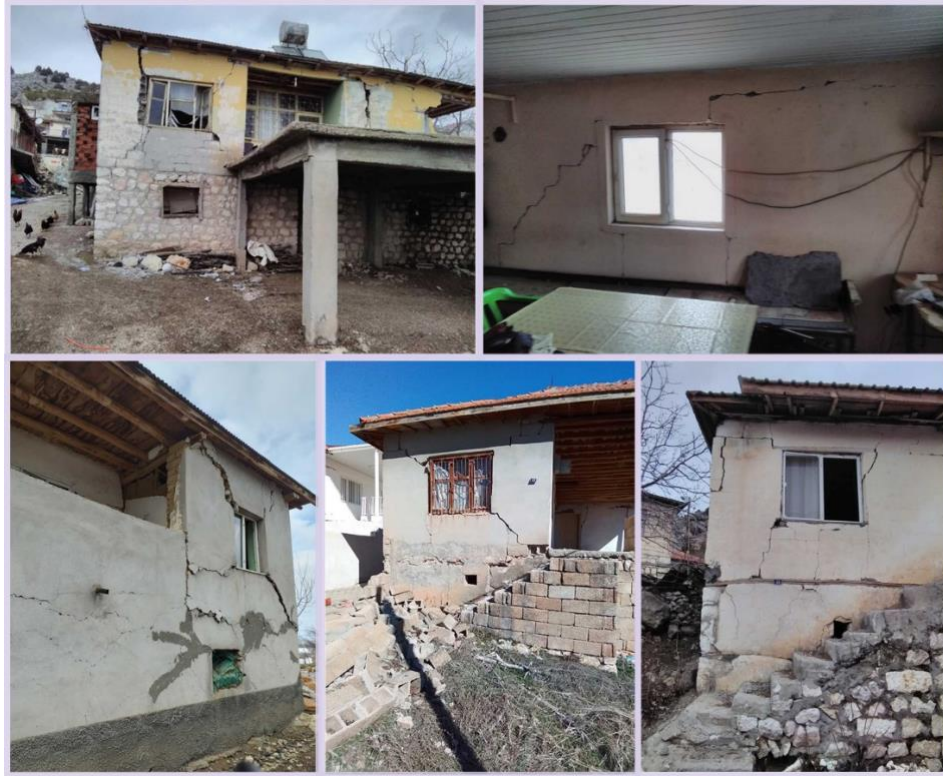
It is known that window and door gaps in masonry structures intercept the load-bearing walls from appropriately transferring bending and shear stresses [59-61]. Door and window openings reduce the cross-sectional area of load-bearing walls in masonry buildings, causing shear and bending stresses to increase. This situation reduces the capacity of the wall and reduces the strength of the structure under the influence of forces such as earthquakes. Such damages are frequently encountered because gaps do not meet the boundary conditions specified in earthquake codes. Examples of such damage are shown in Figure 7.

**Figure 7.** Damages at window corners

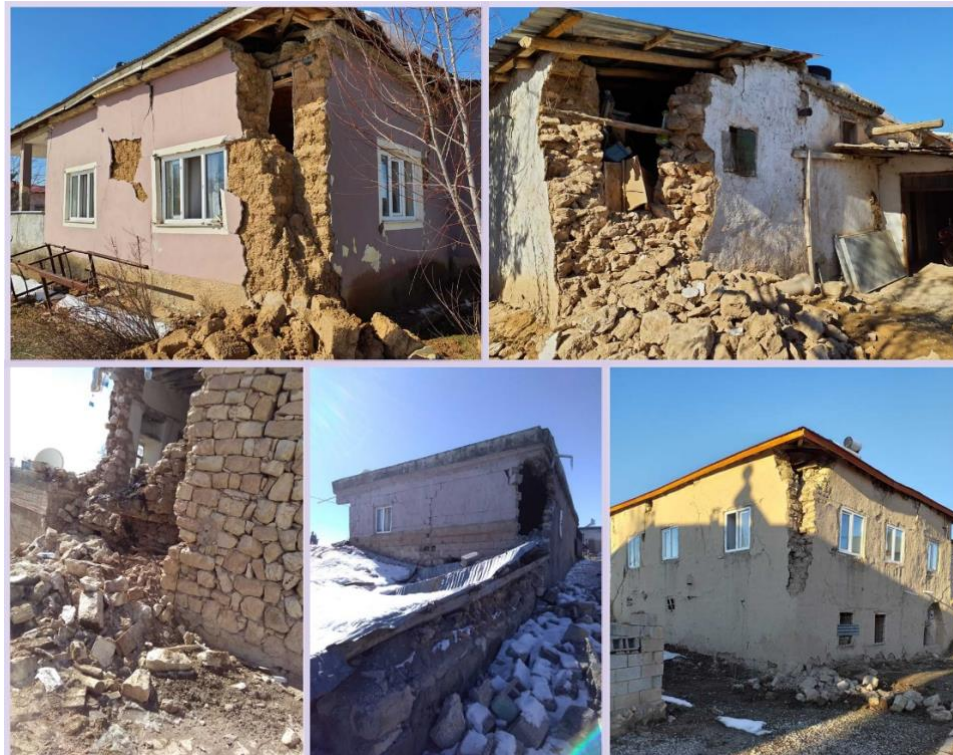
Failure to create appropriate joints in both directions at the corners of the load-bearing walls may reduce the rigidity of the walls and lead to further damage to the buildings. As a consequence of the observations made in the field after the Kahramanmaraş earthquakes, the failure to create appropriate joints in these areas caused out-of-plane wall damage at the corners. Examples of such damage are demonstrated in Figure 8.

**Figure 8.** Examples of out-of-plane wall corner damage

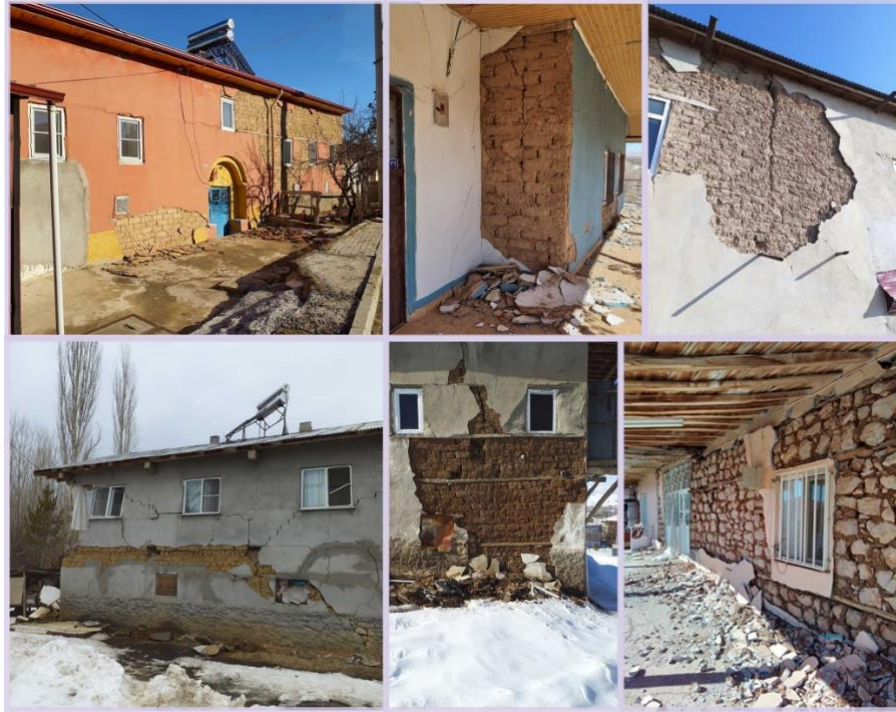
One of the other types of damage encountered is the falling of the outer coverings of the wall materials used in masonry structures, which are used to make their appearance smoother. It has been determined that exterior coatings made using low-strength mortar are generally subject to out-of-plane behavior. Examples of such damage are shown in Figure 9.

**Figure 9.** Falling of exterior materials

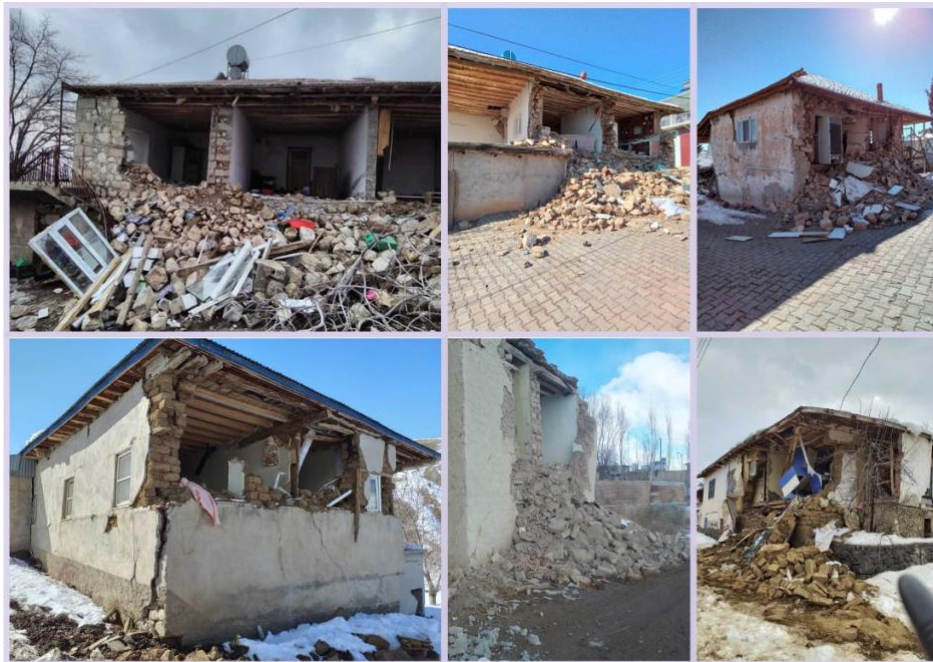
One of the damages frequently observed in masonry structures in earthquake zones is the out-of-plane movement of load-bearing walls. In addition to the low mechanical properties of the wall and connection material used, inadequate wall-wall connections cause out-of-plane movements on the walls, causing damage. Examples of such damage are demonstrated in Figure 10.

**Figure 10.** Example of out-of-plane movement on load-bearing walls

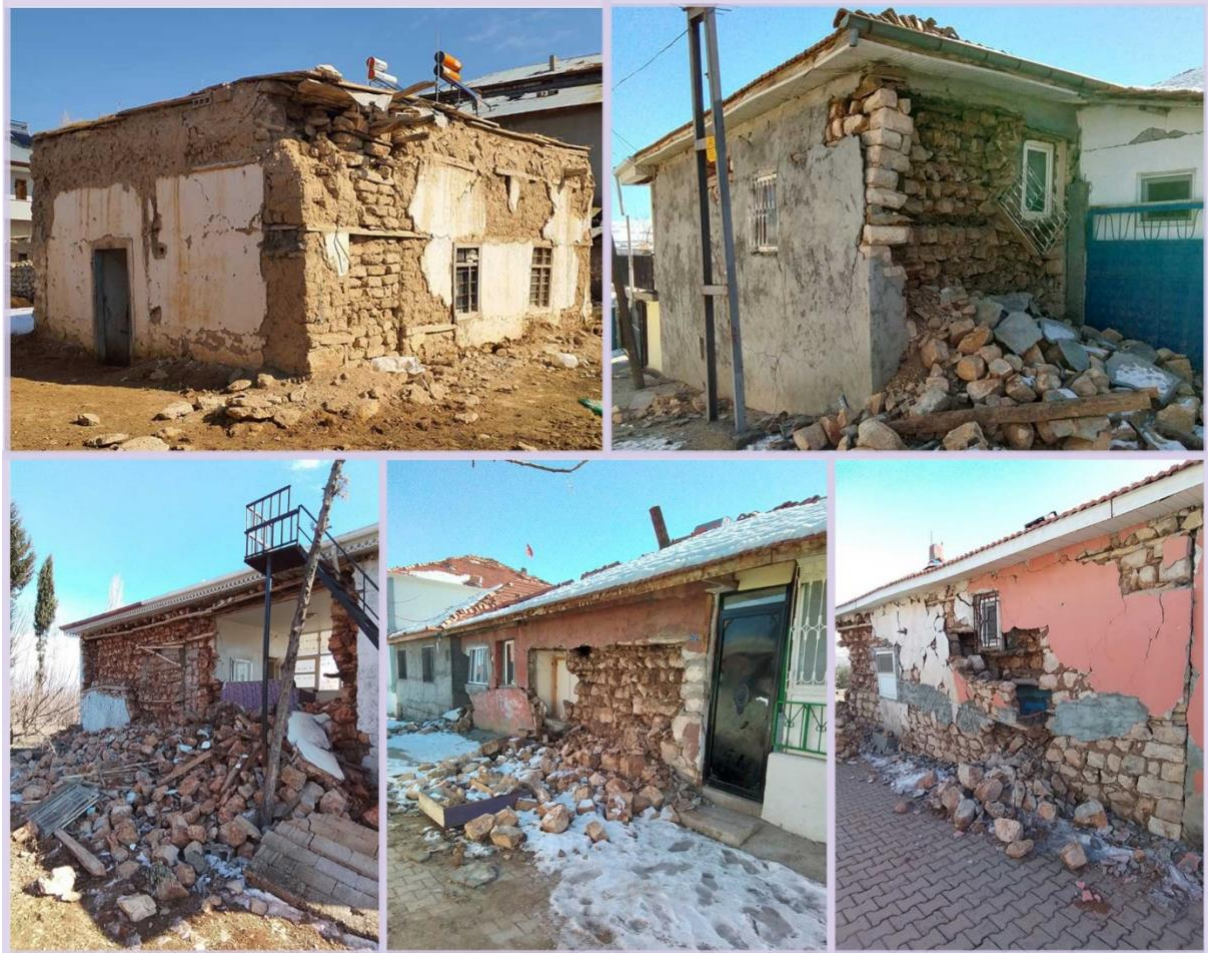
Due to the fact that masonry buildings do not have any frame system and the low strength properties of the materials used in the construction of the walls, their wall thickness increases significantly compared to reinforced concrete structures. Wall layers are created to provide this thickness. Inadequate connections between layers and the combined use of wall materials with different properties caused these layers to separate under the earthquake effect and receive damage at different levels. Examples of such damage are shown in Figure 11.

**Figure 11.** Examples of damage caused by inadequate connections between layers

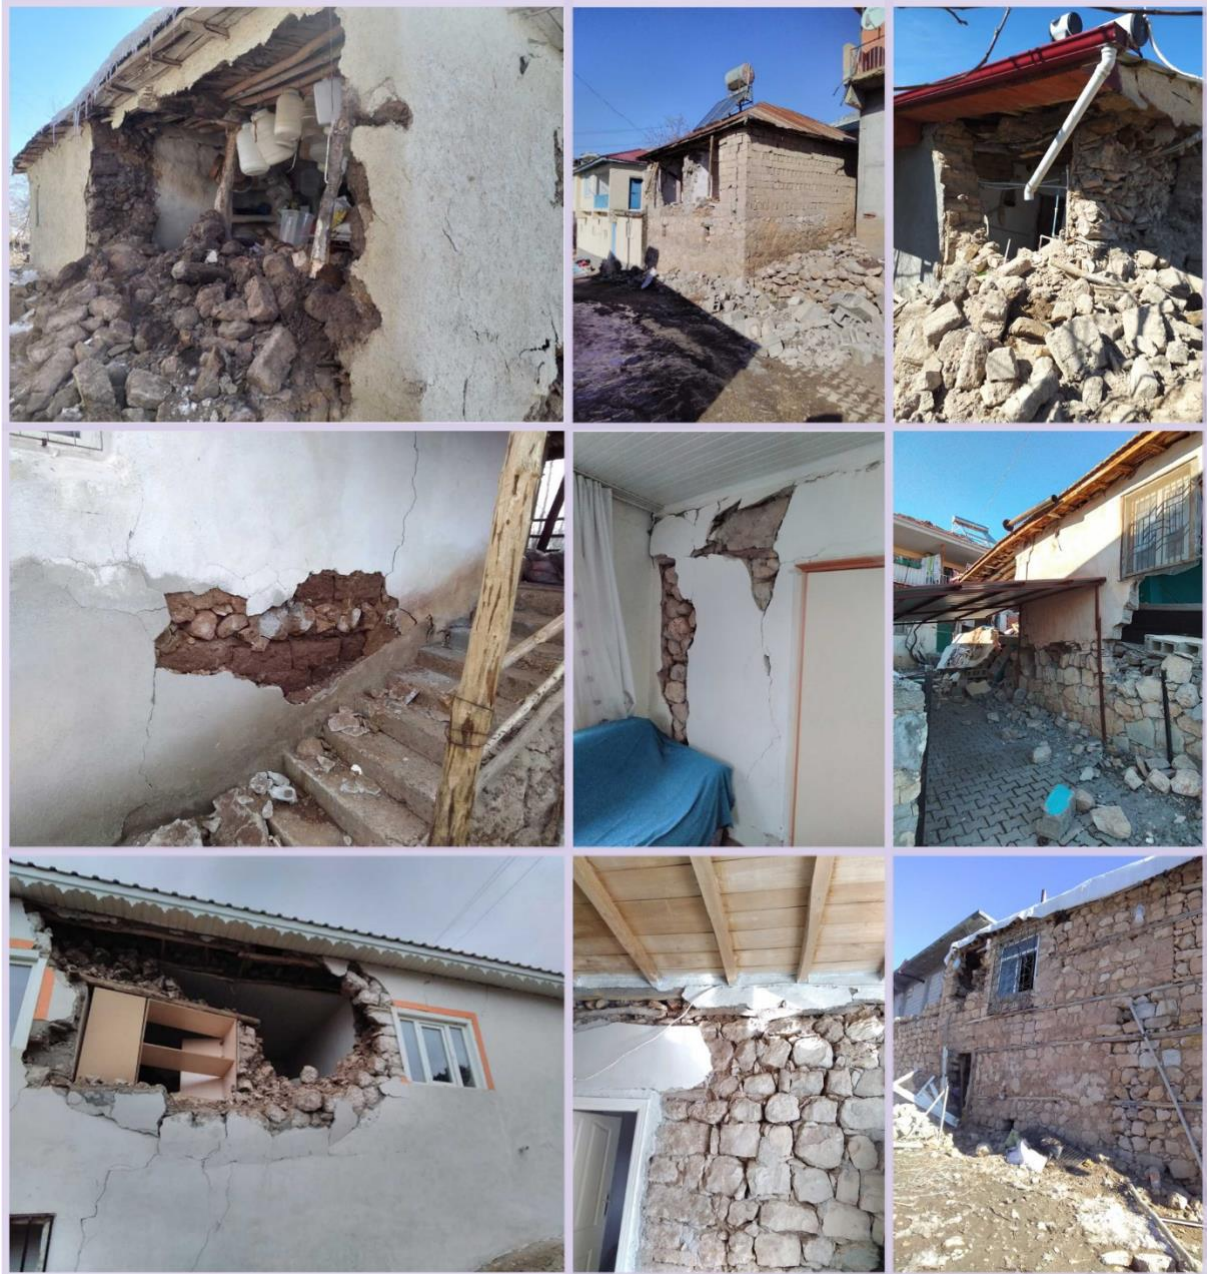
In masonry structures, using wall materials that are not regular in shape, incorrect wall material placement, poor masonry workmanship, and unsuitable connection mortar have also caused various levels of damage to the load-bearing walls. Examples of such damage are demonstrated in Figure 12.

**Figure 12.** Examples of wall damage caused by various reasons
