TITLE: A study on the determination of damage levels in reinforced concrete structures for different earthquakes

# A study on the determination of damage levels in reinforced concrete structures for different earthquakes

Bitlis Eren University, Department of Civil Engineering, TR-13000, Bitlis, Türkiye

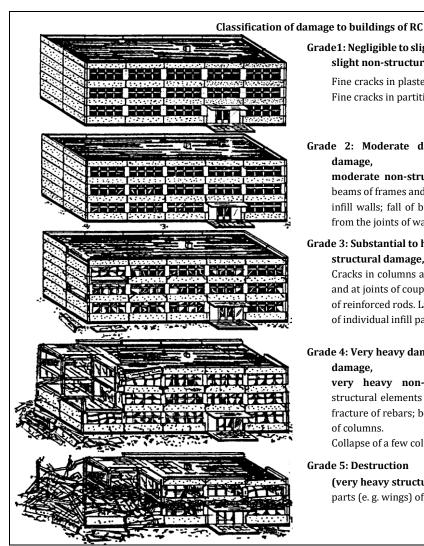
Figure 2. Damage grades in RC structures according to EMS-98

#### Grade1: Negligible to slight damage (no structural damage, slight non-structural damage)

Fine cracks in plaster over frame members or in walls at the base. Fine cracks in partitions and infills.

#### Grade 2: Moderate damage (slight structural damage,

moderate non-structural damage) Cracks in columns and beams of frames and in structural walls. Cracks in partition and infill walls; fall of brittle cladding and plaster. Falling mortar from the joints of wall panels.

#### Grade 3: Substantial to heavy damage (moderate structural damage, heavy non-structural damage)

Cracks in columns and beam column joints of frames at the base and at joints of coupled walls. Spalling of concrete cover, buckling of reinforced rods. Large cracks in partition and infill walls, failure of individual infill panels.

#### Grade 4: Very heavy damage (heavy structural damage.

very heavy non-structural damage) Large cracks in structural elements with compression failure of concrete and fracture of rebars; bond failure of beam reinforced bars; tilting

Collapse of a few columns or of a single upper floor.

#### **Grade 5: Destruction**

(very heavy structural damage) Collapse of ground floor or parts (e.g. wings) of buildings.
