TITLE: Investigation of Failure Mechanism of a DCI Engine Connecting Rod

In reciprocating engines, connecting rod cap and connecting bolts are critical as they are exposed to varying loads under different operating conditions. This paper focuses on the failure of the connecting rod of a 1.5 dci K9K diesel engine. As a result of the engine operating for approximately 378400 km, the connecting rod was broken, and the reasons for the failure of the connecting rod cap and connecting bolt were investigated. The connecting rod of the K9K engine was designed in accordance with the dimensions by using SolidWorks software, and then exported to ANSYS software for stress and fatigue analysis. Also, the macrostructure of the broken connecting rod cap and bolt was investigated. We knew that the mechanic who fixed the engine about two years ago tightened the connecting rod bolts without using a torque meter. Therefore, stress and fatigue analyses were performed to determine the effect of different tightening torques (ranging from 22.5 to 52.5 Nm) at 2000 rpm. According to the numerical analysis results, with increasing tightening torque, the maximum equivalent stress and alternating stress valu

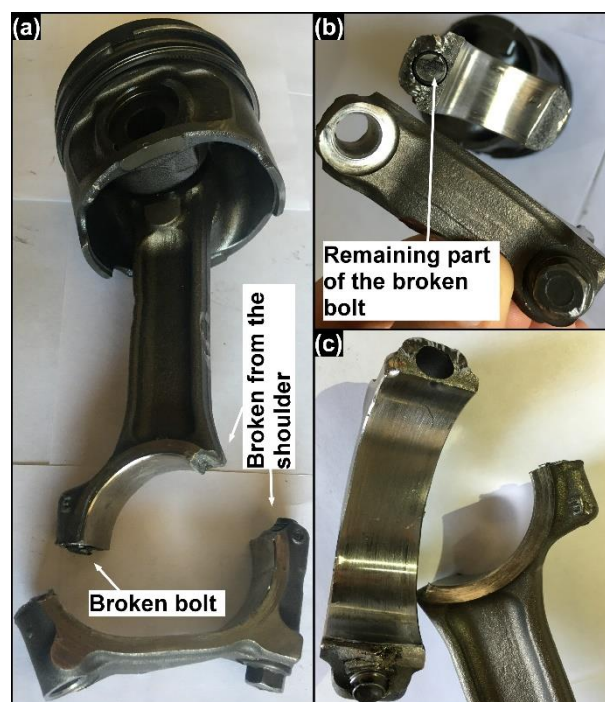
**Figure 1.** Macro view of the connecting rod after failure. (a) general view, (b) and (c) broken parts.

When the engine was disassembled, one of the connecting rods was found to be broken. The vehicle was known to be at 378400 km when the failure occurred. Also, about 2 years ago from the connecting rod failure, the crankshaft was changed for another reason, and therefore the connecting rods were removed and reassembled. However, it was learned that the mechanic did not use a torque meter during this removal and reassembly of the connecting rods. The connecting rod was removed, and as seen in Figure 1 (a), in the big end region, the left bolt connecting the lower cap and the upper cup of the connecting rod was broken in the middle. The remaining part of bolt on the connecting rod shank could be seen in Figure 1 (b). The bolt on the right was intact (Figure 1 (a and c)). However, the right side of the connecting rod was broken from the big end shoulder. Also the lower cap of the big end was deformed.

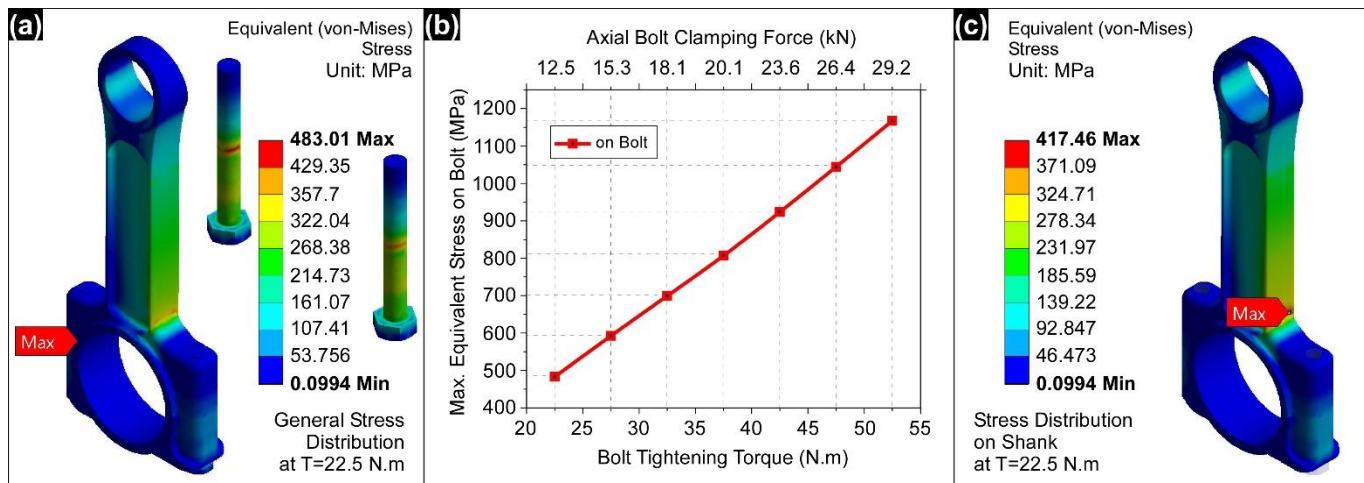
**Figure 3.** (a) equivalent (von-Mises) stress distributions on the all components of connecting rod, (b) graph of max. equivalent stress values on the bolt as a function of bolt tightening torque, (c) equivalent stress distributions on the connecting rod shank.

As a result of nonlinear static analyzes performed with the application of different bolt pretensions, maximum equivalent stress values in the connecting rods were obtained (Table II). During the analyses, bolt pre-tensions caused by different tightening torques varying in between 22.5 - 52.5 Nm were applied to the connecting rod. As seen in Figure 3 (a), the zone of maximum equivalent stress (483.01 MPa) at normal bolt tightening torque (22.5 Nm) was observed at the left-side bolt. This zone corresponded to the junction of the lower and upper cup of the connecting rod. In fact, as seen in Figure 1, the bolt on the left-side was broken at this zone. This equivalent stress value was considerably lower than the yield strength value of the bolt (1540 MPa). Therefore, at normal tightening torque, the stress safety factor in this zone was about "3.2" and it did not pose any problem. However, as seen in Figure 3 (b), the maximum stress value in this region significantly increased with the increase of the tightening torque. Such that, at the 52.5 Nm tightening torque, the maximum equivalent stress value on the bolt was 1167.5 MPa. This meant that the stress safety factor was approximately "1.3".

Witek et al. [24] stated that connecting rod bolts were subjected to complex loads acting as both tension and compression during engine operation. Therefore, the risk of breaking of the connecting rod bolts was high when the bolts were tightened above the normal tightening torque. On the other hand, as seen in Figure 3 (c), the maximum stresses on the connecting rod shank were concentrated in the right shoulder zone (417.46 MPa). This zone (right shoulder region of the connecting rod) was also the region where the break in the connecting rod shank occurred (see Figure 1). Because the maximum in cylinder pressure occurred when the crank angle was  $10^\circ$  after the piston top dead center, the load was applied to the piston pin of the connecting rod at an angle of  $3.55$  degrees. Therefore, the zones where the stresses concentrated on the components of connecting rod and the zones where the fractures occurred were completely matched.

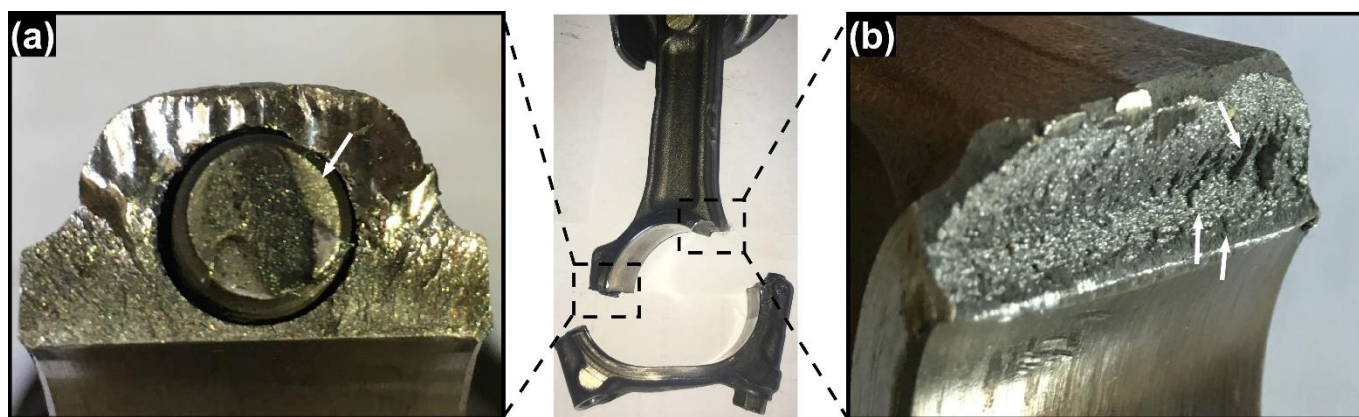
**Figure 5.** Macrostructure of damaged zones. (a) fracture surface of the remaining part of the broken left side bolt and (b) fracture surface of the broken right side shoulder.

The macrostructural photograph of the damaged zones of the connecting rod was given in Figure 5 (a and b). In Figure 5 (a), the possible fatigue area in the remaining part of the broken bolt is indicated by the arrow. Due to the fact that the mechanic did not use a torque meter, fatigue occurred in the over-tightened bolt, and the remaining section of the bolt after the fatigue damage area was broken because it could not bear the axial clamping force. As proved in the previous sections, the stresses in the broken region of the bolt were maximum and the safety factors were minimum. Immediately after the bolt on the left broke, the right shoulder area of the connecting rod was overloaded (stresses were also concentrated in this area as the maximum cylinder pressure took place at the crank angle of  $10^\circ$  ATDC). The deformed lower cap hit the cylinder liner and broke on the right shoulder and completely separated from the connecting rod shank. As a result, a brittle fracture occurred in the right shoulder region (Figure 5 (b)). As evidence of this, chevron markings (indicated by arrows in Figure 5 (b)) were observed in the fracture zone. Because it was reported that chevron markings typically result from the brittle fracture of steel materials [32]. Then the rings and valves took damage due to the uncontrolled movement of the piston. Thus, the connecting rod bolt, which had fatigue fracture due to excessive tightening torque, caused the connecting rod to break completely and the engine to be seriously damaged.

fracture occurred in the right hand bolt. Immediately after, the lower cup deformed and crashed to the cylinder liner. Therefore, a brittle fracture occurred on the left shoulder of the connecting rod shank. The chevron markings were clearly visible in the macrostructure as evidence of brittle fracture. As a result, the use of torque meters was very important in the assembly of engine post-repair parts.
