TITLE: Wood Damages and Improvement in Rural Mosques: Ordu Mosque

AUTHORS: Sengül YALÇINKAYA

Wood Damages and Improvement in Rural Mosques: Ordu Mosque

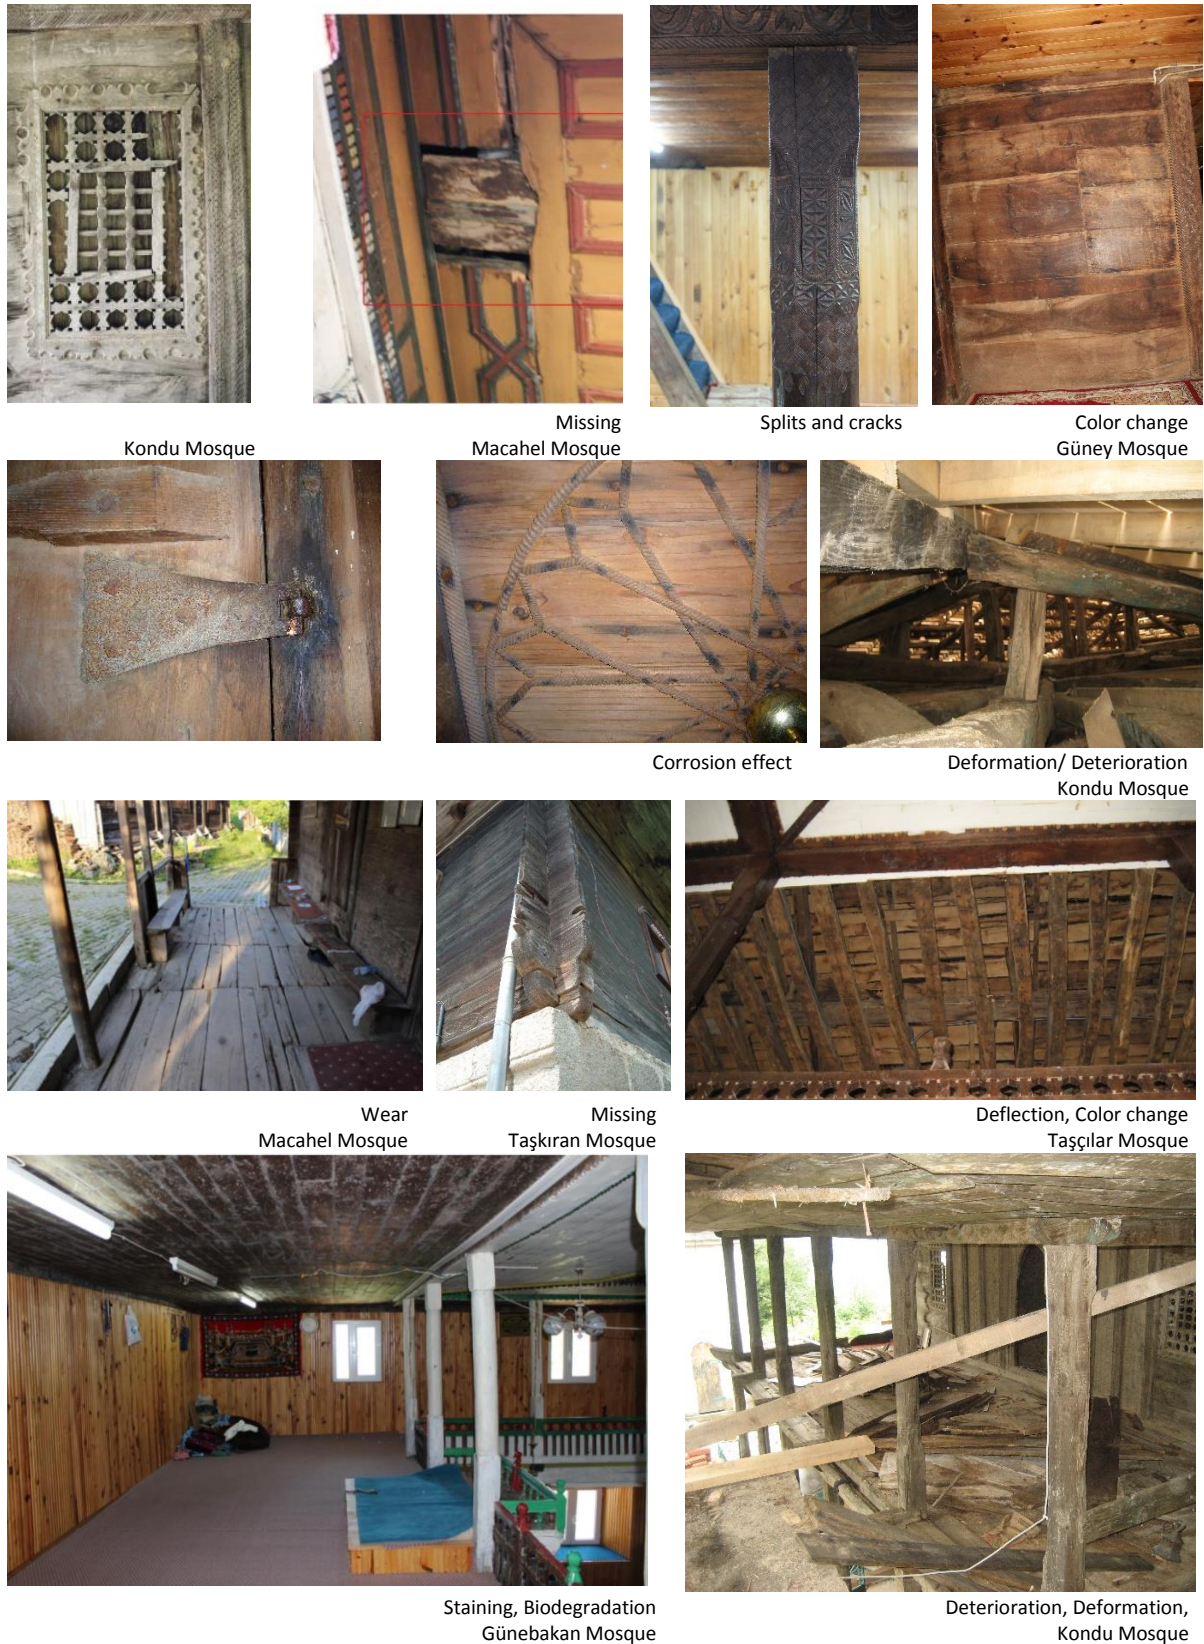
Figure 5. Examples of deformation in wood material originating from the environment in Wooden Mosques

Another factor that causes damage to wood is bacteria and fungus in the environment. Bacteria, fungi and insects can be physically and biologically effective on wood material. They commonly cause increased water permeability of the material, decreased strength, and damage such as odour, deterioration, cracking, discoloration and staining. Insects also cause damage such as flying holes, insect galleries and dusting on wood (Peker, 2010; Tunca, 2019) (Figure 4) (Figure 5).

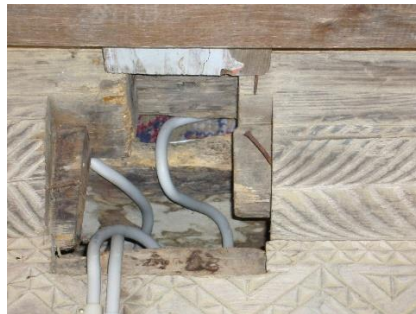
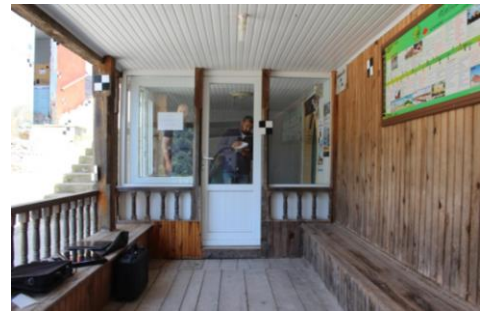
Figure 6. Examples of human-induced deformation of wooden materials in wooden mosques

Depending on the needs that emerged over time in mosques, interventions were made to the original plan. The space can be divided or the gathering-place floor can be enlarged. This floor is made of wooden material, and the material may be damaged at the junction points of the new addition and the existing wooden elements. On the other hand, it is possible to come across examples in the region where deformations on wooden wall surfaces are used instead of maintenance and repair. The construction technique gives wooden mosques the ability to be dismantled and rebuilt. In this process, reasons such as changing the order of the wooden boards and loss of parts cause damage to the building in case of transport (Figure 6).

Plumbing system attachment
Kondu Mosque

additional space, use of unqualified materials
Günebakan Mosque

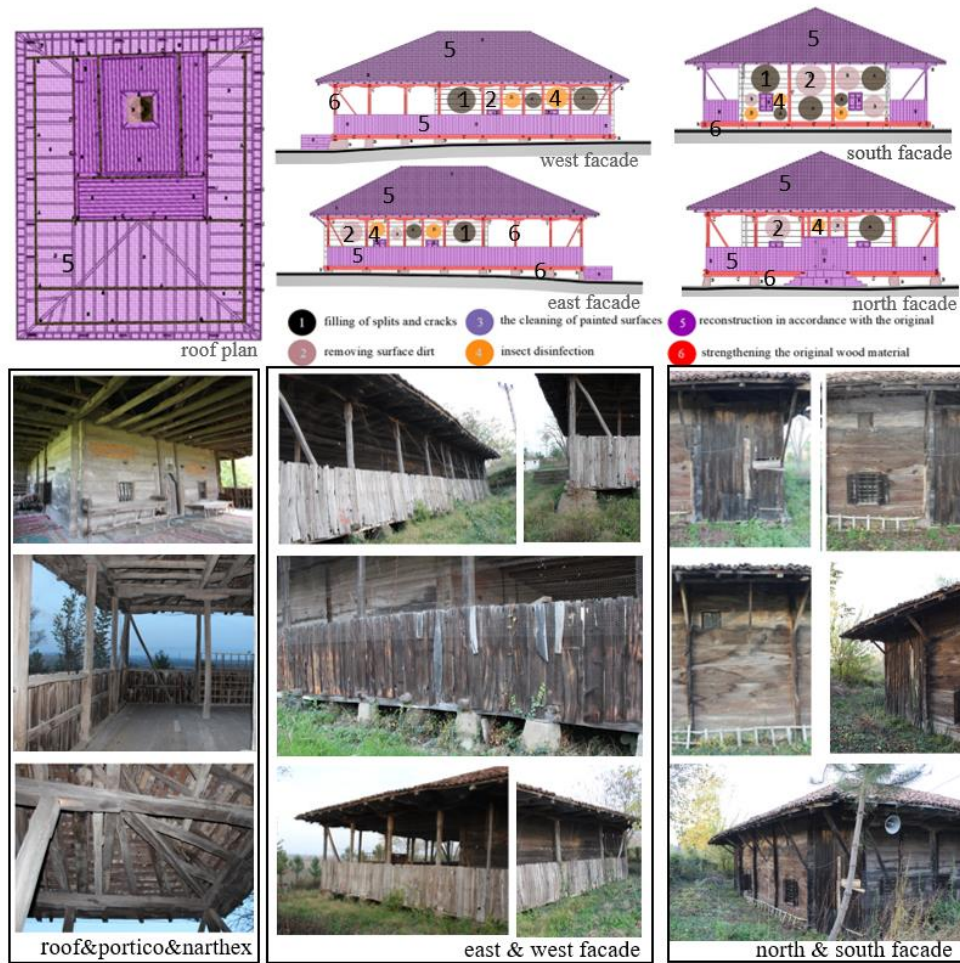
Figure 9. Deformations and interventions in wooden material in Ordu village mosque; roof, narthex, portico and façade

The condition of the wooden material in the building is discussed under two headings indoor and outdoor. When the deformation of the wooden material in the roof, narthex, portico and façade areas exposed to the outdoor conditions and the intervention made are evaluated (Figure 9);

- The fact that the columns, railings and beams in the narthex and portico section are open to atmospheric factors caused the formation of holes, cracks and crevices in the material. Again, physical damage such as deterioration, wear and tear were observed in the exterior wall coverings and flooring in this section (Zan Mimarlık, 2015b). In the areas that were problematic in the protection process, the surface was cleaned, and holes, cracks and crevices were filled and strengthened in the wooden material in the first step. The areas with high deformation were renewed in line with the original.

- The wooden balustrades around the narthex and portico sections of the building were deformed due to atmospheric factors. The damaged wooden balustrades were rebuilt with hardwood in line with the original (Zan Mimarlık, 2015b). Again in this section, the openings covered with metal gauze were restored by removing the metal.

- On the south façade of the mosque, the southeastern and southwestern parts of the portico were covered with unqualified wood. The woods in this area were removed and the portico area was completed with wooden railings and supported with wooden studs.

- Various reductions and deformations have occurred on the window door in the building with the effect of time. The damaged, missing and broken wooden parts on the windows have been renewed. The south façade of the mosque has two window openings to the right and left of the mihrab. These two unqualified windows have been removed and their gaps closed. At the entrance to the sanctuary, the surface was cleaned, and the damaged and rotten parts were taken care of; holes, cracks, and crevices were filled and strengthened (Zan Architecture, 2015b).

- Widespread deformation was observed on the roof. As a general approach, the solid elements were preserved in the wooden roof, and the damaged ones were renewed.

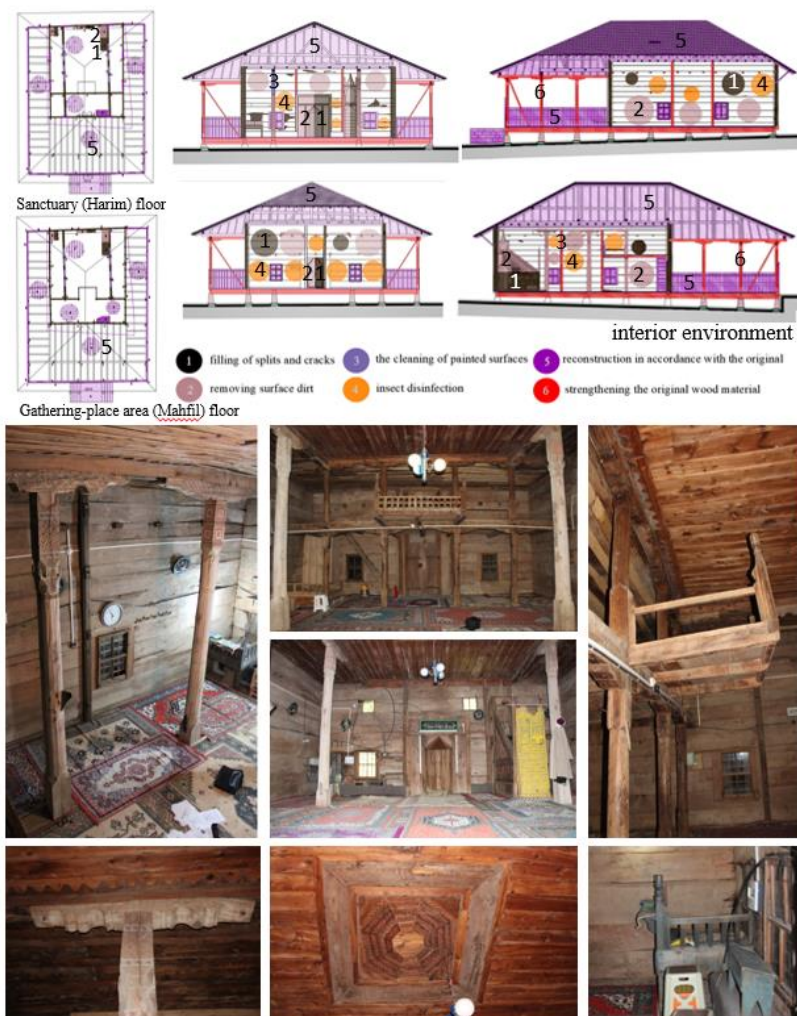
Figure 10. Deformation and interventions in wooden material in Ordu village mosque; sanctuary, gathering place and wooden items

Ordu mosque has a sanctuary and a gathering-place area as an interior environment. Items such as the pulpit, mihrab and lectern in this area are made of wood. When the deformation of the wood material in the indoor environment and the intervention made are evaluated (Figure 10);

- Deformations and deterioration were observed on wooden walls, wooden columns and beams in the sanctuary and gathering place. Common contamination, loss-deformation and discoloration were observed on wooden surfaces indoors. The surface has been cleaned in the problematic areas, and holes, cracks and crevices have been filled and strengthened.

- Deformation and missing were observed in the wooden material in the core of the wooden ceiling. The damaged parts are refurbished from hardwood.
- Wood deterioration was common in the flooring in the sanctuary and gathering place. Corrosion was also found on the wooden staircase connecting the sanctuary and the gathering place. Problem areas on the floor and stairs were renewed with hardwood in line with the original.

- Physical destructions such as deterioration, wear and tear have occurred in elements such as the pulpit, mihrab and gathering-place kiosk, and lectern (Zan Mimarlık, 2015b). These items have been strengthened by cleaning the surface and filling holes, cracks and crevices.

- Missing and damaged sections were found on the railings on the gathering-place floor (Zan Mimarlık, 2015b). The railings were scraped and their damaged and missing parts were renewed.

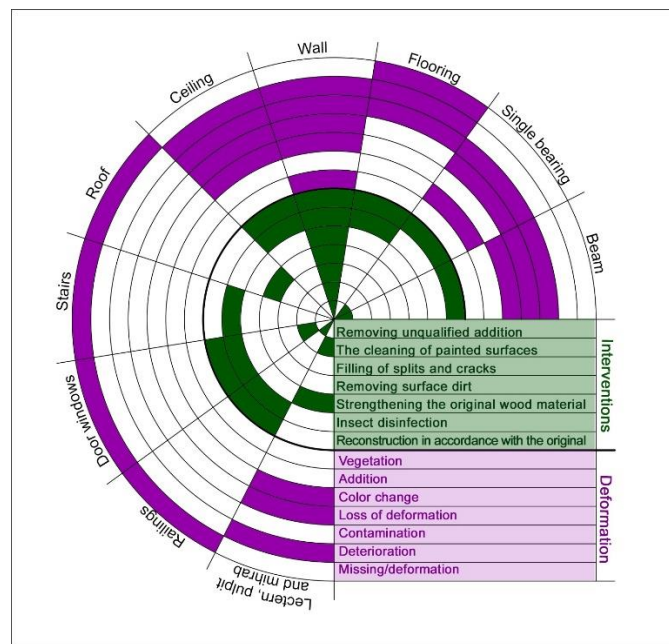
Figure 11. Deformation and interventions in wooden material in Ordu Mosque

When the problems and interventions in wooden material in Ordu mosque are evaluated on the basis of the construction element and its element (Figure 11);

- 6 different types of wood damage were found on the wall element of the mosque. These are missing/deformation, contamination, addition, vegetation and deterioration in wooden elements. These problems were intervened in the form of strengthening the original wood, removing surface dirt and insect disinfection (spraying) and removing unqualified addition.

- Missing / deformation and deterioration were observed in the wooden elements of the flooring. For this, strengthening the original wood material, insect disinfection and reconstruction in accordance with the original were preferred.

- In the single bearing, contamination and deformation were observed in the wooden element. Here, the cleaning of surface dirt and painted surfaces and the strengthening of the original wood material were followed.

- Deterioration was observed in the beams and throughout the ceiling, as missing and deformation of the wood in the ceiling core. Filling of splits and cracks, strengthening of original wood, cleaning of surface dirt and insect disinfection were carried out.

- Deterioration in the stairs, door windows and railings, loss of deformation and vegetation in additions and materials were seen. On the roof, on the other hand, problems of losing strength have emerged. In these four areas, it has been tried to be reconstructed in accordance with the original.

- Filling the splits and cracks, cleaning the surface dirt and insect disinfection for the addition and contamination seen in the lectern, pulpit and mihrab in the building.

Missing/deformation and deterioration of wooden material in the building are seen in points throughout the building and in larger areas in flooring. It is seen that the repair is based on the building in general, and the building element has been changed with the reconstruction in accordance with the original on the stairs, floor and roof.
