TITLE: Investigating the Geoenvironmental and Climatic Impacts on the Facades of Historical Houses in Killit (Dereiçi) Village, Mardin

Investigating the Geoenvironmental and Climatic Impacts on the Facades of Historical Houses in Killit (Dereici) Village, Mardin

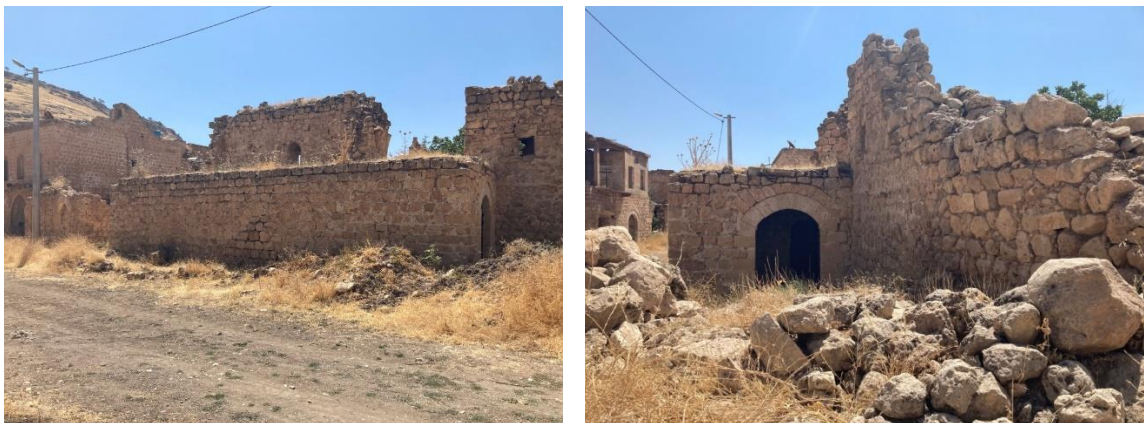
Figure 7. Deteriorations observed on parcel 1-2 of plot 179

The main building material of structures, which is stone, features smooth limestone used in the arch stones, window and door openings, and facade corner joints. Four of the upper-level window openings on the south facade of the parcels have wrought iron railings, and the surroundings of the window openings are adorned with material made of smooth limestone. The upper right part of the south facade is enriched with facade ornamentation and decorative elements using smooth limestone. Additionally, this part of the facade is terminated with a profiled sill and parapet stone made of smooth limestone. Iron railings that deviate from the original texture are used on the windows of the south facade of the parcel. A garden gate made of wood that deviates from the original texture is seen in the garden wall. On the ground floor of the parcel, on the left side, there is a wooden door with an ornate stone arch. Next to it, passing through a pointed-arched eyvan, there is a low-arched wooden door. On the upper floor, there are four circular-arched windows with smooth limestone. The upper floor is terminated with a row of sill and parapet stone. There are three decorative elements on the facade surface. On the protruding rubble stone wall between the entrance floor and the first floor, plant formations can be observed. The stone surfaces exposed to atmospheric conditions for an extended period show darkening. Cement-based material has been used in the joints on the facades (Figure 7). Corrosion is visible on the iron railings that have reached the present day. Large-scale disintegration is observed on the facades of the structures. Advanced levels of erosion issues are observed on the stone surfaces (Figure 8).

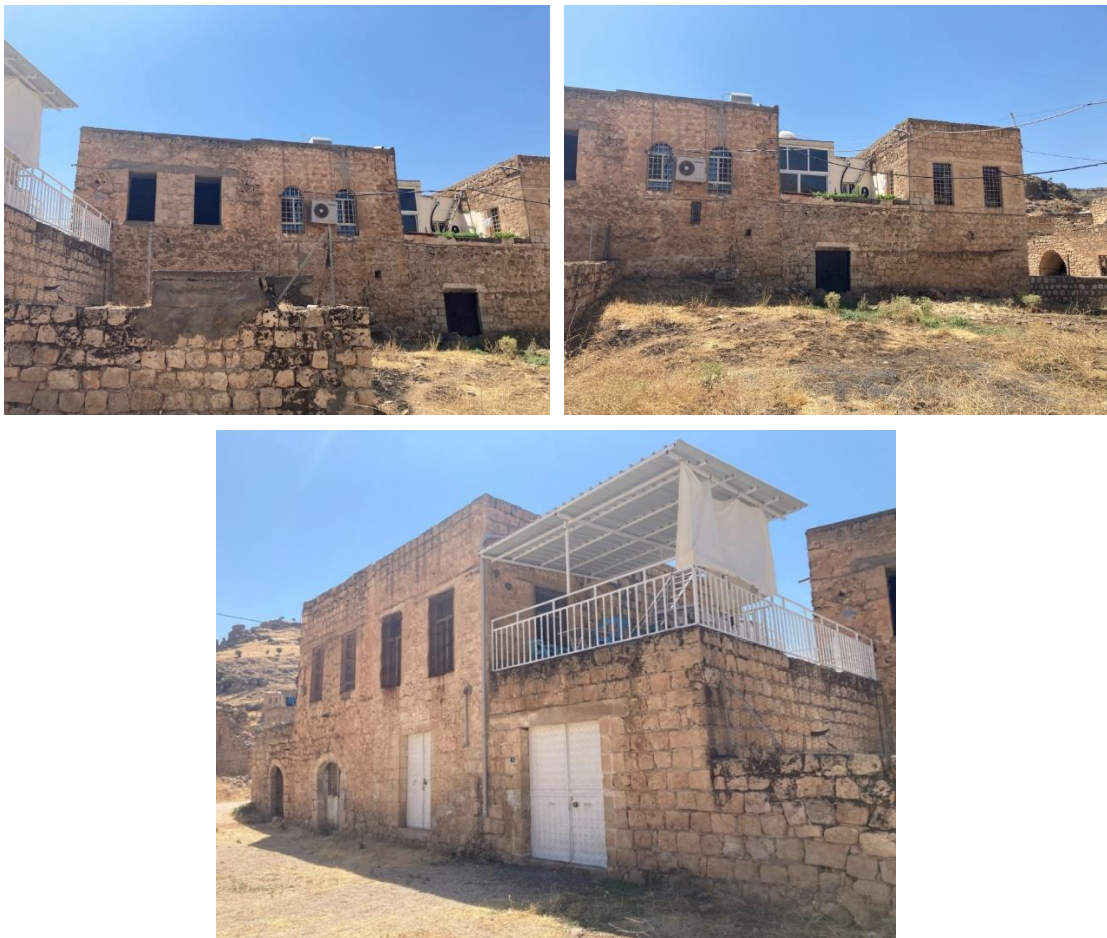
Figure 9. Deteriorations observed on parcel 3-4-5-6 of plot 179

In the Savur region on the facades of the structures, there is a significant occurrence of mortar voids between the joints and the problem of 'missing parts' on the facades. The walls of the structures exhibit a significant issue of "discoloration." Additionally, the street facades on the northern side, which do not receive direct sunlight, show a lesser extent of deterioration. Another observed form of deterioration is the use of cement mortar to connect and fill the large cracks and missing parts in many of the stone blocks used in some facade walls (Figure 9).

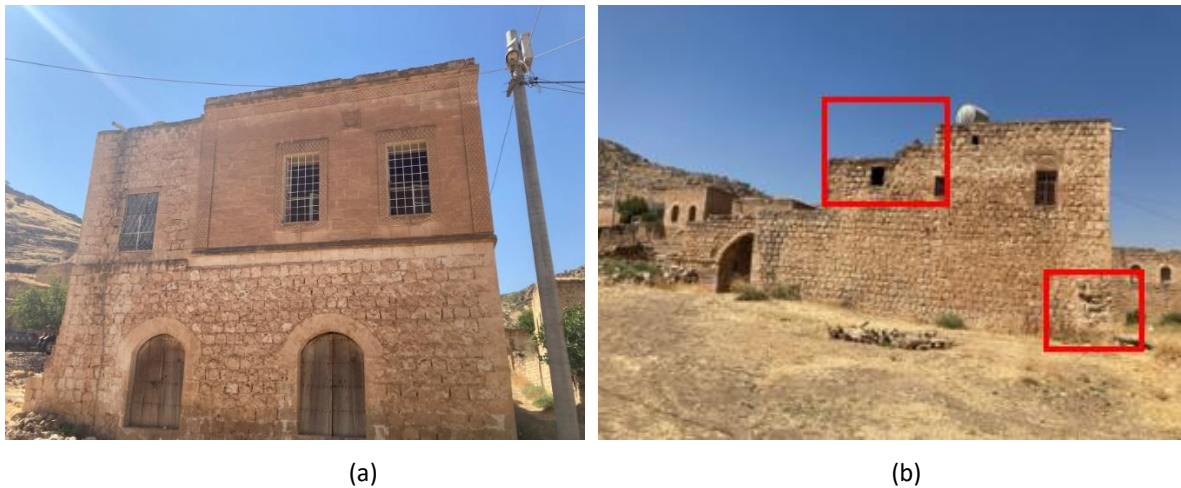
Figure 10. Deteriorations observed on the facade of parcel 1 on plot 186

The examined parcel is currently not in use. Discolorations are observed on the stone surfaces exposed to atmospheric conditions for an extended period on the facade. Cement-based material has been used in the joints on the facades. Collapses are observed in the staircase leading to the upper floor. Corrosion is visible on the iron railings that have reached the present day. Damage and deteriorations are observed in the wooden veneer doors. Unqualified fillings are observed inside and around the structure. Poorly executed window openings have been added later to the east facade of the structure. Two iron doors that deviate from the original texture have been installed. Window railings that do not conform to the original texture have been applied on the facade surfaces. Large-scale disintegration is observed on the facades of the structures (Figure 10a). Particularly, these damages are more prominently observed at the junction points of the walls and at the highest points (Figure 10b).
