TITLE: Analysis of Deterioration on Stone Surfaces: The Case of Kasimiye Madrasah

Analysis of Deterioration on Stone Surfaces: The Case of Kasımiye Madrasah

Citation: Biçen Çelik, A., Ergin, Ş., Dal, M. & Ay, İ. (2023). Analysis of Stone Deterioration on the Facades of the Kasımiye Madrasah. *Journal of Architectural Sciences and Applications*, 8 (2), 696-712.

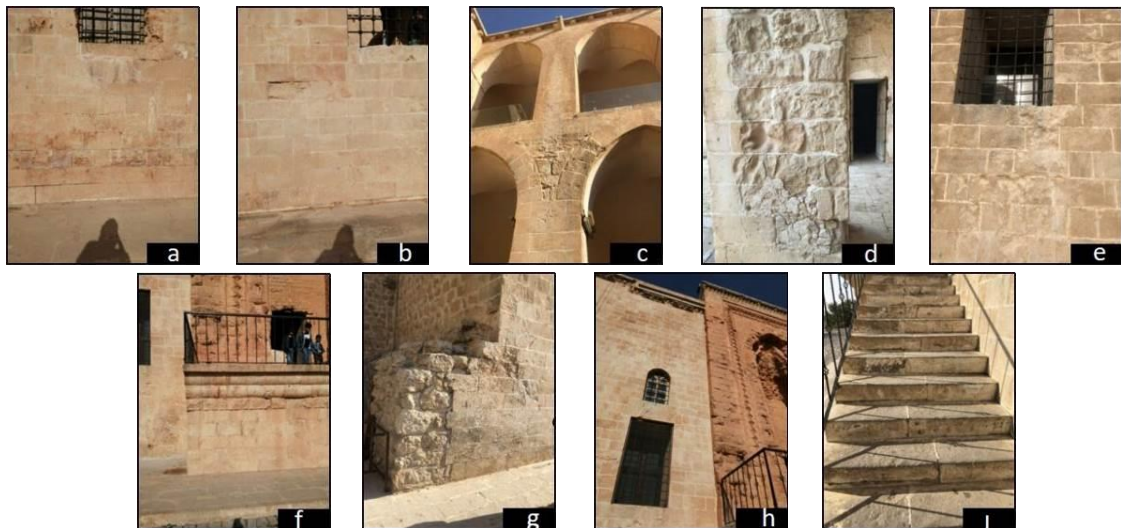
Figure 5. Physical deterioration of Kasımiye Madrasah (Biçen Çelik, 2019)

The deterioration of Kasımiye Madrasah was analysed in four groups physical, chemical, biological, and anthropogenic deterioration. The physical deterioration of Kasımiye Madrasah as a result of environmental and climatic factors is shown in Figure 5. As a result of climatic factors, capillary cracks in the walls (Figure 5a), fragment breaks in the window openings (Figure 5b), fragment breaks in the inner courtyard (Figures 5c and 5d), abrasion caused by wind-borne dust on the south façade (Figures 5e and 5f), fragment breaks, capillary cracks and joint discharges on the main portal and west façade of the building (Figures 5h and g), and abrasion on the entrance staircase due to visitor flow (Figure 5i).

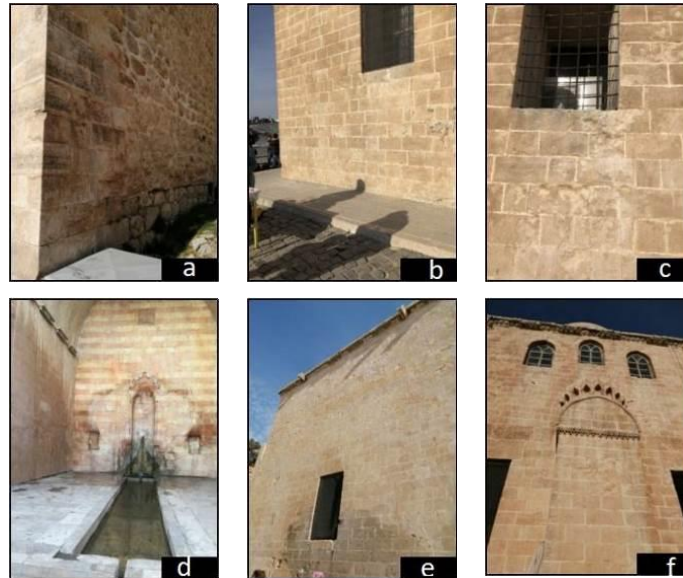
Figure 6. Chemical deterioration in Kasımiye Madrasah (Biçen Çelik, 2019)

Salination and discoloration caused by climatic factors in Kasımiye Madrasah are shown in Figure 6. Salination is caused by the dissolution and evaporation of the salts in the limestone under the influence of humidity and temperature (Figure 6a, 6b and 6c) and discoloration is caused by the interaction of the minerals in the stones (Figure 6d, 6e and 6f) were observed.

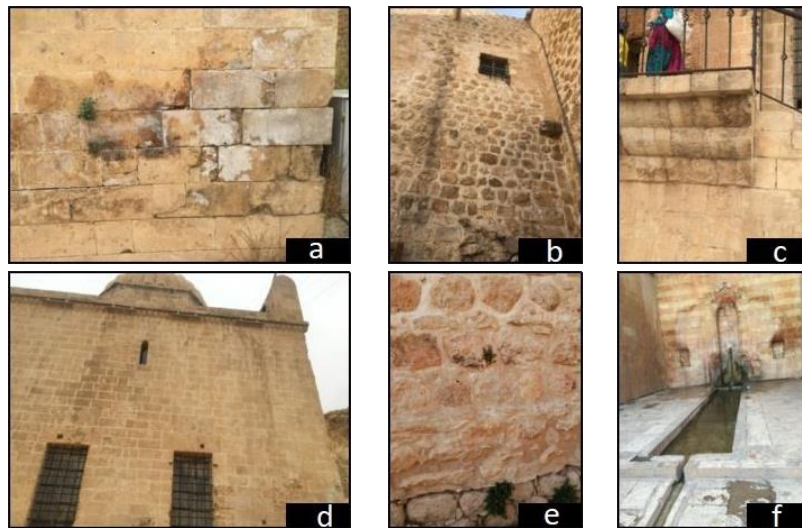
Figure 7. Biological deterioration in Kasımiye Madrasah (Biçen Çelik, 2019)

Biological deterioration occurring in Kasımiye Madrasah is shown in Figure 7. Plant formations are observed as a result of the interaction of the seeds that settle inside the capillary cracks with water (Dal & Yardımlı, 2019). Plant formations were observed on the south façade (Figure 7a) and east façade (Figure 7e) of the building, biochemical deterioration caused by bacteria settled on the stone surfaces (Figures 7b and 7c), deterioration caused by bird droppings (Figure 7d) and moss formations in the selsebilli iwan (Figure 7e).

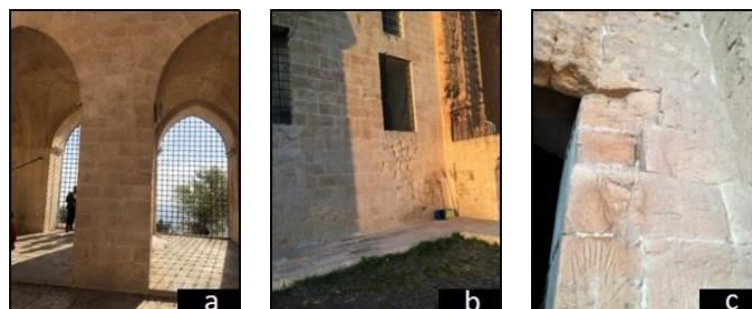
Figure 8. Anthropogenic deterioration of the Kasımiye Madrasah (Biçen Çelik, 2019)

The deterioration of Kasımiye Madrasah as a result of anthropogenic impacts is shown in Figure 8. As a result of the damage caused to the building by unconscious users with sharp tools, deterioration was observed on different facades (Figure 8a, 8b and 8c).

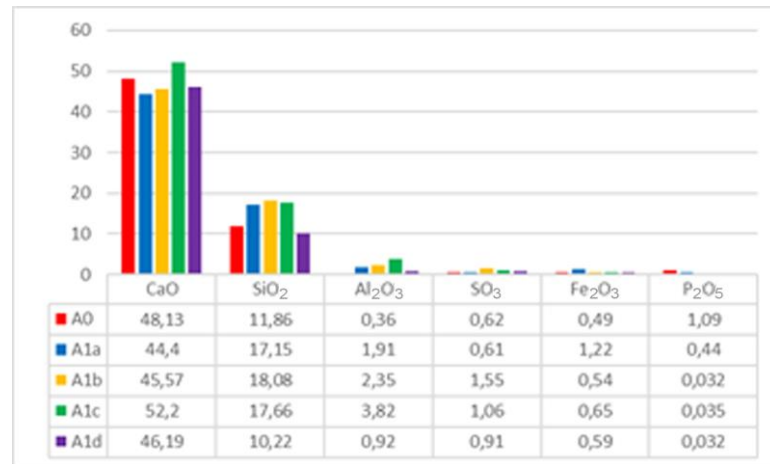
Table 7. XRF chemical analysis results of physical deterioration observed on the facades of Kasımiye Madrasah

The results of the analysis of the physical deterioration in Kasımiye Madrasah according to XRF analysis method are given in Table 7. According to the analysis results, changes in SO_3 , SiO_2 and CaO ratios are remarkable. An increase in SO_3 occurred in A1b stone. The increase in SO_3 ratio is due to the air pollution of the stone. It can be said that the strength of the stone increases with the increase in SiO_2 ratio. While the SiO_2 ratio was 11.86% in A0 stone, this ratio was 18.08% in A1b stone. The clays decomposed on the stone surface cause the SiO_2 ratio to increase. Changes are observed in the stones due to daily and annual temperature differences and different minerals in the stones. Physical deterioration such as capillary cracks, surface abrasions and fragment fractures were observed in Kasımiye Madrasah (Karataş, Alptekin & Yakar, 2023).

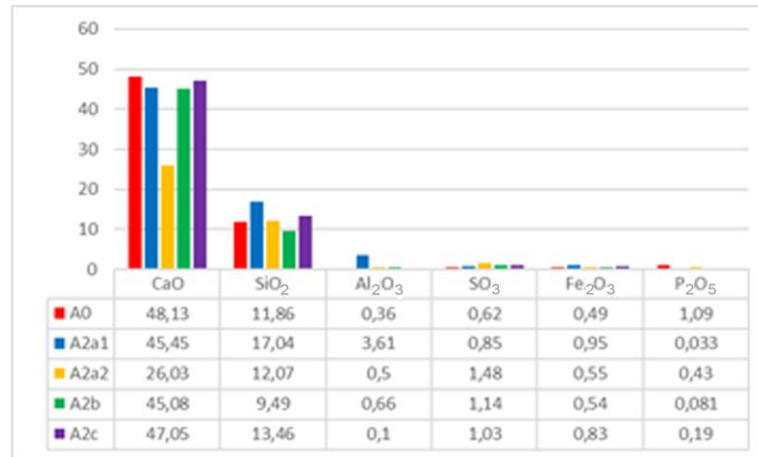
Table 8. XRF chemical analysis results of chemical deterioration observed on the facades of Kasımiye Madrasah

The results of XRF chemical analyses of the chemical deterioration in Kasımiye Madrasah are shown in Table 8. According to the results obtained, it is seen that the CaO ratio decreased in stone A0 compared to other stones. Since the SO_3 ratios in A2a2 and A2b stones are high, it can be said that they are affected by air pollution. While the SiO_2 ratio was 11.86% in A0 stone, this ratio increased to 17.04% in A2a1 stone. This increase is due to the carbonated silica and marl (clayey limestone) content in the structure of the stone. When other compounds are examined, it is seen that there are no serious changes (Table 8).

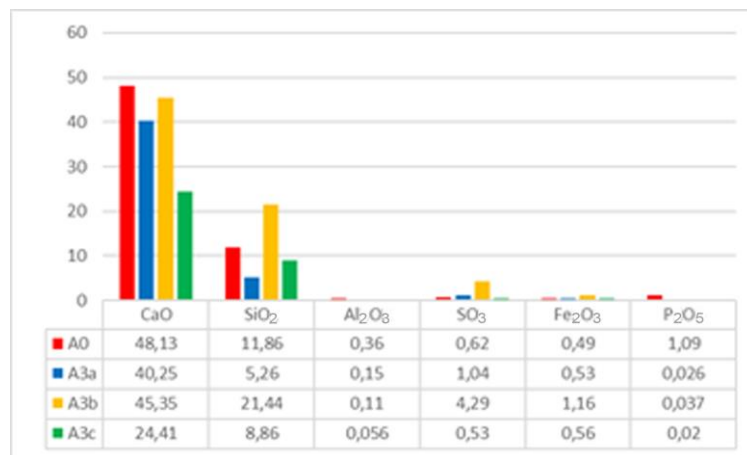
Table 9. XRF chemical analysis results of biological deterioration observed on the facades of Kasımiye Madrasah

The results of the analysis of biodeterioration in Kasımiye Madrasah are given in Table 9. According to the analysis results, a decrease in CaO ratio was observed. It can be said that the reason for the decrease in CaO ratio in stone A3c is the interaction of acids secreted by bacteria. The change in the SiO_2 ratio in stone A3b draws attention. While this ratio was 11.86% in stone A0, it was measured as 21.44% in stone A3b. No significant changes were observed in other compounds (Table 9).

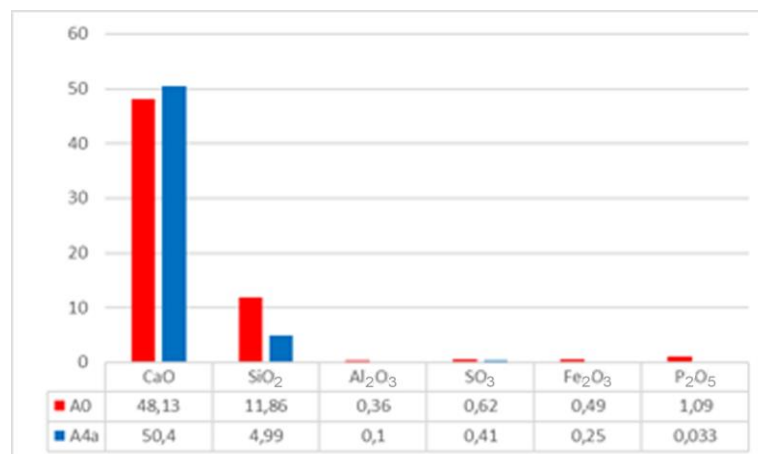
Table 10. XRF chemical analysis results of anthropogenic deterioration observed on the facades of Kasımiye Madrasah

When the anthropogenic deterioration in Kasımiye Madrasah was analysed by XRF chemical analysis method, an increase in CaO ratio and a decrease in SiO₂ ratio were observed. While the SiO₂ ratio was 11.86% in stone A0, this ratio decreased to 4.99% in stone A4a. Clay deposits were observed from the degraded stone surfaces (Table 10).
