TITLE: Investigation of the Morphological and Color Changes of Damaged Green Plums During Storage Time Using Digital Image Processing Techniques

# Investigation of the Morphological and Color Changes of Damaged Green Plums During Storage Time Using Digital Image Processing Techniques

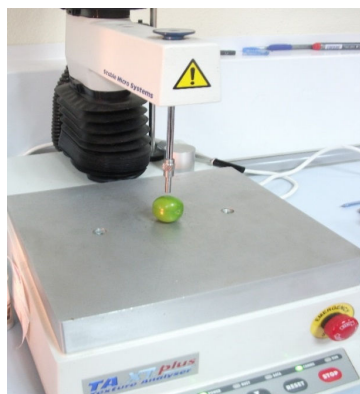
A damaging application was performed on green plums using a Texture Analyzer (TA.XTPlus, Texture Technologies Cor., Scarsdale, N.Y., USA) (Figure 1). Each green plum was punctured from a different distance. The distances were 3 mm, 5 mm and 10 mm. The texture analyzer executed at 3 mm/s constant speed with a compression mode using a 5 mm diameter probe.

Figure 1. An image of damaging application of the green plums

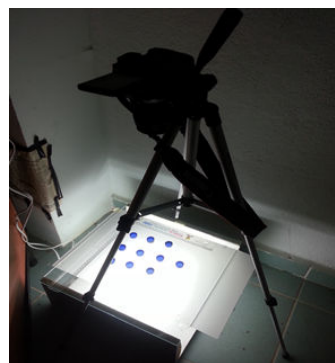
*Image acquisition system:* It contains image acquisition tool and digital camera. Image acquisition tool is prepared size of 40 cm x 40 cm x 15 cm as shown in the Figure (2). Fujifilm FinePix AV100 model digital camera is used to capture and it is placed on a tripod to prevent vibrations that may occur during shooting.

Figure 2. An image of image acquisition unit
