TITLE: A Visual Approach to the Damage Diagnosis of Monoliths from the Monquirá Archaeological Park - El Infiernito in Colombia

AUTHORS: Ali Duran Öcal, Thomas Cramer, Selim Aziz Kapur

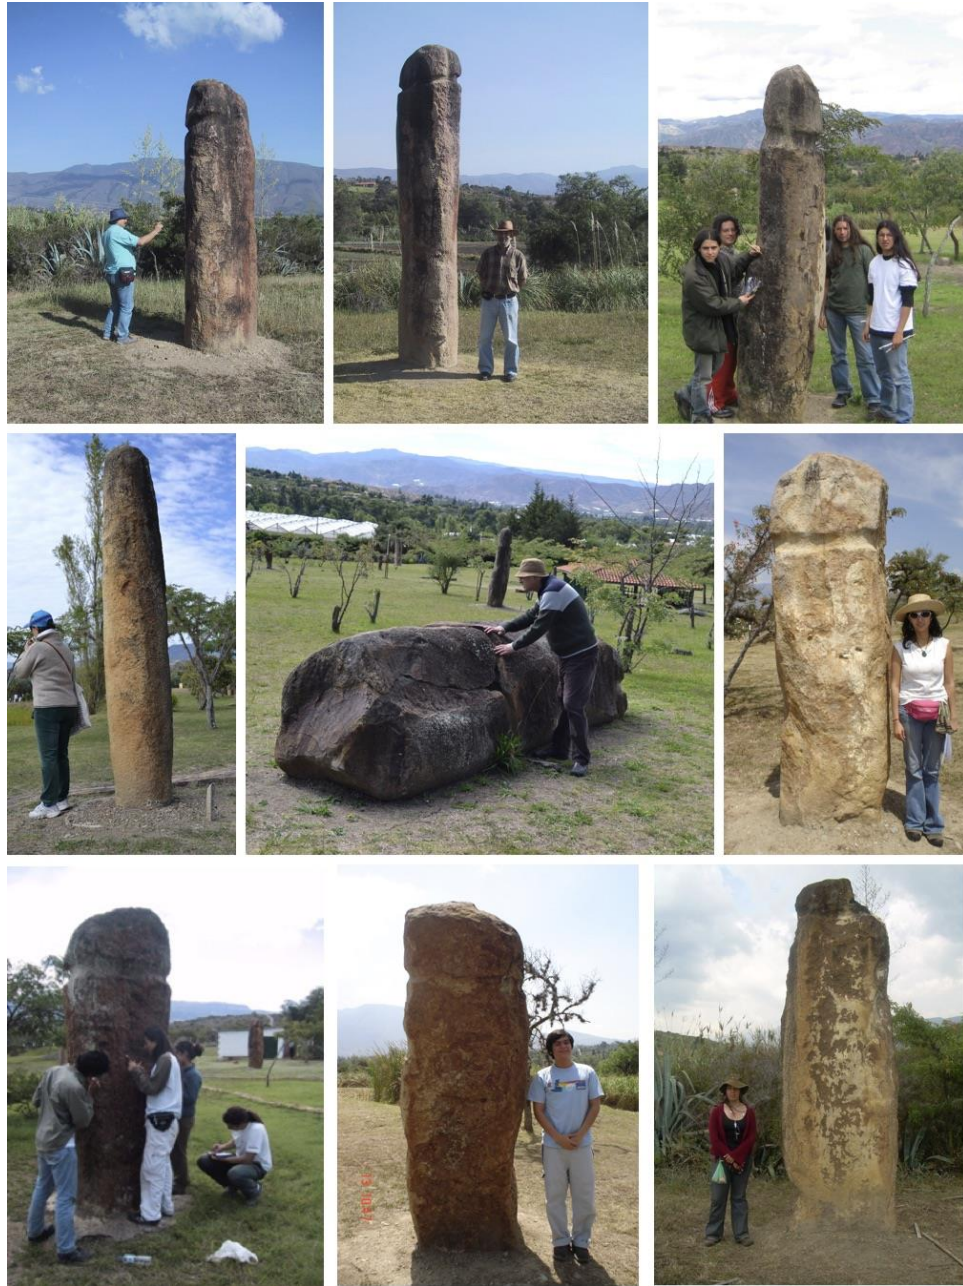
More than 150 monoliths of various shapes, sizes and layouts on the grounds of the Monquirá Archaeological Park "El Infiernito" have been studied in detail [18-20] and the deterioration indicators were defined in situ (Figure 3). The deterioration of a stone monument is characterized by the type and extent<sup>4</sup> of the damage. In order to accurately record deterioration phenomena, a differentiated classification scheme was needed.

**Figure 3.** Images of the monoliths with people to get a general idea of their sizes; some monoliths are fallen on the ground

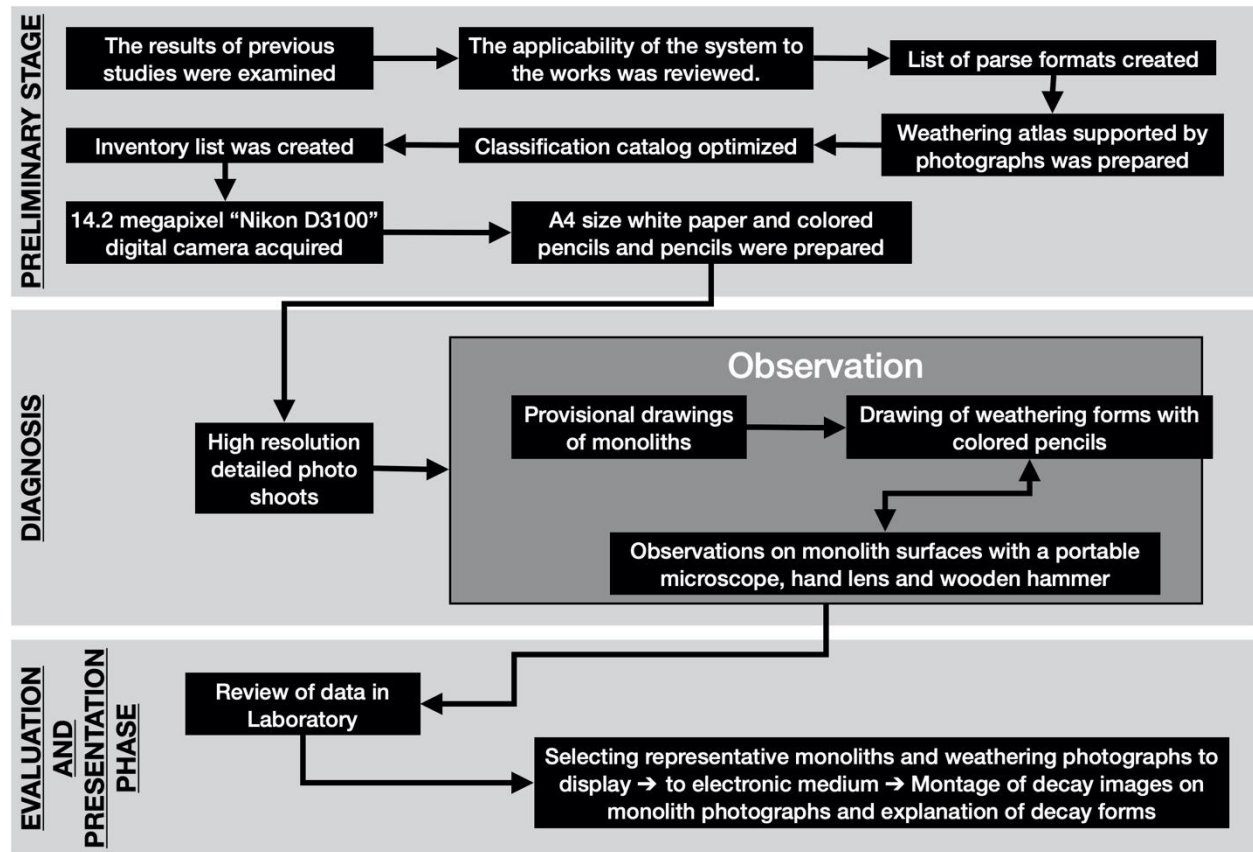
**Figure 4.** Schematic representation of the workflow

This study focused on the sandstone monoliths decay using photographic documentation and in situ observations. As the first step, preliminary preparations were undertaken by compiling earlier photographic materials, documents concerning production and previous methodologies. With or without earlier documents, a damage picture is only useful as a deformation-based inventory measurement, utilized to precisely record existing sculpture details. Thus, the natural stones found were registered in lithographic inventories, including any existing stonemason's marks, inscriptions, small art pieces, etc. Sculptural details such as defects, damages and recognizable repairs were also documented.

In the second stage, the observations at the monuments site were integrated into a temporary deterioration map. The activities at the research site included the description of the monoliths and photographic documentation. These documentations were conducted on the determination of the damage of the monoliths that were necessary to provide sufficient information for an adequate diagnosis and selection of the solutions for their conservation and maintenance. In the third and final stage of the study, the temporary weathering-state map created was evaluated and the work was continued by moving to the final mapping that concerned the accomplishment of the final version of the deterioration map. Moreover, at this stage, synoptic damage posters of selected monoliths were arranged and visual descriptions of the deterioration of the artifacts were developed.

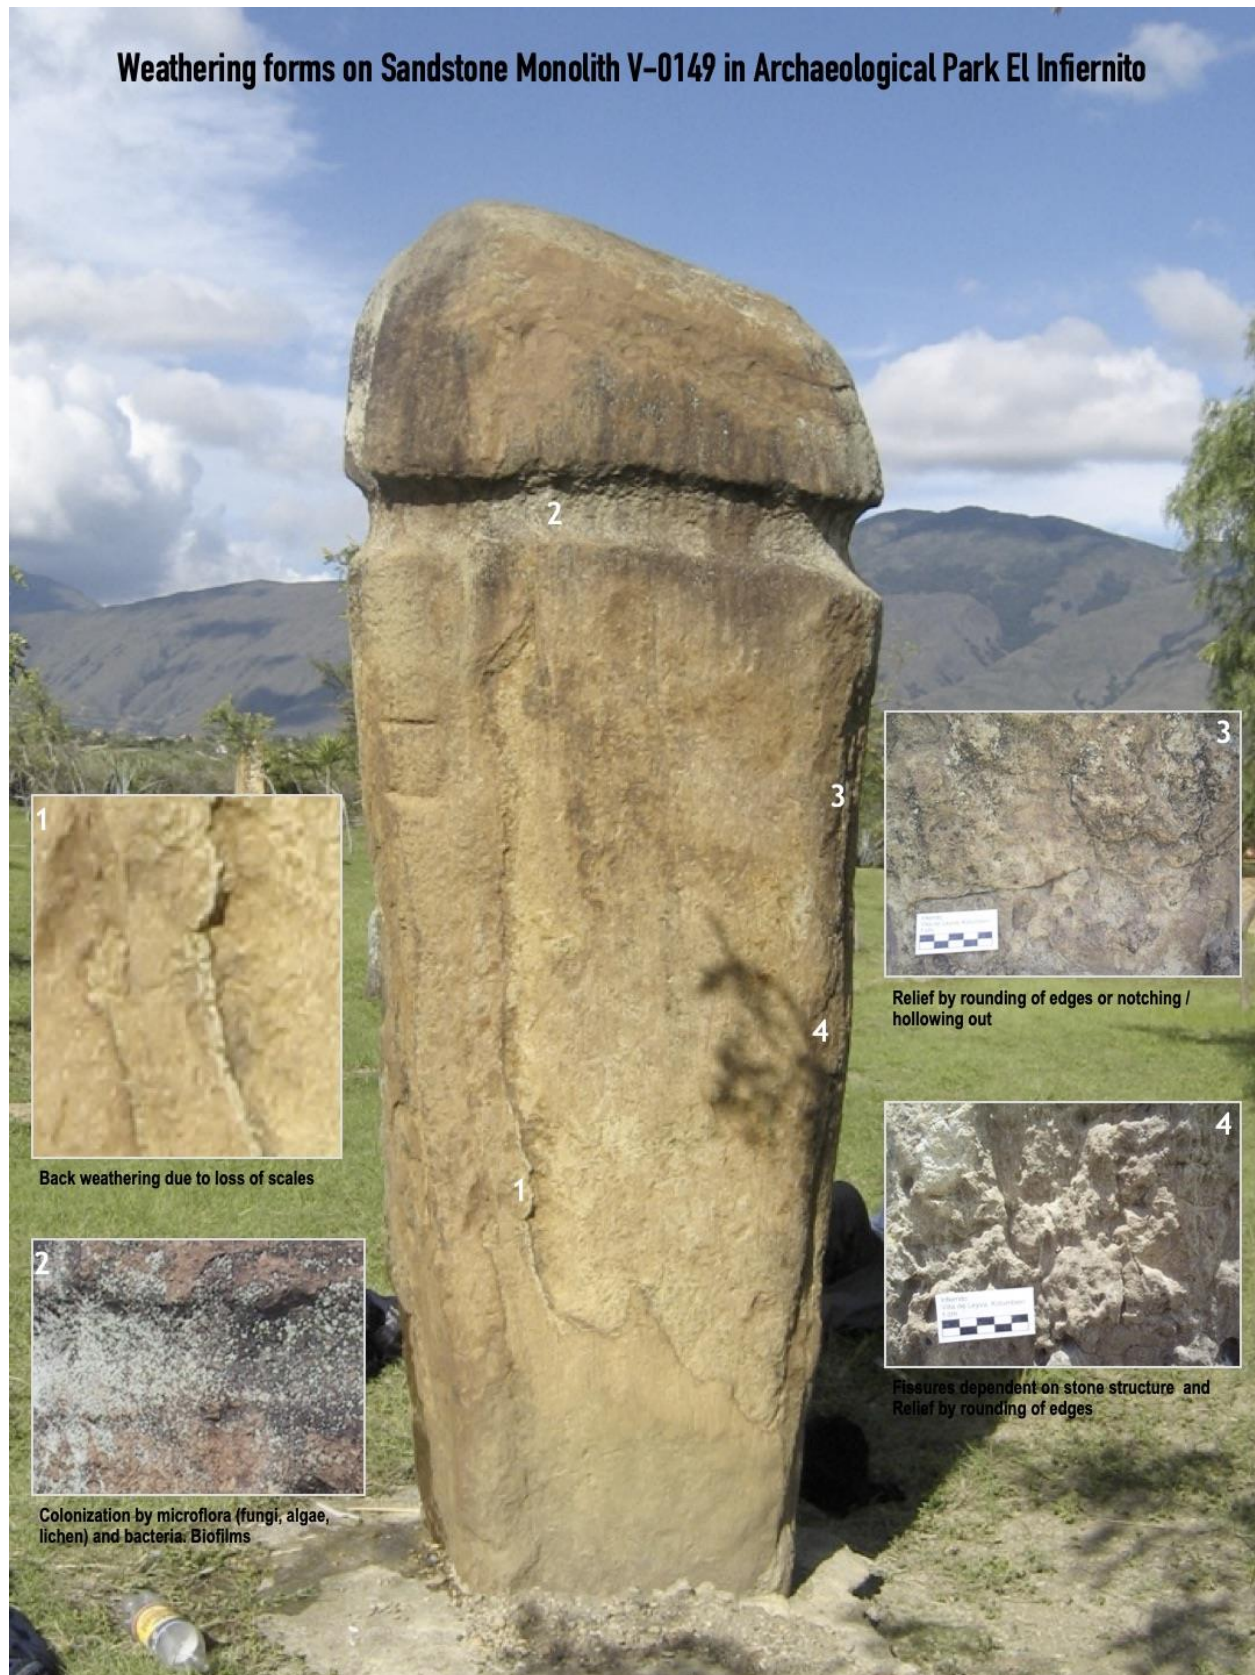
**Figure 6.** Visual representation of the deterioration on the synoptic damage poster of the selected monolith V-0149

The damage detection in the monoliths used the synoptic photographic presentation experiments (Figure 6-8) in this study, which were conducted to ensure a more rapid perception of the damage on the artifacts in search of an alternative visuality, in addition to the preparation of damage maps. This type of a synoptic poster shows ways of presenting and characterizing the processes of morphological change occurring in monoliths. This photographic approach can provide researchers and decision makers with a brief view of the conservation processes, the types of degradation revealed as a result of the research, and can help speed up the monument preservation process as it will be easier to understand.

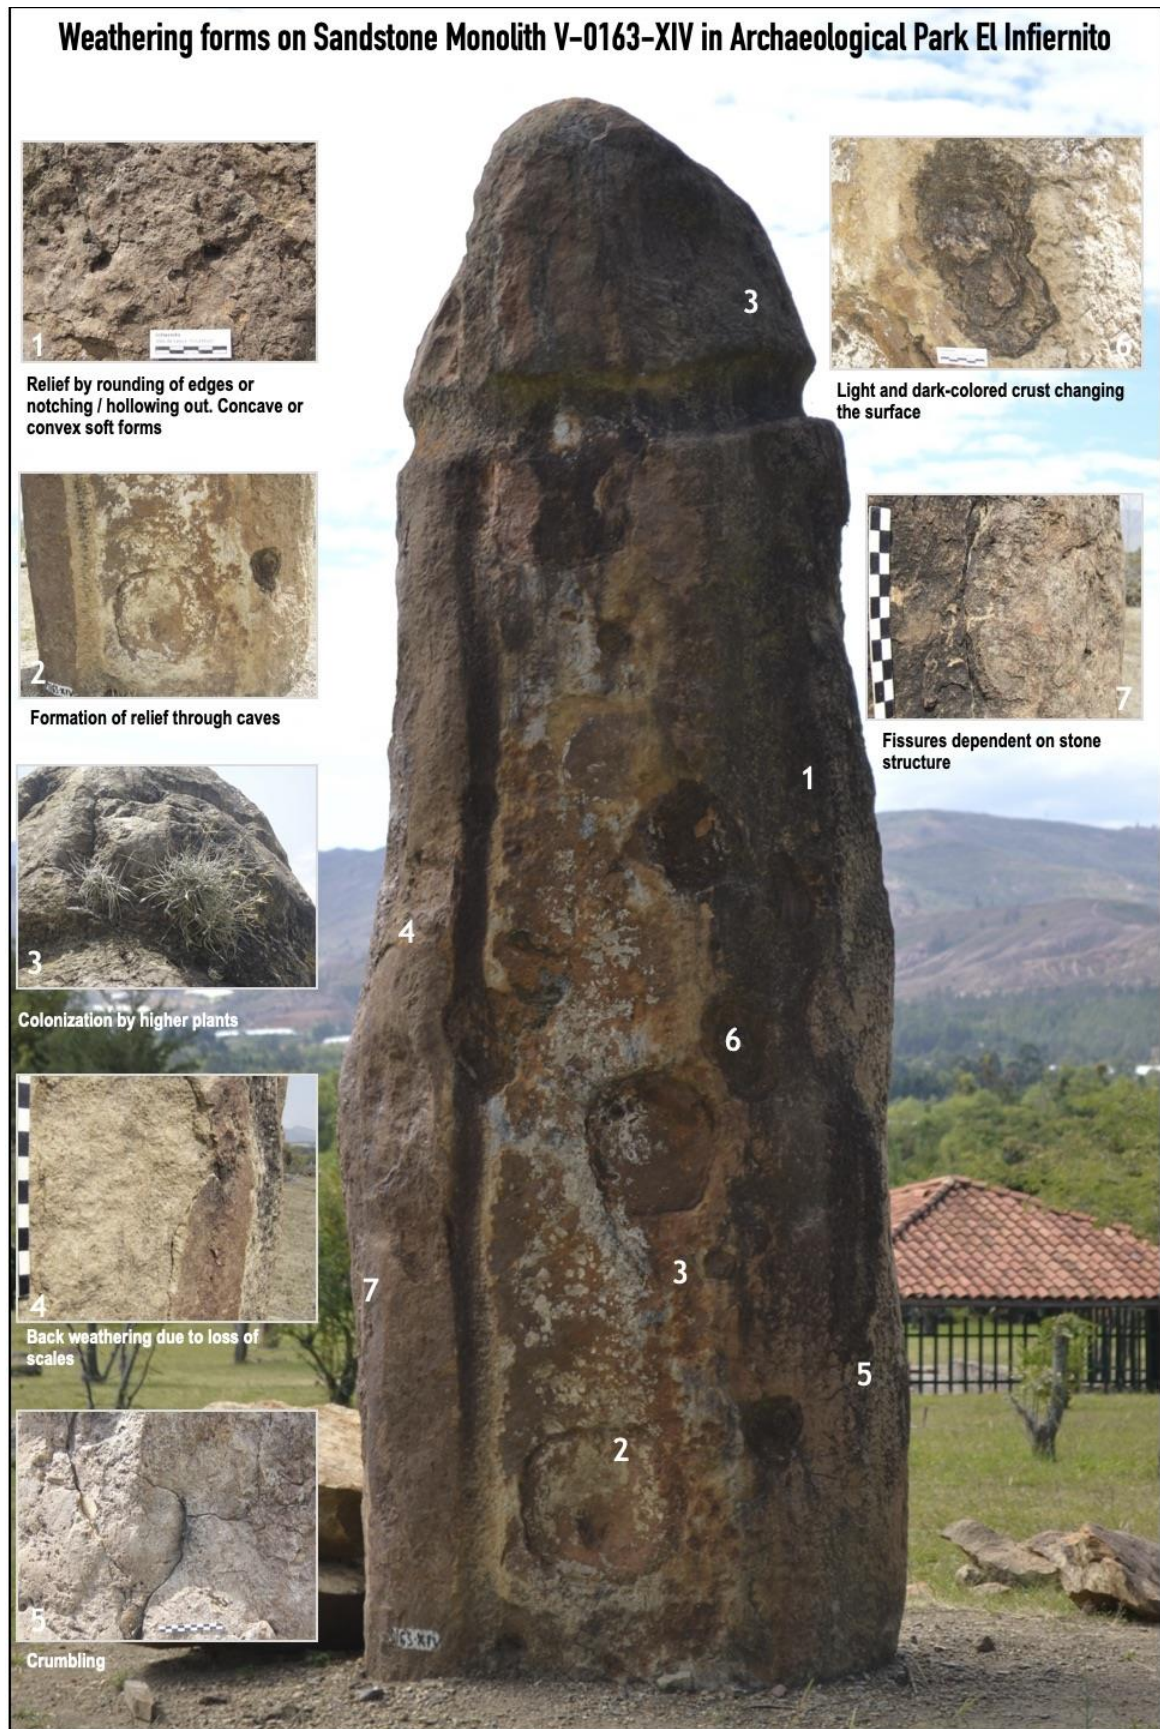
**Figure 7.** Poster of Monolith V-0163 showing damage patterns in synoptic image-analytical evaluation

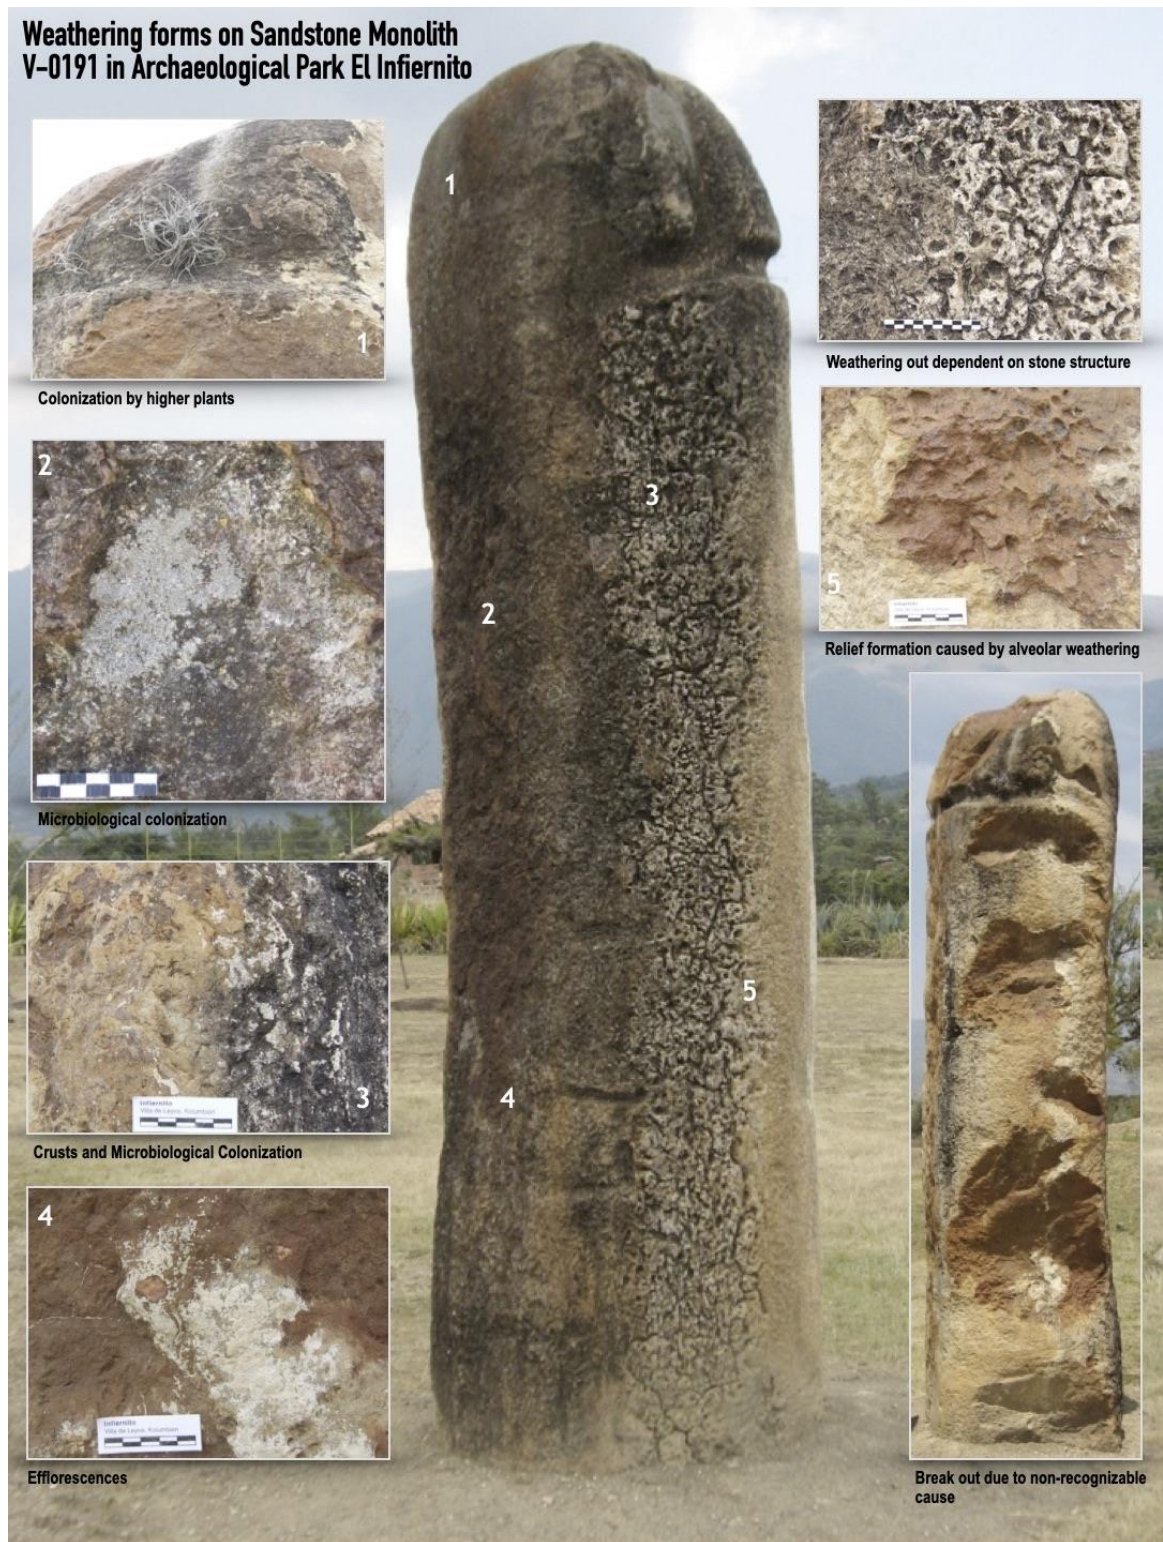
**Figure 8.** Synoptic damage poster of monolith V-0191 with well-represented degradation samples

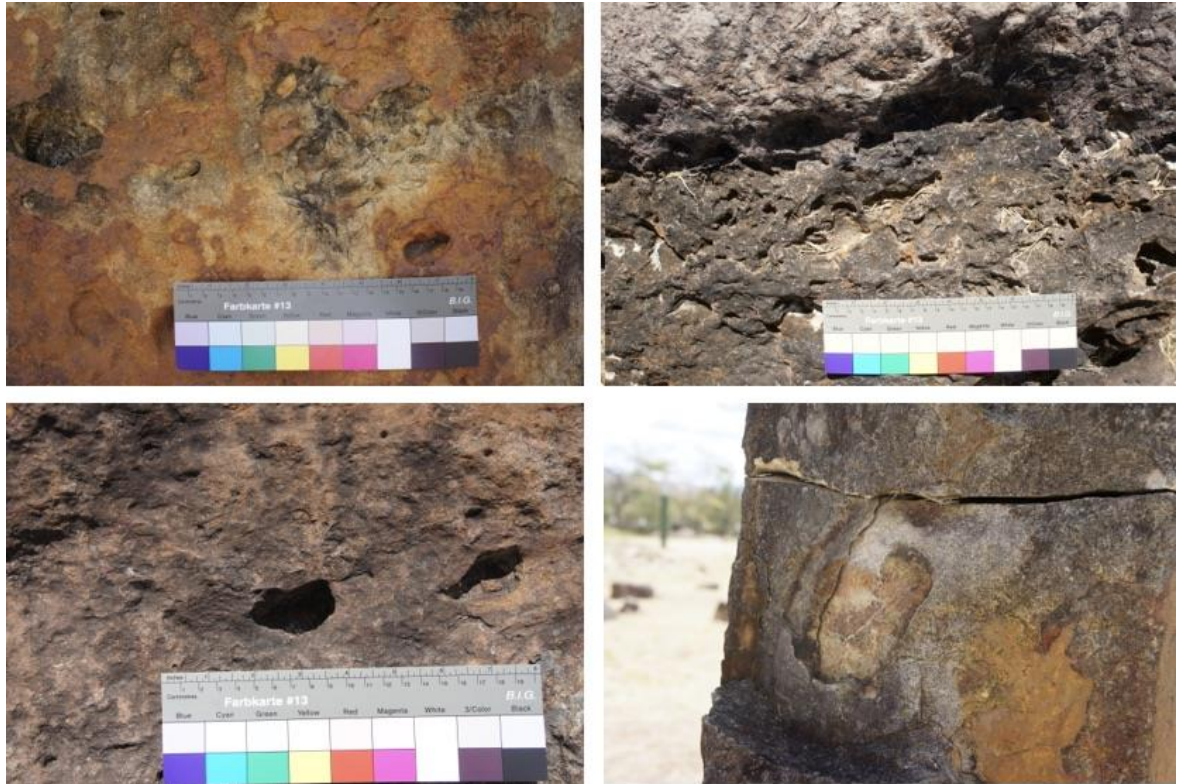
The predominantly occurring types of damages observed on the monoliths are: alveolization, bursting, back-weathering, relief and covings and rounding. Areas near the surface of the stone erode to different degrees and create a relief in movement, by loss of components or by weathering parallel to the outer or sedimentary layer. As typical of alveolar weathering, honeycomb-shaped structures frequently occur in monoliths (Figure 9).

**Figure 9.** Relief caused by out-weathering of fossil components (upper left) and alveolar weathering (upper right); cavernous weathering (down left) and bursting on the monoliths

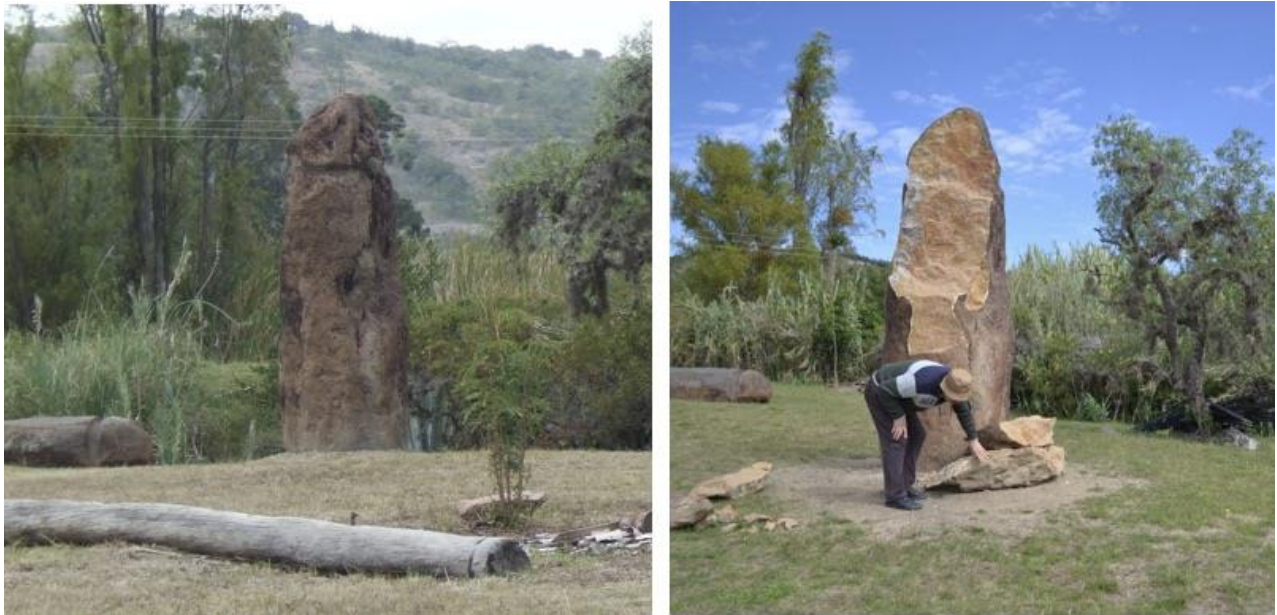
especially in the sites of water splashes, salt was visibly produced. Loss of material and discoloration were observed in some monoliths, whereas other sites show large cracks while exposure-related flake formations are clearly recognizable.

**Figure 10.** *The weathering of the Monolith V-0163 within 10 years (2009 to 2019), probably because the necessary conservation measures were not taken*
