TITLE: The Basilica Mosaic on Asar Island at Myndos

AUTHORS: Derya Sahin,Y Selçuk Sener

The Basilica Mosaic on Asar Island at Myndos

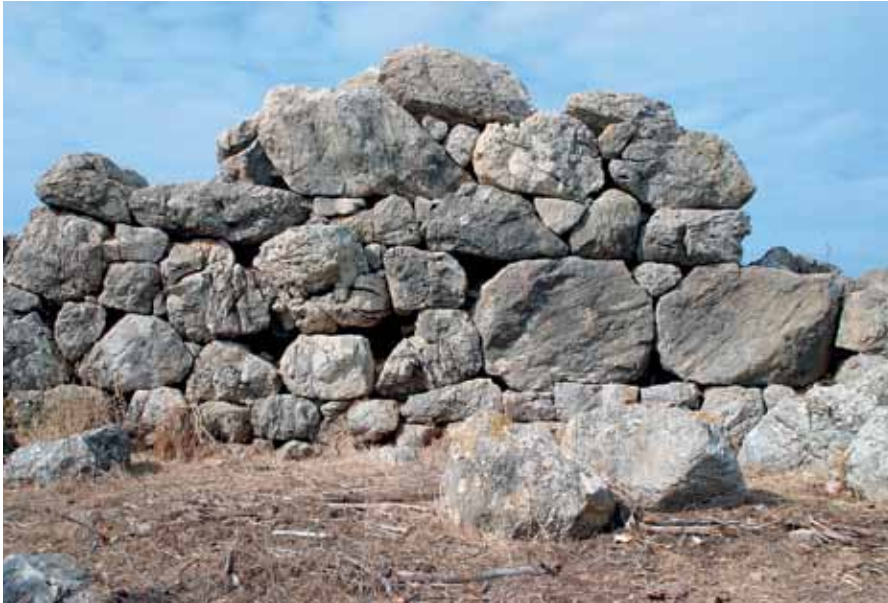
Figure 5
Lelegian Walls
(Myndos Excavation Archive)

In the city is a second city wall, which only surrounds the peninsula and is not connected to the other walls (Fig. 5). Larger stone blocks are used in the wall, and thus, it is called the “Leleges wall”. The technique and the gray stone distinguish it from the other walls. The stones are rectangular and polygonal. In some parts the thickness of the wall is 1,20 m. The appearance and technique of the

wall is similar to the city walls of Tiryns, which are dated to the second half of the 2nd millennium B.C.. This dating corresponds with Strabon's account and confirms that the foundation of the city has to predate Mausolos.

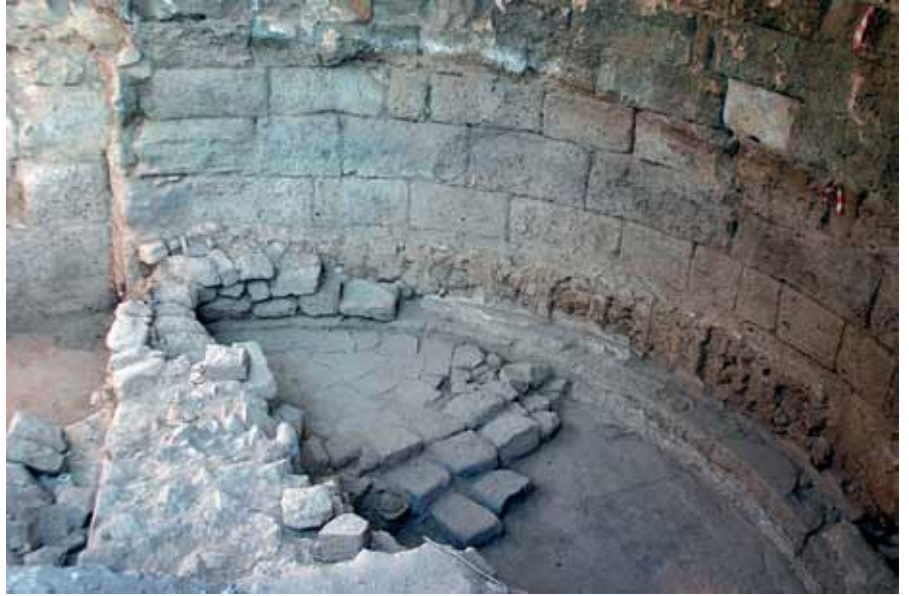
Figure 6
The Bath
(Myndos Excavation Archive)

Another preserved building could be an imperial bath and lies 20 m northeast of the church (Fig. 6). The preserved length is 38 m and the width 12 m. Only the caldarium with the apse is still standing. According to local inhabitants, many marble bath basins were taken out of a cistern 100 m to the south; the owner of the land eventually stopped this practice and covered the well. Another interesting discovery was the artifacts in the mouth of the artificial harbor, which would have protected the eastern harbor. Here, we found two rooms, which lie upright on the foot of the slope and parallel to the artificial harbor, with a girdled cover. Traces of a mosaic pavement remain on the floor. The threshold of the southern door leads us to believe that this place was.-

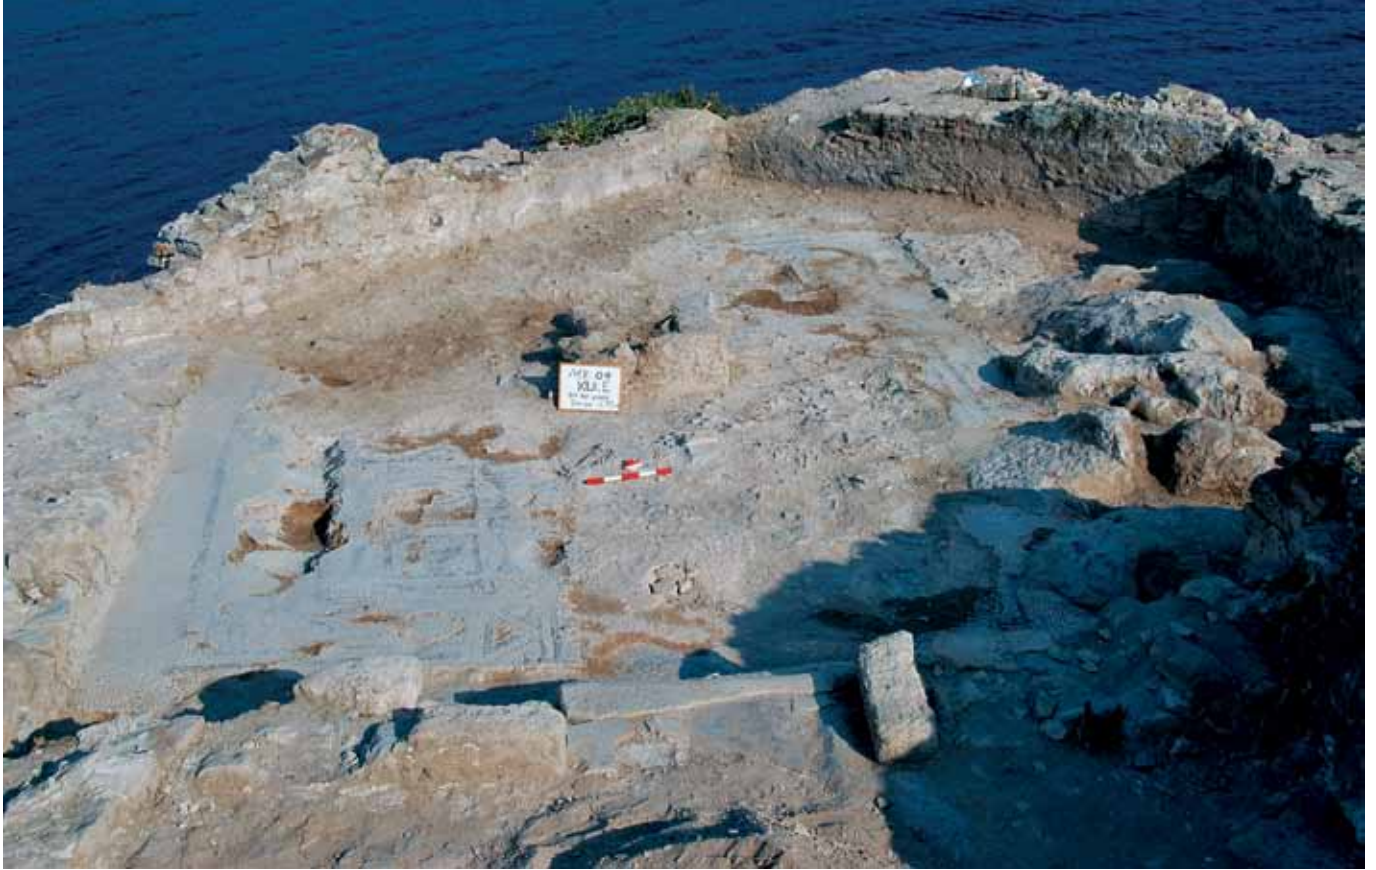
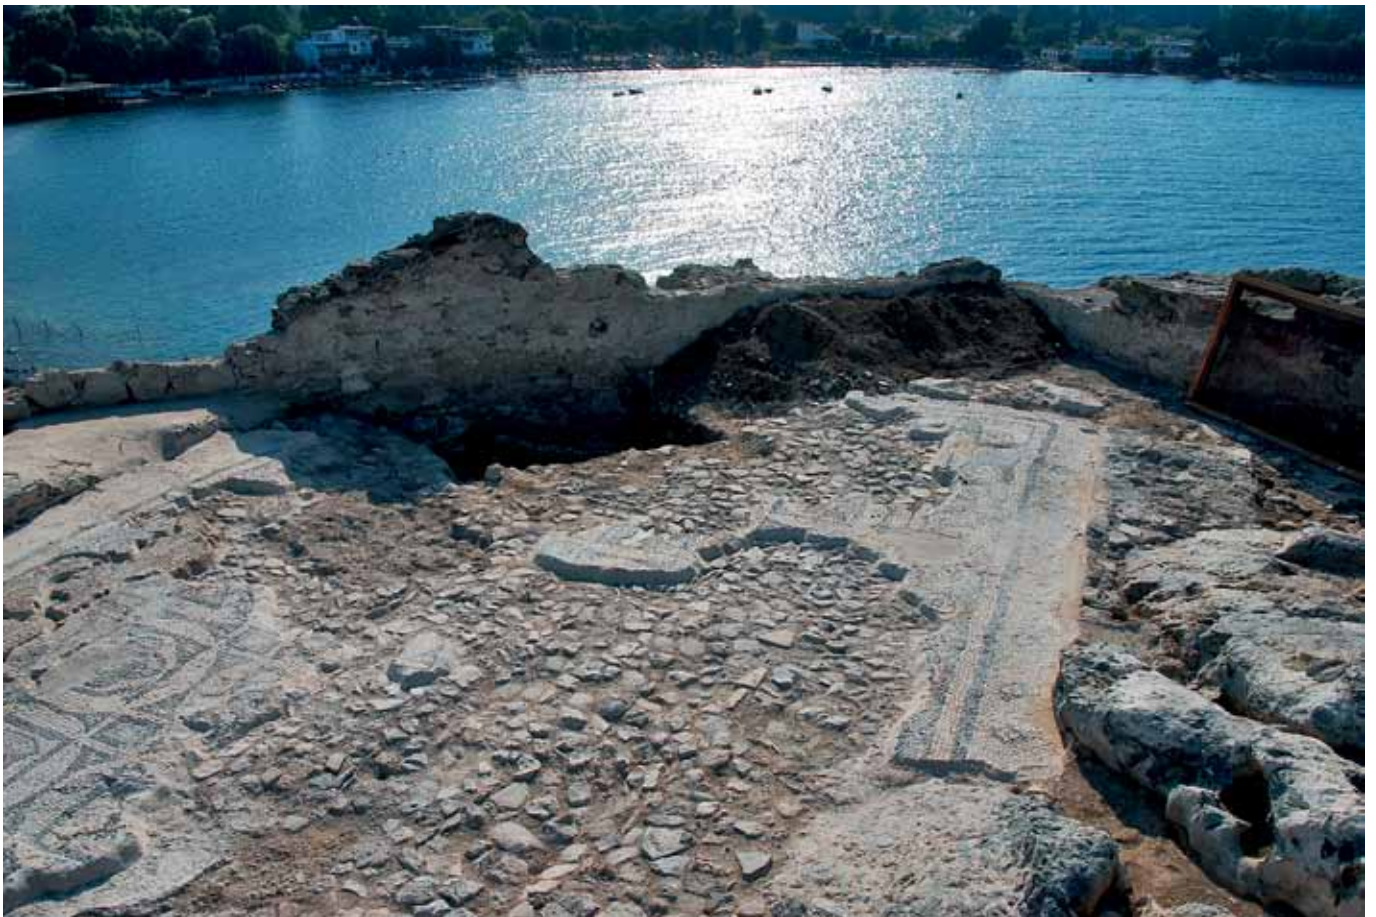
Figure 8
General view of the Mosaic
from Asar Island
(Myndos Excavation Archive)

Figure 9
General view of the Mosaic
from Asar Island
(Myndos Excavation Archive)

Excavations began with a 4x3 m drill into the middle of the tower building; because the finds exceeded our estimations, the excavation spread to the entire zone within the ramparts. During the excavations, the whole building was unearthed. There is a mosaic base on the floor (Şahin 2009). The mosaic floor is partially destroyed, most likely from later settlement phases (Figs. 8-10). The mosaic floor here points to the existence of a building other than a watchtower.

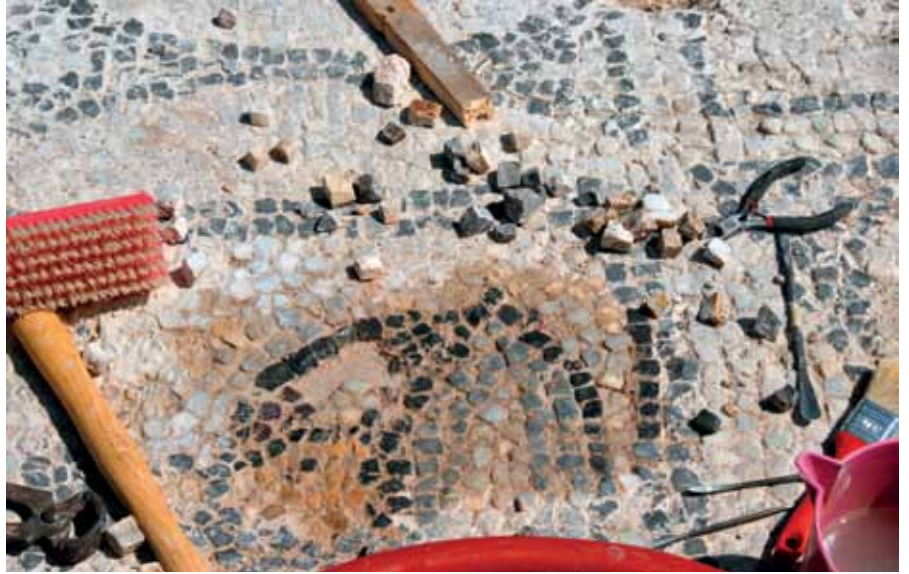
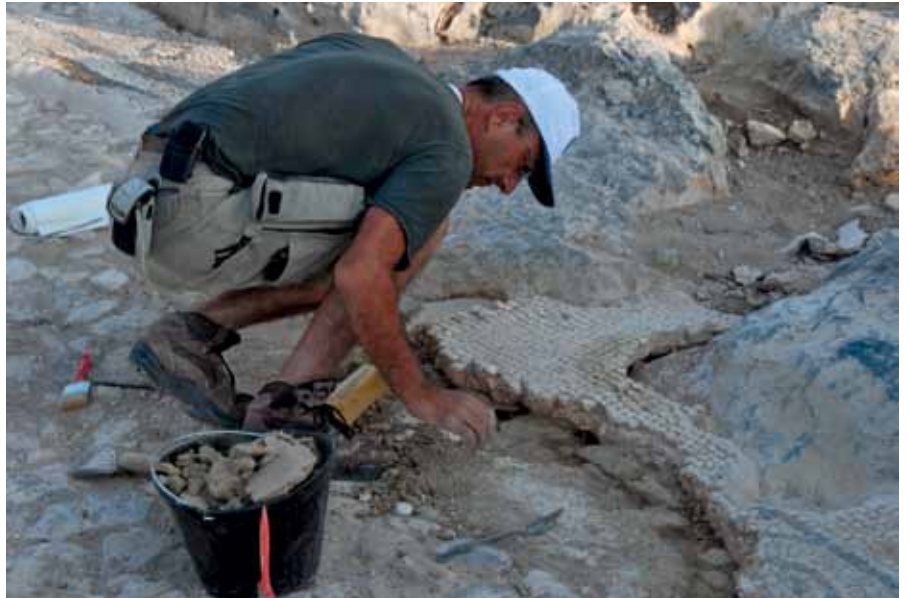
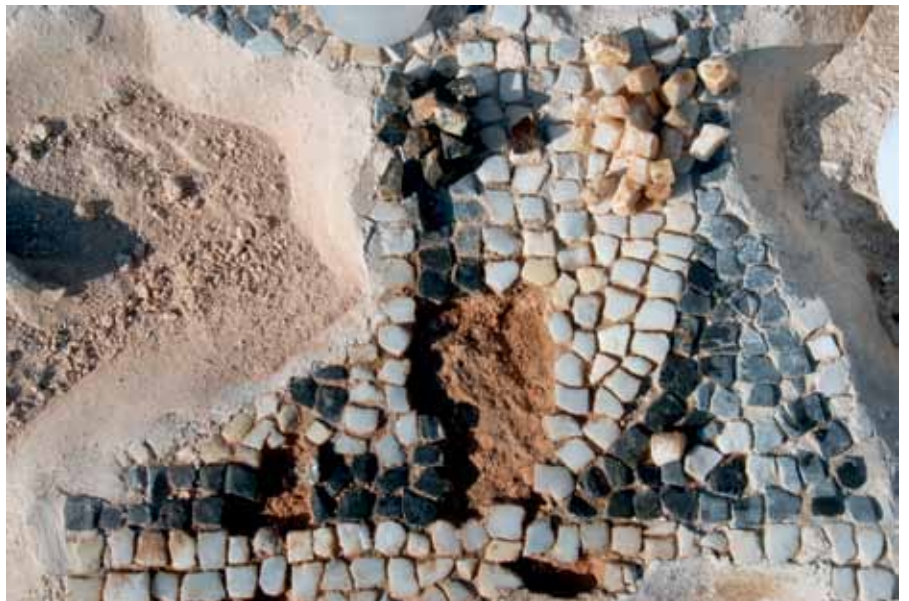
Fig.14
Restoration Work on the
Mosaic from Asar Island
(Myndos Excavation Archive)

There is a depression 2.5 m long and 40-50 cm wide near the north side of the existing mosaics, most likely caused by heavy falling objects from the collapse of the original structure. The formation of a depression and the existing mortar layers suggest that the base of the mosaic softened from exposure to dampness and was subsequently significantly deteriorated. The deterioration, in addition to changing the mosaic's structure, led to further deterioration because the weakening in the depressed and surrounding area enabled plants to root easily. The roots observed growing in the depression; the resulting large crevices, cracks, and tesserae losses; and the disintegration, pulverizing, and splitting in the lower layer of mortar support this idea.

Cracking appears at the deterioration of the unity of the surface and the layer, which is about the tessellatum layer with the nucleus and rudus mortar layers below. Cracks, although they can be as wide as 1 cm, are mostly 1-2 mm wide and are localized.

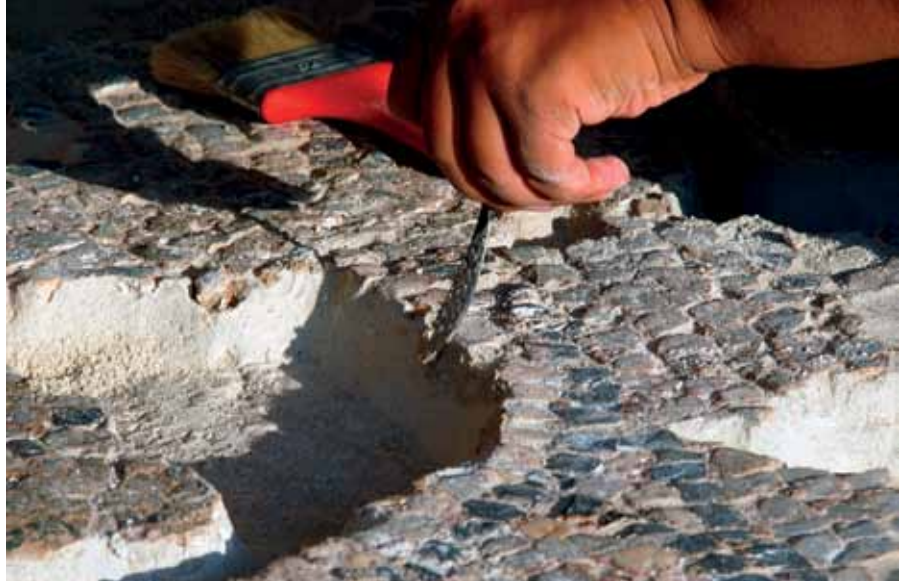
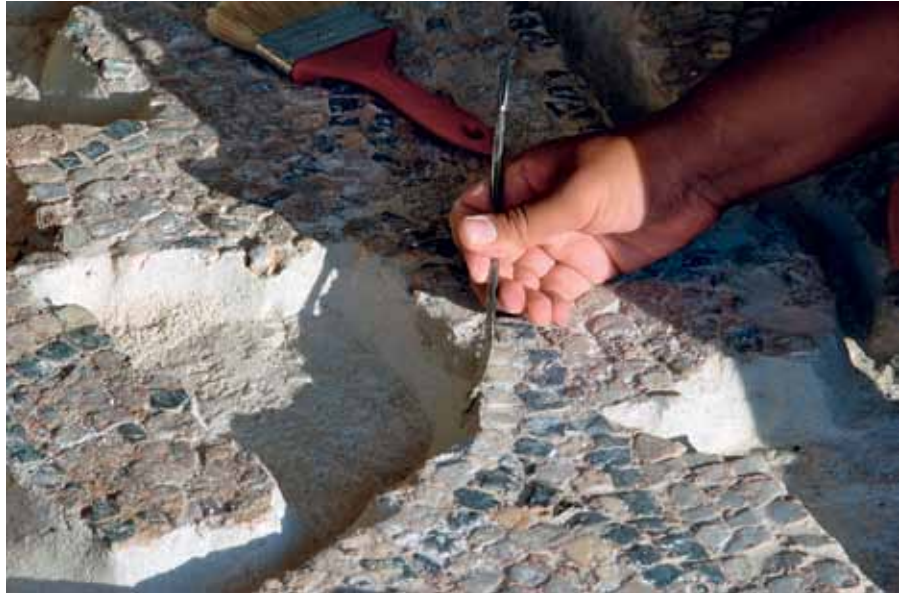
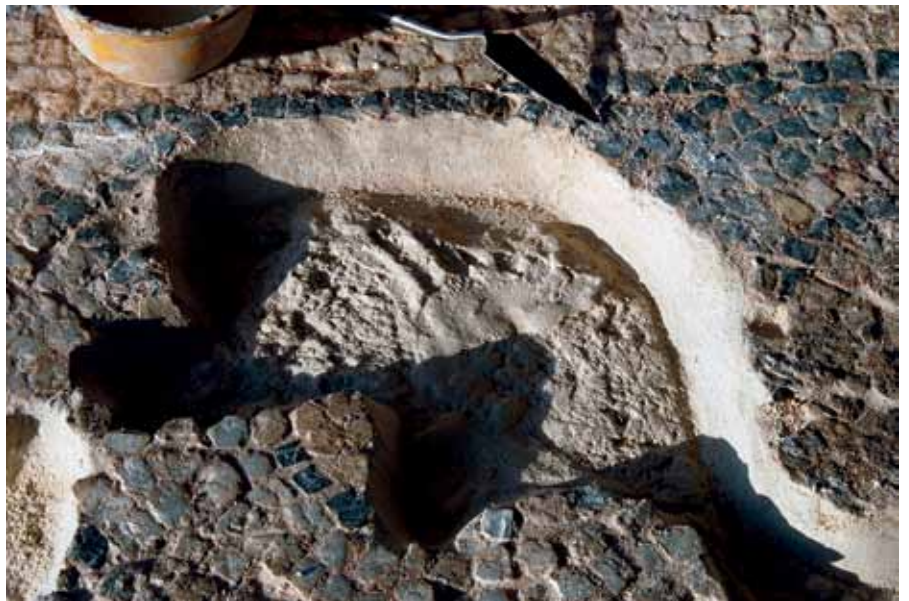
Fig.17
Restoration Work on the
Mosaic from Asar Island
(Myndos Excavation Archive)

Corrosion is found in reintegration areas, especially in areas with ochre yellow-colored sedimentary stones. The corrosion is a result of the stone becoming softened from contact with water and causes losses of varying degrees from the tesserae surface to the underlying layers. The deterioration occurred extensively in the knotted edges on the tesserae located in the areas where the stone reintegration was applied. Deterioration is also seen in other sedimentary stone areas as partial losses of sides and corners or on surface layers, although sometimes the deterioration is not advanced.
