TITLE: A Research of Samsun City Floods with Infrastructure Problems

A Chronological Research of Samsun City Floods

ABSTRACT: Samsun is the largest city of the Turkey's Middle Black Sea region, between Kizilirmak and Yesilirmak river deltas. With a height of 735 mm mean annual precipitation Samsun is above the national average. In addition to Kizilirmak and Yesilirmak rivers, there are many large and small streams in study area. Samsun city is exposed to floods every two to three years. A long-time series of damaging flood records in Samsun for 1960–2017, gathered from many documentary sources, is reviewed. In this study, a historical chronology of Samsun city floods has given. Depending on the rapid growth and development of urbanization, the decrease of rural areas, the paving of soil floors with concrete and asphalt and impermeable materials, most of the precipitation has become runoff, and besides the infrastructure system has not been able to carry that flow. Some dry stream beds were ignored and transform into the streets, stream beds were zoned for construction and multi-story buildings were built on them. The lack of adequate infrastructures caused the water could not rea

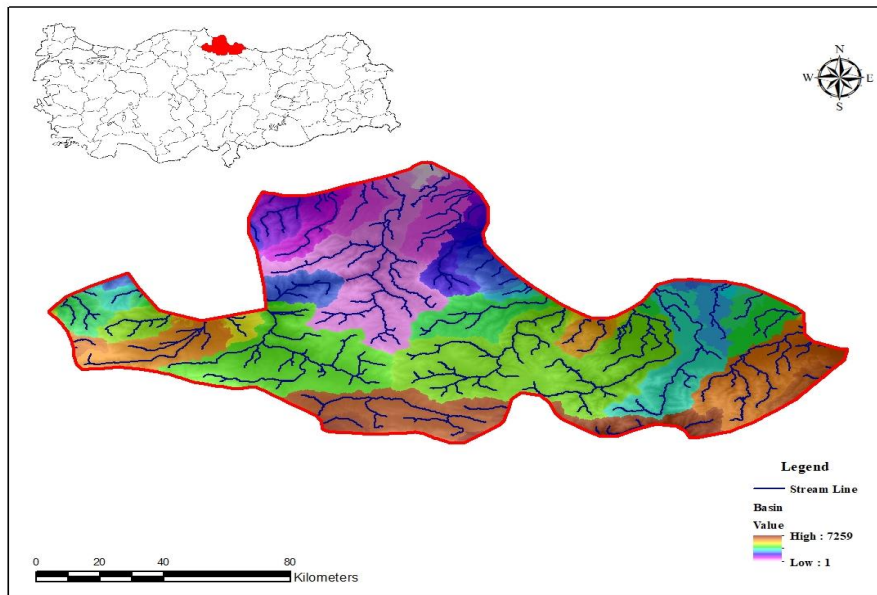
Figure 1. Location of the Samsun city with streams and basins

Samsun generally has a temperate weather. Beside of that, climate has two distinct characteristics in the coastal strip and interior areas. The effects of the Black Sea climate are seen on the coastline (City centre, Terme, Carsamba, Bafra, Alacam, 19 Mayıs, Tekkekoy and Yakakent). Summer is hot on the coast and the winter is warm and rainy, while inner areas, (Vezirkopru, Havza, Ladik, Kavak, Asarcik ve Salipazari) under the influence of Akdag Mountain, which is 2000 meters high and Canik Mountains, which is 1500 meters high. As a result of this influence of the mountains, the winter season is cold, rainy and snowy and summer season is cool. The mean annual precipitation total is above the country average (735 mm). On the other hand, the rate of precipitation at the end is different from that of the western Black Sea region. Most of rainfall values are between October (86.5 mm) and November (81.2 mm). The amount of precipitation in the east of the province is higher than in the west. The average number of rainy days per year is around 156 days (web, 2017). Precipitation values of Samsun province between 1975 and 2010 are given in Table 2. Samsun city is very rich in terms of water resources. The greatest rivers of the province are Kizilirmak and Yesilirmak. These two rivers reach the Black Sea after passing the provincial lands. Besides of that, there are many small streams on the eastern side as shown in Figure 1. However, these streams have irregular regimes.

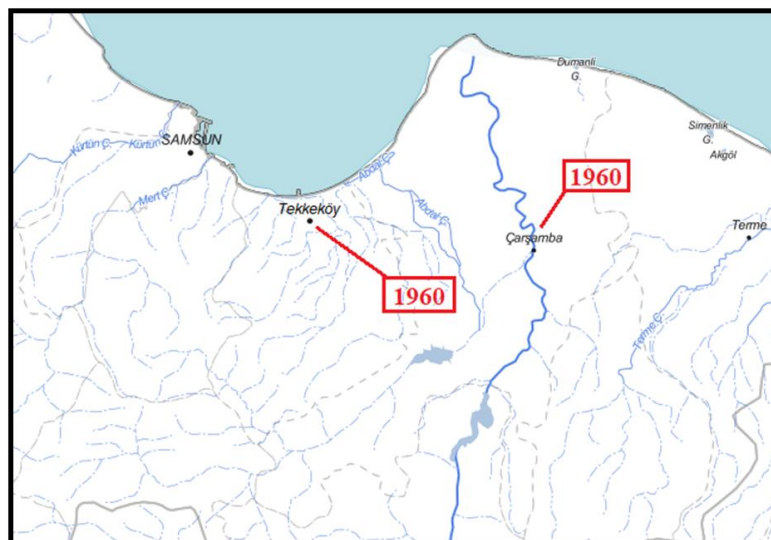
Figure 2. 1960 Flood Event

On 29.08.1960, the large amount of precipitation which falling in Carsamba and surrounding area was gathered at places deprived of the possibility of drainage and caused significant damage (Figure 2). The daily precipitation value was measured 203 mm at Carsamba. At the same time for Samsun this value was 9.4 mm; especially in the upstream parts Tekkekoy and Abdal canals is more filled up. The flood value calculated from the water traces in Tekkekoy was 80 m³/s.

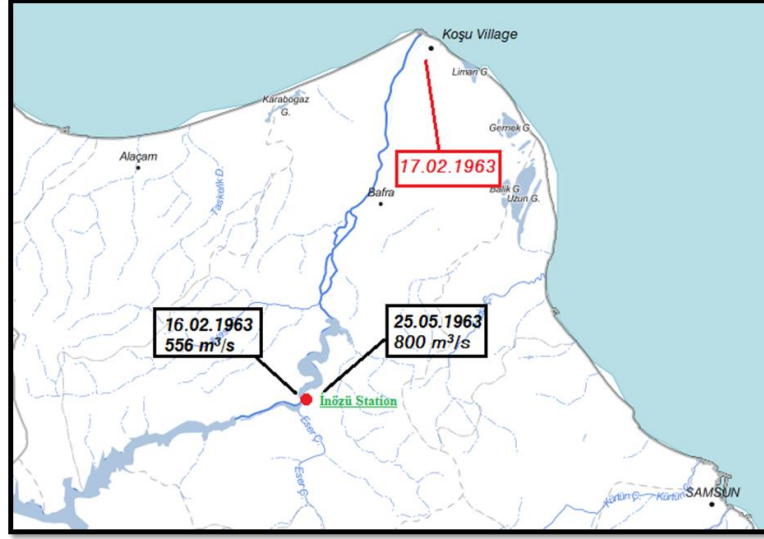
Figure 3. 1963 Flood Event

As a result of continuous precipitation and snow melt in the Kizilirmak basin on 17.02.1963, various damages occurred along with the coastal carvings by overflowing to Kizilirmak River, especially to Bafra's Kosu Village (Figure 3). The flow value was measured, 556 m³/s on 16.02.1963, at the Kizilirmak-Inozu gauge station. In the same area, the flood peak value was measured 800 m³/s for the same observation station that occurred on 25 May of the same year.

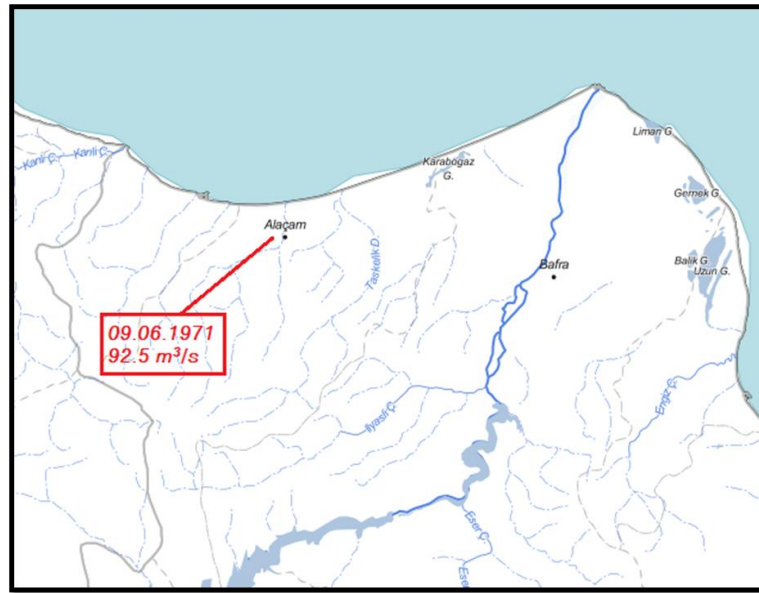
Figure 5. 1971 Flood Event

On 09.06.1971, in the upstream parts of the basin at Samsun-Alacam district Gumenez stream was filled with heavy rainfall and eventually it was flooded (Figure 5). The local precipitation which made the flood was measured more than the precipitation values measured at meteorological stations. According to the calculations made at the cross section of the flood, the flood discharge was $92.5 \text{ m}^3/\text{s}$. The flood peak value calculated $86 \text{ m}^3/\text{s}$ and the flood flow exceeded this value. There is also a person died at the area of this flood.

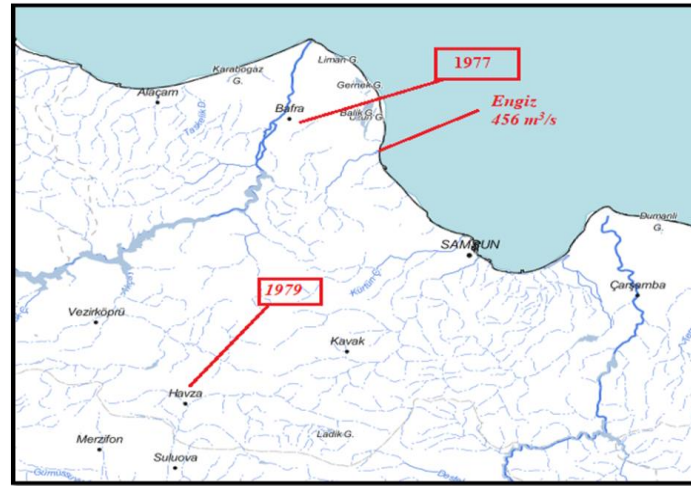
Figure 6. 1977-1979 Flood Events

On the day of 04.07.1977, floods occurred on the right side of the Bafra delta, between the Samsun and Bafra which is pouring into the Black Sea, at Degirmen, Cakirlar, Taflan, Musta, Karakoy and Kumsalcayi (Figure 6). The peak values observed during the floods vary between 22 and $90 \text{ m}^3/\text{s}$. However, in this flood the greatest flow was in Engiz and Karakoy streams with peak values $456 \text{ m}^3/\text{s}$ and $306 \text{ m}^3/\text{s}$ respectively which calculated from the flood traces. These values correspond to the 100-annual flow for Karakoy Stream and 25 annual flow for Engiz Stream.

Extreme precipitation and extreme cold on 30.08.1979 caused floods which leading to loss of life and property in the Samsun-Havza, Amasya-Suluova-Merzifon, Tokat-Turhal and Corum-Mecitozu regions (Figure 6). As a consequence of the flood, the flood discharge of Suluova Kavalcik River was $88 \text{ m}^3/\text{s}$ and the overflowing of the water caused the death of 27 people.

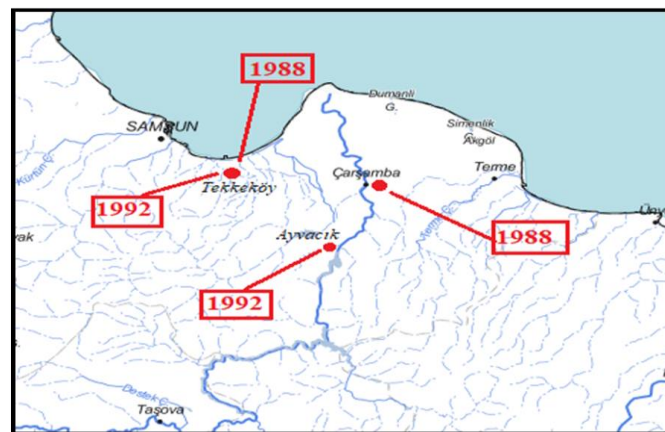
Figure 7. 1988-1992 Flood Events

The precipitation which started between 30.06.1988 to 01.07.1988 at Carsamba and Tekkekoy districts caused the floods (Figure 7). On the same day, precipitation was measured 406 mm at Hasanugurlu State Hydraulic Works station. On 01.07.1988, the flood measured 676 m³/s and 1300 m³/s in Yesilirmak Kale and Carsamba stream gauging stations (SGS) respectively. The important result of this flood that the construction of the Hasan Ugurlu and Suat Ugurlu dams provide great control on floods. Also on the same day, the flood passed the peak value 1175 m³/s in the Abdal River. This flow value is recurrence every 250 years.

Between 16.06.1992 and 22.06.1992, on various days in Samsun-Tekkekoy and Ayvacik region, very local and variable heavy torrential rainfalls led to floods on the side of Catak in Ayvacik district (Figure 7). The area where the floods have taken place is the coast of the Black Sea on the left bank of the Yesilirmak basin. Tekkekoy Kirazlik, Sabanoglu and Hidirellez of streams flood are estimated to be 60 m³/s. This corresponds to a recurrence of about 13 years.

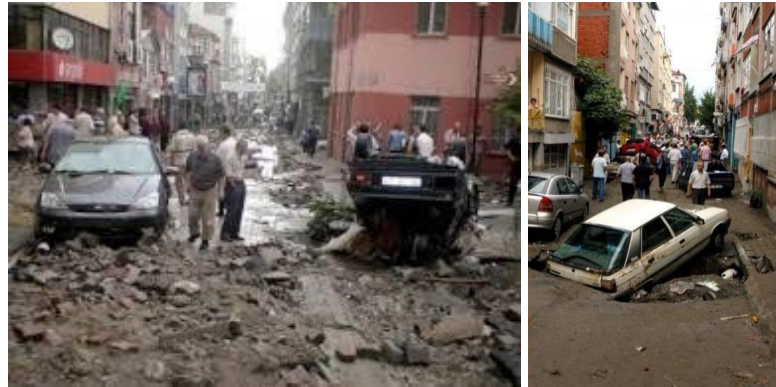
Figure 8. Damages of Flood in Derekoy and Samsun City

On 24.08.2007 Friday, extreme precipitation started from 03:40 and continued till 05:18 which caused floods in Samsun city center and Derekoy area (Figure 8). Floods occurred at Karasamsun stream, Military Branch stream, Agabali, Kelin, Stream No. 1, Sitmapinari, Gulistan, Ortadag and Fideli streams which located in Samsun city center and Derekoy area. Flooded area was about to 25 km².

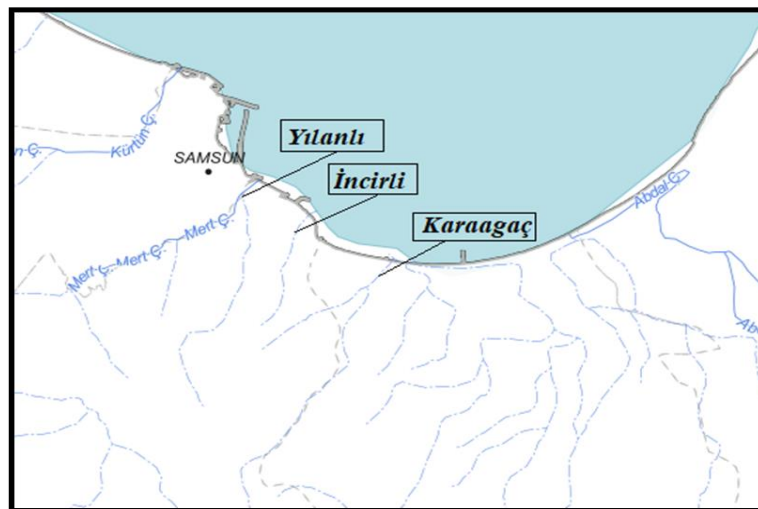
Figure 9. 2012 Flood Event

As a result of the extreme precipitation in Samsun provinces and districts between 04.07.2012 and 07.08.2012, a flood occurred that caused serious damage in the city center and the districts (Figure 9).

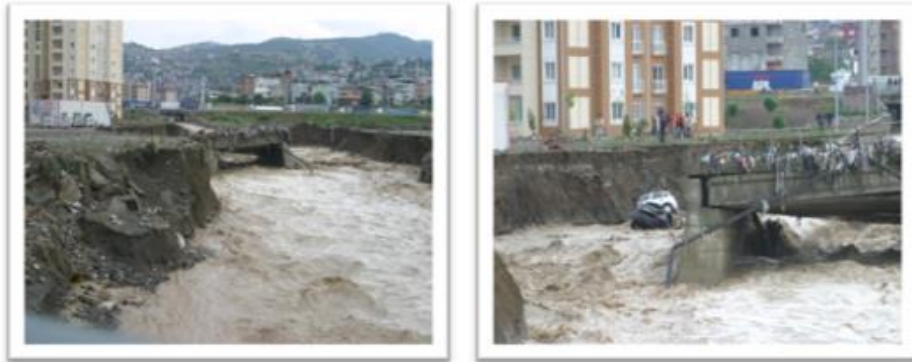
Figure 10. Damages of Yilanli Stream Flood in Canik District

The 1000-year frequency flood peak of the dam was $Q=217 \text{ m}^3/\text{s}$. Flow rates during flood calculated as $710 \text{ m}^3/\text{s}$. The important thing that the incoming flood was 2.37 times bigger than the catastrophic peak and that indicates us that was a disaster dimension. As a result of this flood, 7 people lost their lives in Yesilova Street and the shopping center, many houses, old industry and stadium of the city were damaged by the flood (Figure 10).

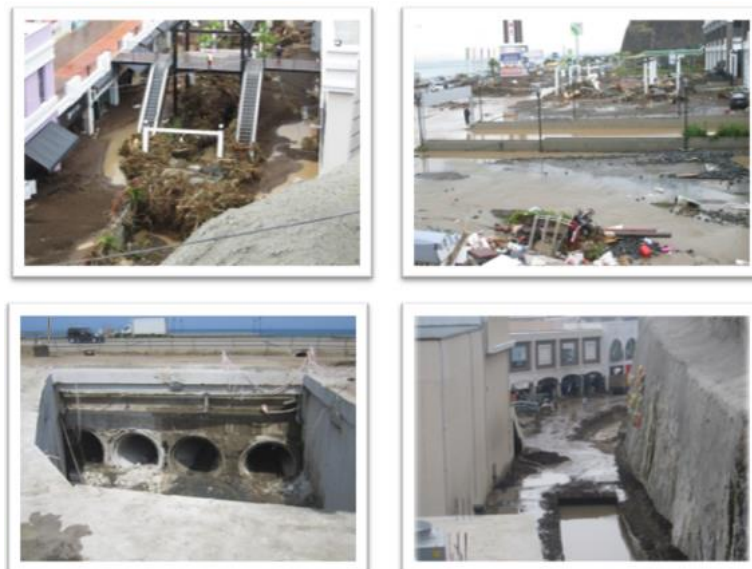
Figure 11. The Damage Caused by Incirli Stream Flood to the Shopping Mall

The 1000-year frequency flood peak of the stream was $Q=121.3 \text{ m}^3/\text{s}$. The flow rate during the flood was calculated $172.7 \text{ m}^3/\text{s}$. It is also seen that the incident was in disaster dimension. The shopping centre which located in the Haskoy surrounding has also suffered from big financial damage (Figure 11).

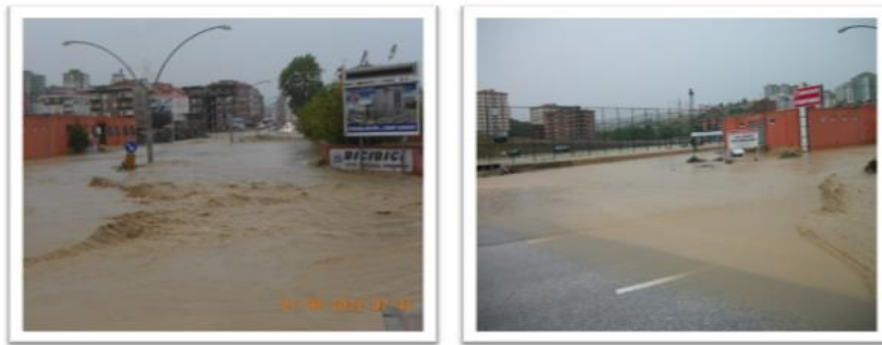
Figure 12. The Damages Caused by the Kuruzeytin (Cobanlı) Stream Flood

The 1000-year frequency flood peak was $Q=160.7 \text{ m}^3/\text{s}$. Flow rate during flood calculated as $55 \text{ m}^3/\text{s}$. This flow rate is even smaller than the calculated $Q_{100}=100.3 \text{ m}^3/\text{s}$. Since the downstream part of Kuruzeytin (Cobanlı) was used as a road after the flood, flood waters caused material damage in many buildings and workplaces around the access road (Figure 12).

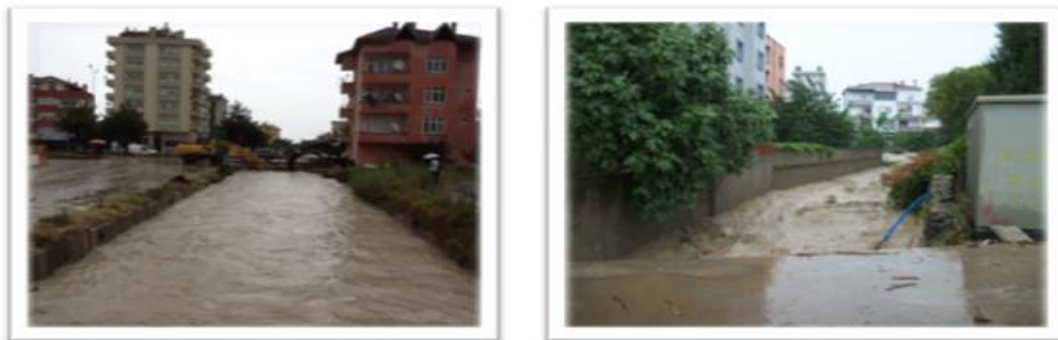
Figure 13. The Damages Caused by the Afanlı Stream Flood

The 1000-year frequency flood peak was $Q=254.1 \text{ m}^3/\text{s}$. The flow rate during flood calculated as $75 \text{ m}^3/\text{s}$. This flow is calculated as the flood gauge $Q_{100}=157.1 \text{ m}^3/\text{s}$. It shows that flood disaster occurs because of interfering in the stream beds. After the flooding, material damage has occurred in vehicles and workplaces due to the inadequacy of the culvert on the stream passing over the Samsun-Sinop Highway.

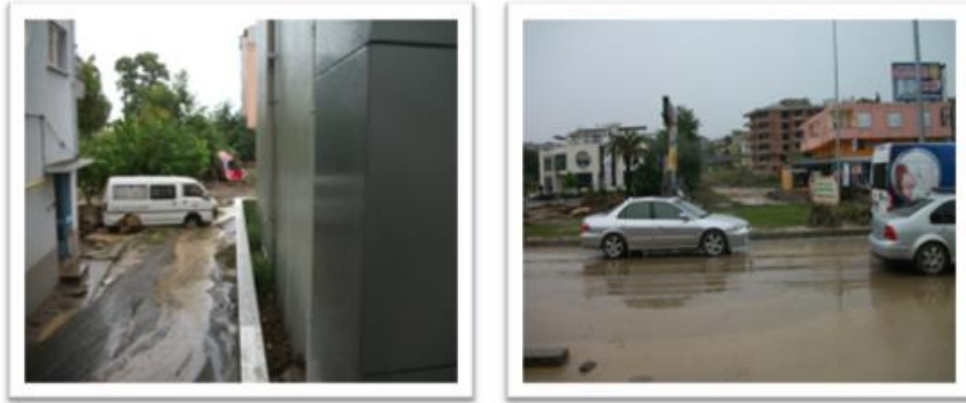
Figure 14. The Damages Caused by the Flood of Degirmen Stream

The 1000-year frequency flood peak of the stream was $Q = 192.4 \text{ m}^3/\text{s}$. Flow rate during flood calculated as $35 \text{ m}^3/\text{s}$. This flow is even smaller than the calculated $Q_{100} = 117.5 \text{ m}^3/\text{s}$. This also shows that flood disaster occurs because of interfering in the stream beds.

After the flood, property damage has occurred in the vehicles and in the workplaces due to the inadequacy of the culvert on the Samsun-Sinop Highway (Figure 14) (Ulke et al. 2013; DSI, 2012).

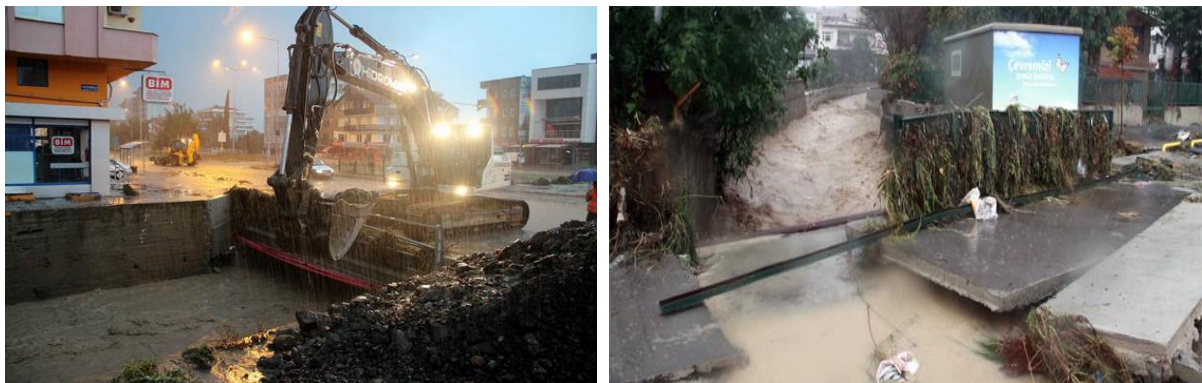
Figure 15. Flood Damage (Highway Bridge) and in Atakum Coastal Road Bridge

Precipitation started at 01:00 am at night and continued until 04:00 in the morning and the heavy precipitation has left 250 kg rainfall per square meter in Atakum district in 07.08.2013. Alanli and Degirmen stream overflowed, especially the result of the overflow of Degirmen stream was tied traffic up and Sinop-Samsun highway traffic was provided after several hours with control (Figure 15).
