TITLE: Research on the change of Ankara Ulus City Center identified with its historical texture

## Research on the change of Ankara Ulus City Center identified with its historical texture

Research Article

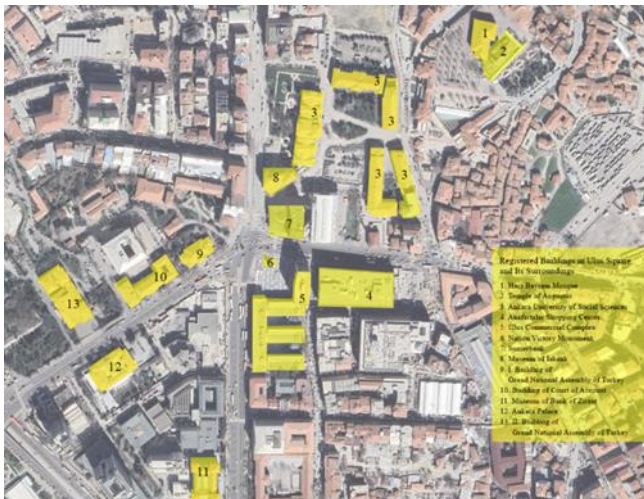
**Figure 1.** Registered buildings in Ankara Historical Ulus Square and its surroundings.

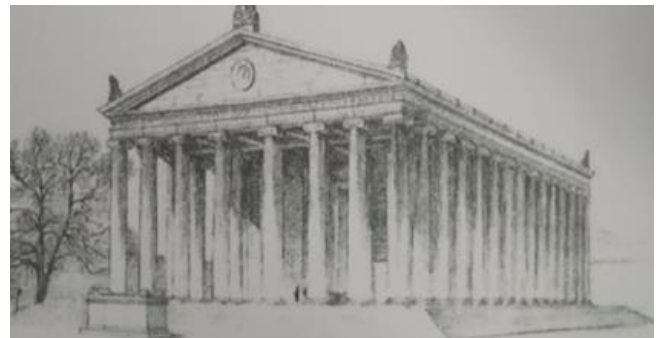
**Figure 3.** Reconstruction drawing of the temple [9]

**Original status:** The marble temple has a pseudodipteral plan rising on a 2 meter platform over an area of 36mx54.82m. It is located in the south-west-northeast direction. It is decorated with 8 ionic columns on the short sides and 15 on the long sides, forming its peristyle. The interior complex (naos) consisted of three parts: 'pronaos' (inner area of the portico), 'cella' (central room) and 'opithodomos' (back porch). Between the extensions of the side walls, there were four Corinthian columns in the pronaos and two in the opisthodomos. The entrance to the cella is through the main door with an ornate lintel located at the rear end of the pronaos. The cella was the sanctuary of the temple, where only priests were allowed [10].

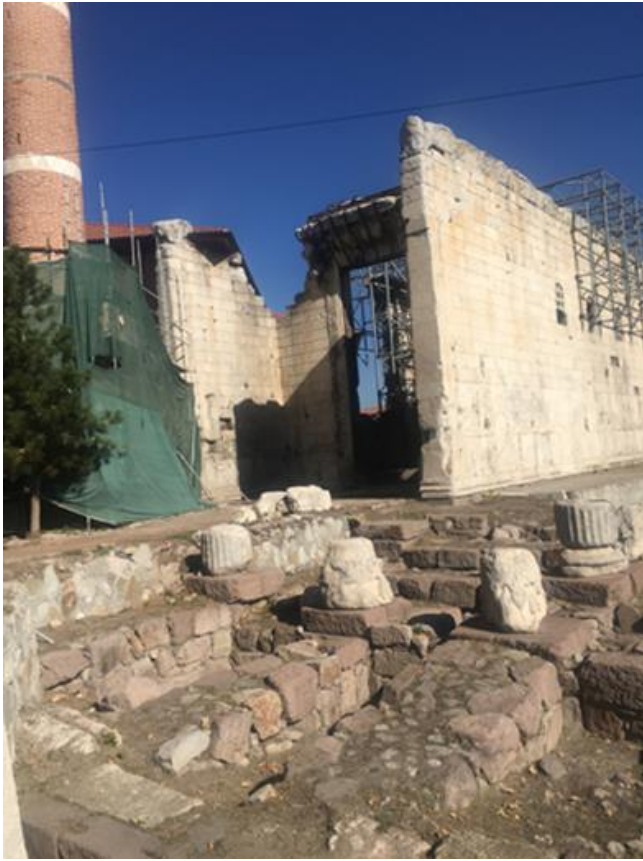
**Figure 4.** The Temple today

**Change:** The monument has undergone various changes in its architecture in later periods. It was converted into a Christian church during the Byzantine Period in the 6th century. Originally an enclosed space designed to exclude sunlight, the Cella is fitted with three large windows on the southwest wall. The raised floor was leveled to the height of the platform, the wall between the cella and the opisthodomos was removed, and the apse wall and crypt were built in its place. It was used as a church until 806. Ancient Wall is currently protected by structural aids from collapsing which was oriented around Fountain [5].

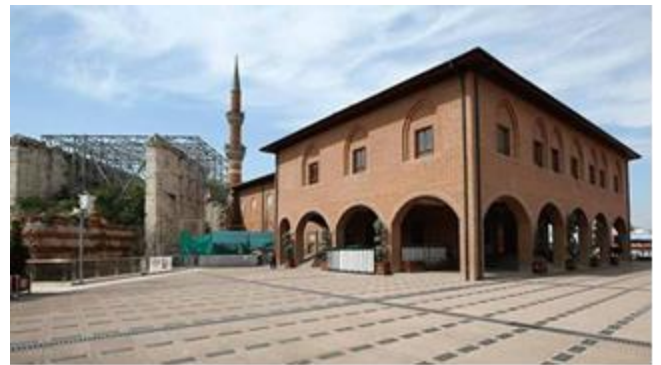
**Figure 6.** Hacı Bayram Mosque today

**Change:** Two inscriptions on the south wall indicate that the mosque was restored in 1714. In 1940 and 1947, it was restored by the General Directorate of Foundations and added to the mosque, and the originality of the work was not preserved. With its current layout, it bears the characteristics of late 17<sup>th</sup> century or 18<sup>th</sup> century mosques. It is thought that the religious and historical mosque has lost its original value [12].

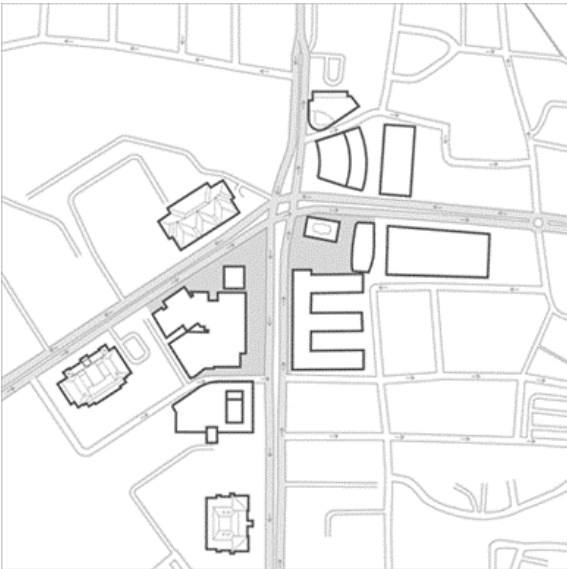
**Figure 8.** Ulus Square today

The Municipal City Garden was located around the square in 1927. However, today Ulus 100<sup>th</sup> Anniversary Commercial Center (Çarşı) has been built in this area. The square has turned into a congested closed intersection square with the increasing vehicle traffic by the construction of the open areas around it.

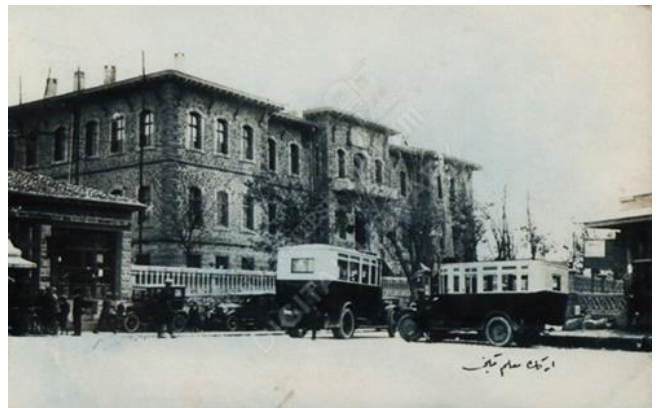
**Figure 12.** Ulus Darülmüallimin Building, 1925 Source: Inv.No: ACF0367\_01 [16]

**Change:** The building, which was built as a school building in 1914, was demolished in 1934. The building, which was completely destroyed, was replaced by the Ulus İşhanı block in 1955.

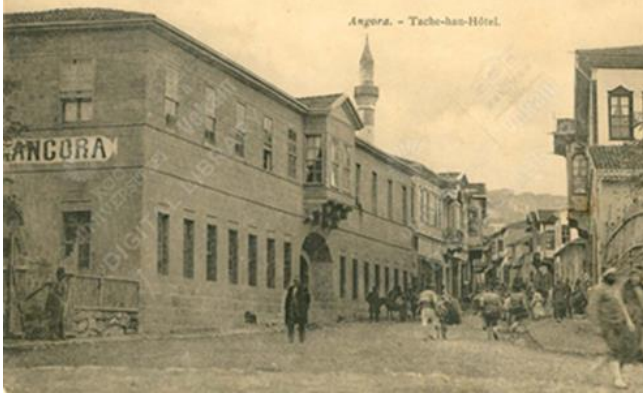
The building, which was built in the last years of the Ottoman Empire, gave its name to the square. The building, built of cut stone, served as a hotel for a long time. The Sümerbank Building was built in place of the building, which was later demolished (1933). The building of Sümerbank in Ulus Square, whose name was given by Atatürk, was built by German Architect Martin Elsaesser.

**Figure 13.** Taşhan Building Source: Inv. No: 0975 [16]

**Change:** The Taşhan building, which was built as a guest house in 1880, was demolished and the Sümerbank Building was built in 1937-38. The building was used as a store in 1988 and transferred to the university in 2013. Today it is used as a university building by Ankara Social Sciences University.

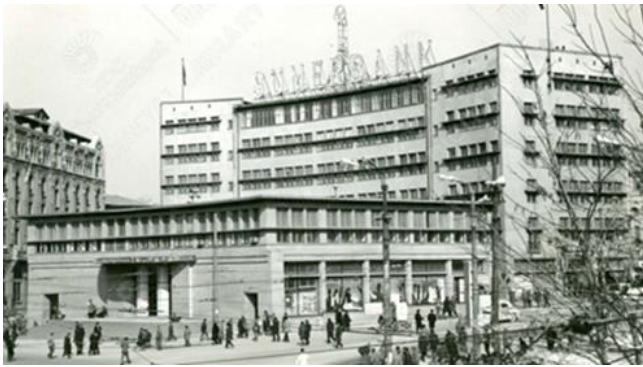
**Figure 14.** Sümerbank, which was built on the place of Taşhan Building Source: Inv. No: 1792 (VEKAM) [16]
