Edirne New Palace excavations (2018-2021)

Research Article

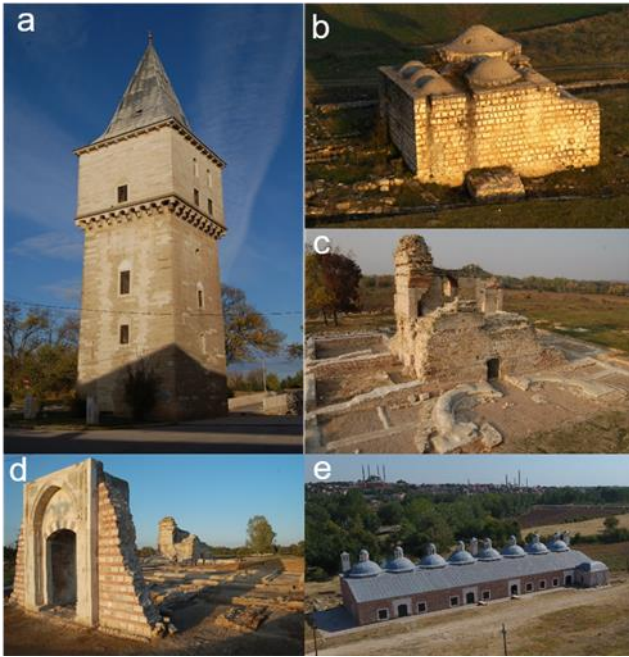
Figure 1. Buildings in the New Palace of Edirne, a. Justice Pavilion, b. Kum Kasrı Bath, c. Cihannüma Pavilion, d. Babüssade, e. Matbah-ı Amire

After the liberation of Edirne from Russian occupation, Governor Rauf Pasha reportedly gave valuable pieces and tiles from certain unscathed parts of the palace as gifts to foreigners. It is believed that 27 chests of plundered valuables were taken this way. Although Hacı İzzet Pasha was reinstated as Governor of Edirne in 1884 and expressed a desire to restore Edirne New Palace, this wish was ultimately unfulfilled. Subsequent governors saw it fitting to acquire the required construction materials from the remains of the Edirne New Palace for the purpose of building barracks and public structures in Edirne [5]. Presently, only the remnants of Matbah-ı Amire and Kum Kasrı Bath, which underwent recent renovation, as well as the Adalet Pavilion, Bâbüssaâde and Cihannüma Pavilion, have survived from the Edirne New Palace [6] (Figure 1).

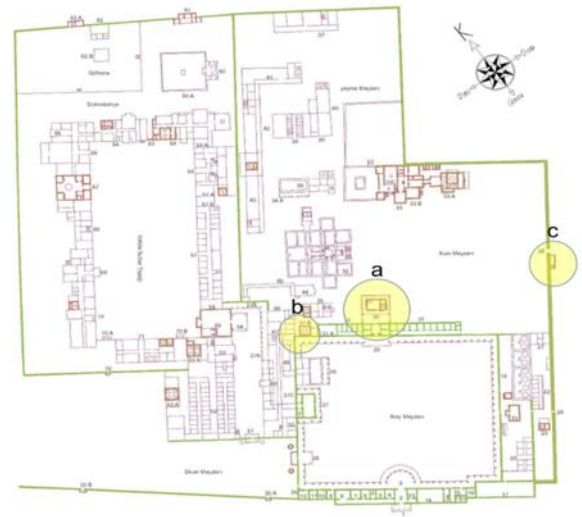
Excavations took place in three areas: the Presentation Room, the Akağalar Wards, and the Iron Gate. The aim was for these three locations to complement each other and aid in understanding the site map. The goal was to find out where Sur-i Sultani separates the two courtyards (Alay Square and Kum Square) of the palace, following the protocol rules of the Edirne New Palace. This research aimed to create a strong foundation for planning the palace as a whole (Figure 2). Unfortunately, this is not easy to do because the New Palace has been mostly destroyed and restoration is difficult.

Figure 2. Areas where excavation works were carried out. a- Presentation Room b- East and north wall of the Alay Square c- Iron Gate, "Engraved from the map of the New Palace in Edirne made by Avadis Benliyan, an army journeyman"

following the remnants of the eastern wall that borders the square and referring to Avadis Benliyan's sketches (Figure 2 - b). Geophysical studies were conducted on the northern wall of Alay Mansion to assist with future planning. Technical term abbreviations were explained upon first use. The text adheres to conventional academic structure, formal register, and clear, objective language.

The third point where the works were carried out was at Demirkapı, which opens to the Fatih Bridge, which provides access from the Kum Square to the Hasbahçe (Figure 2 - c). Demirkapı is located on the wall extending from the east of the Matbah-ı Amire parallel to the Tunca River and defining the eastern border of the Sand Square. A 19th century photograph of the gate, which is on the same axis as the entrance façade of the Cihannüma Pavilion, shows that the wall above the gate makes a curve and that there is a lead-covered, three-faceted

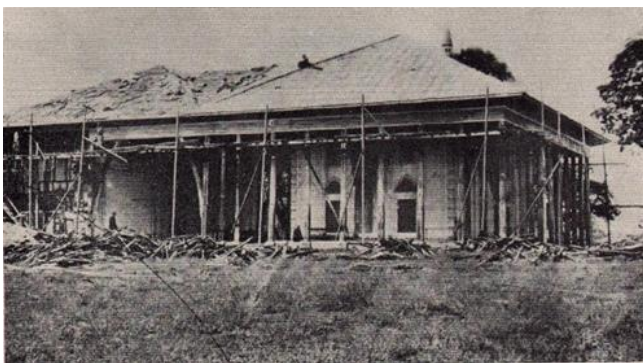
Figure 4. During the 1868 renovation, view of the Arz Chamber from the Kum Square (by Rifat Osman)

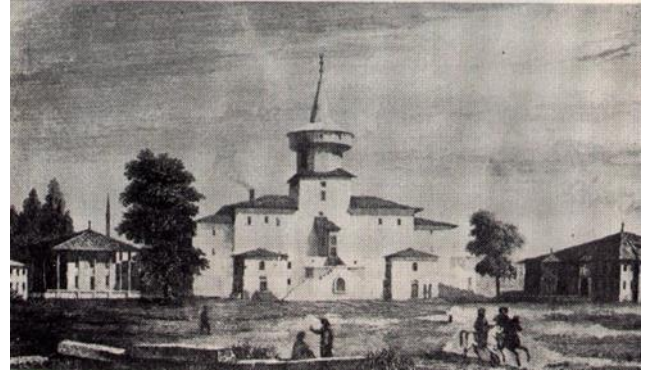
Figure 5. Cihannüma and presentation room engraving. (C. Sayger & A. Desarnod Album)

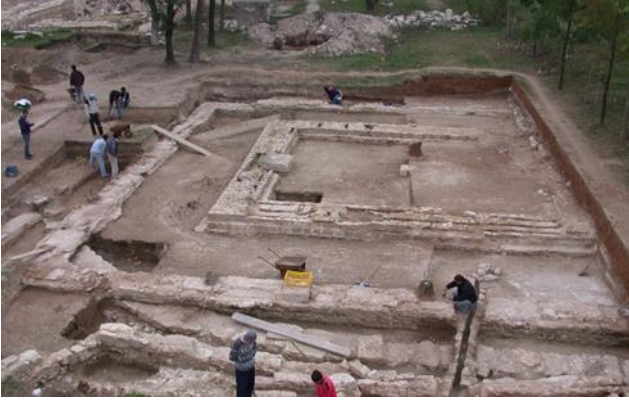
As a result of the excavation in the area, we uncovered the walls that make up the Imperial Throne of the Presentation Room and the portico walls surrounding it. Figure 6 shows the walls uncovered during the excavation (Figure 6). The walls were discovered at the same height, leading us to believe that the land had been leveled and the building was subsequently removed, likely using machinery to shave it down. It is believed that the construction of the structure occurred during the building of the embankment on the south side, overlooking the sand square. The flood level of the Presentation Room was reached at the 37.67 elevation level, in the area descending down to 37.40 elevation level. Furthermore, during the drilling process, excavation of waste and clean water canals that belong to the palace, as part of a broader system were found at the 37.41 water level elevation [9] (Özer and Dündar 2019).

Figure 6. General view from the Presentation Room excavations. (by EYSK Archive)

The wall foundation encircling the Presentation Room and supporting the portico pillars has a thickness of 95 cm. It consists of a mixture of irregular stones and mortar. The strength of the 80 cm wide wall, which rises above the foundation and was built from a combination of mortar and rubble, was enhanced with wooden beams. While carrying out this work, a well-cut stone measuring 75cm x 66cm was discovered on the southwest portico wall. Traces on the northwestern and northeastern walls of the portico exhibited similar stone widths, as the stone found on the southwest wall. This stone was identified as one of the pedestal stones supporting the portico pillars.

The façade walls of the main space, also called the Presentation Room, have a varying thickness of 110 cm to 150 cm and were constructed using uneven stonework. Chipped face stones were used on the cheeks of the wall, which was filled with masonry rubble and brick particles. The wall was then reinforced with wooden beams.

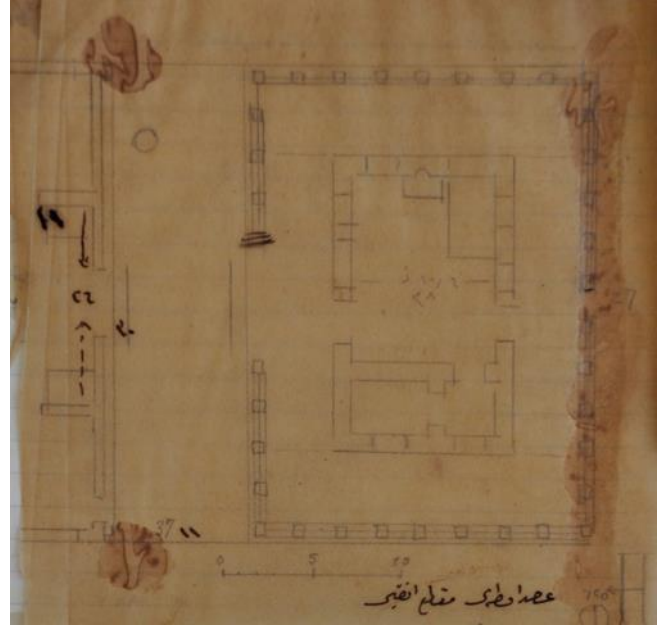
Inside the northwest wall, there is a stone structure measuring 1.19 m x 1.05 m made of old stone. The structure contains a large monolithic stone measuring 15.5 inches, which has been identified as a hearth stone based on information provided on the Presentation room drawings made by Rifat Osman (Figure 7). To the south of the Presentation Room, remnants of a wall have been discovered which separates the chamber where the Imperial Throne is situated from the ablution and toilet areas. The investigation indicates that a significant portion of the wall is still present below the State Hydraulic Works Disaster Set. The internal wall length measures 7.58 metres. Upon examining the main walls of the Presentation Room, which were uncovered during the excavation, it is apparent that the walls above the flood level detected at an elevation of 37.67 have been levelled at 37.89, revealing that the building follows different axes than the flood level. This disparity can be attributed to the building's repairs.

Figure 7. The plan of the Presentation Room in Rifat Osman's book "Edirne New Palace" From the original copy in Edirne Bayezid II Complex.

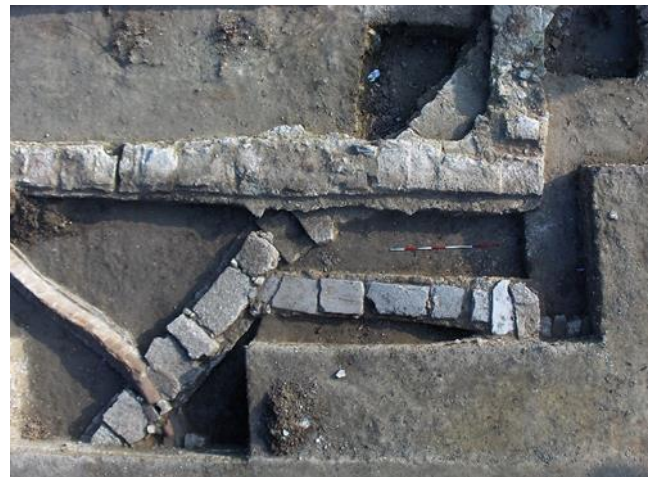
During the excavations in the area; besides the remains of the walls of the Presentation Room; water canals belonging to the palace were also encountered. There are two different types of canals; waste and clean water canals (Figure 8).

Figure 8. View from the water canals. (by EYSK Archive).

They were built of brick and stone masonry and covered with large cap stones. The canal, of which the first cover stone was encountered at level 37.30, was observed to extend in the north-south direction. The fact that the canal is inclined towards the south indicates that it flows into the Tunca River approximately 300 m in this

direction. However, it was possible to follow the canal until below the DSI disaster embankment. It was observed that it merged with another wastewater canal at 37.35 elevation level, which was identified at 37.53 elevation level and extends in southwest-northwest direction. It was observed that the canal running in southwest-northwest direction was more regular than the canal running in north-south direction. This canal was formed by covering large schist stones as a cover over the brick masonry body wall. The canal extending in southwest-northwest direction merges with the canal extending in north-south direction. This situation suggests that it was built in a later period. In general terms, it is observed that these canals have poor insulation against external factors and have a rough form. Similar ducts were encountered during the excavation and cleaning works in Matbah-ı Amire. The fact that the same sloppy structure was observed here and the remains of wastes were also encountered inside suggests that these canals were built for sewerage purposes.

They have a more elaborate structure compared to waste water canals. The joints of terracotta drains laid on a brick floor were sealed with "lökün", a paste produced by mixing lime, olive oil, cotton and egg white. The top of the funnels was covered with a hipped roof made of bricks, and the canals, which were given a triangular form by plastering between the bricks with mortar, became more resistant to external factors. The clean water canal passes over the waste water canal. At the top of the clean water canal, where it gains height as it passes over the waste water canal, it is seen that a limestone with a hole in the centre opens out. It is probable that this hole was made to allow the water to rise to the surface, which indicates the presence of a fountain here.

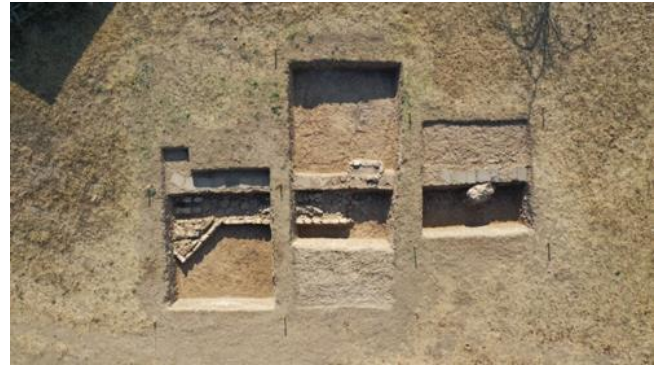
The sources were used as a basis for the study, which focused on the 5x5 m intersection of the eastern wall that separates Birun and Enderun from the northern wall. The study involved four trenches, each measuring 1.55 cm. During the conducted studies, archaeologists uncovered the remnants of a wall running in an east-west direction that coincides with a wall extending from Bâbüssaâde (Figure 9).

Figure 9. Alay square east wall (by EYSK Archive).

The width of the wall, constructed with rubble stone, measures 95 cm. Additionally, three rows of foundation beam gaps, measuring 10x10 cm each, were discovered. Additionally, researchers have identified one of the triangular buttresses that extends parallel to the western wall of the eight-domed dining hall at Matbah-ı Amire, which was previously unearthed. A set of schist stones, the exact characteristics of which are not completely understood, have been found at the upper levels of the wall, resting against the section overlooking Alay Square. This finding suggests that soldiers during the Balkan Wars utilized rubble to fill the soil between walls as a temporary solution. Further data in later stages of the study may shed light on the nature of this finding.

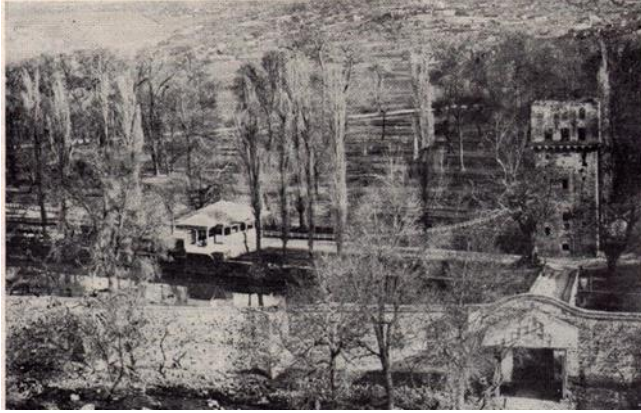
transom on the side facing the Sand Square. It is reported by Rifat Osman that there was also a fan-shaped sayeban on the Hasbahçe side. The triangular buttresses on the eastern wall of the Alay Square can also be identified in the photograph (Figure 10).

Figure 10. Iron Gate, Justice Pavilion and Iftariye Pavilion (by Rifat Osman)

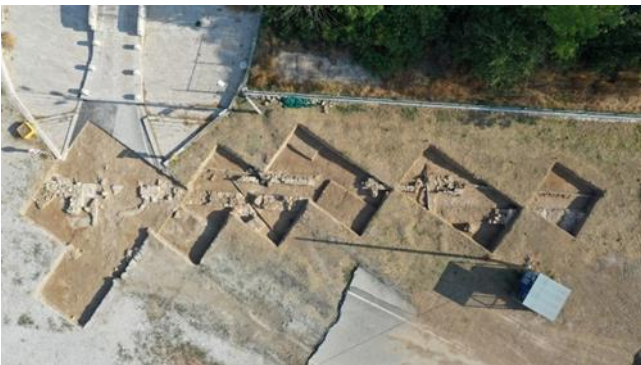
In the first days of the works, the asphalt that was built to provide the connection between the stadium where Kirkpınar wrestling was held and Yeni İmaret Neighbourhood was dismantled. Then, at a point very close to the surface, the largely destroyed traces of Demirkapı were reached. However, no reliable plan of the remains of the gate, which was exposed to vehicular traffic for many years and pressurised during the asphaltting works, could be reached. On the other hand, one of the triangular buttresses, which can also be identified in the photograph, could be identified. In addition, the direction of the wall (Sur-i Sultani) on which the gate was placed, extending in the north-south direction parallel to the Tunca River and forming the eastern border of both Alay Square and Kum Square, could be identified (Figure 11).

Figure 11. General view of Demirkapı and Sur-i Sultani excavation site. (by EYSK Archive)

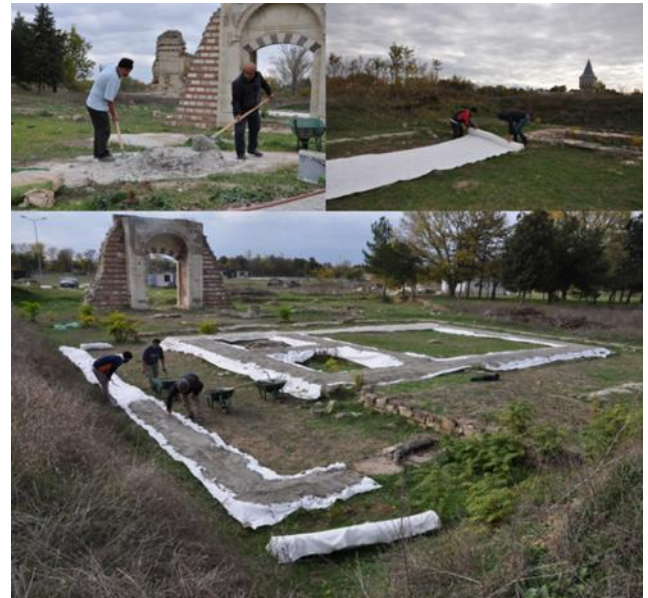
Within the scope of the applications, firstly, dry cleaning was carried out with the help of soft-tipped brushes and small dental tools, and the dry deposit and soil layer were removed from the surface of the find. After the architectural finds group was documented, it was covered with geotextile. Then it was covered with a high soluble lime mortar prepared with three parts of aggregate (river sand, stone dust, marble dust and some firebrick dust) and one part of lime (calcium hydroxide). The mortar was about 10 cm thick and applied in herringbone form to prevent water retention on the surface (Figure 12).

Figure 12. In-situ conservation practices (by EYSK Archive)

is to protect the architectural findings unearthed in these areas against deterioration that may occur due to external factors such as seasonal conditions, human destruction and flooding. The applications carried out within this framework were carried out with a conservative approach and it was planned to provide temporary protection before a possible comprehensive repair activity.

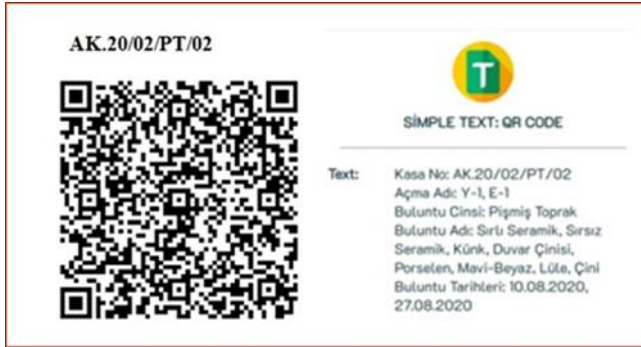
Figure 13. QR code system used in artefact storage.

system, a QR code system was introduced. In this system, the general information of the artefacts in the vault (find location, find type, find name, find dates) was transferred to the QR code via the computer. The barcodes were printed out and hung on the board. If these barcodes are scanned by downloading any QR Code programme from a mobile phone, the information about the type of finds in the vault will be accessed (Figure 13).

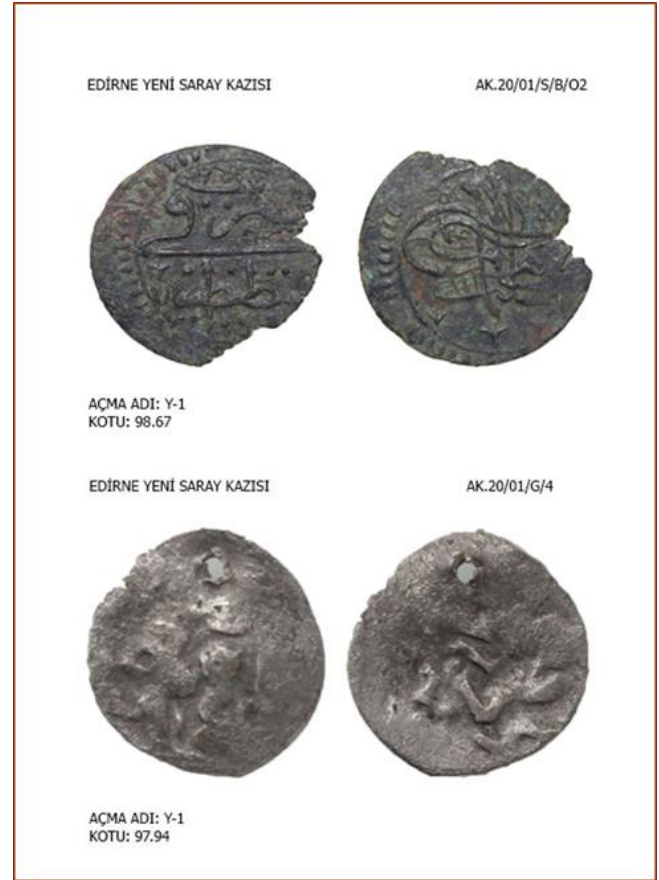
Figure 14. Examples of conserved coins (by EYSK Archive).
