TITLE: SHEAR BOND STRENGTH OF PREVENEERED POSTERIOR STAINLESS STEEL CROWNS

SHEAR BOND STRENGTH OF PREVENEERED POSTERIOR STAINLESS STEEL CROWNS

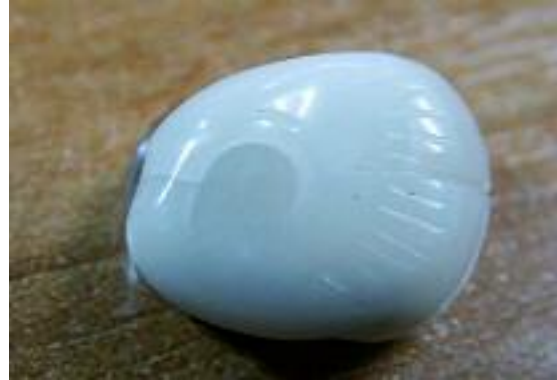
Figure 1. Cohesive failure, cracking in the veneer material of upper second primary molar (Original magnification X10)

fracture extents were compared using Kruskal-Wallis test, there were no significant differences between crown groups ($P>0.05$). The fractures that occurred at veneer material of each crown group were characterized either cohesive or mixed failures (Figs. 1 and 2). Specimens showed cracking, loss of a third or one second fracture extends (Figs. 1, 2, 3 and 4). None of the specimens had loss of complete at fracture extent. In addition, dislodged veneer material was observed by a spalling (Fig. 3).

In this study, failure types of veneer material were cohesive or mixed failure (adhesive/cohesive) (Table 2; Figs. 1 and 2). None of them showed adhesive

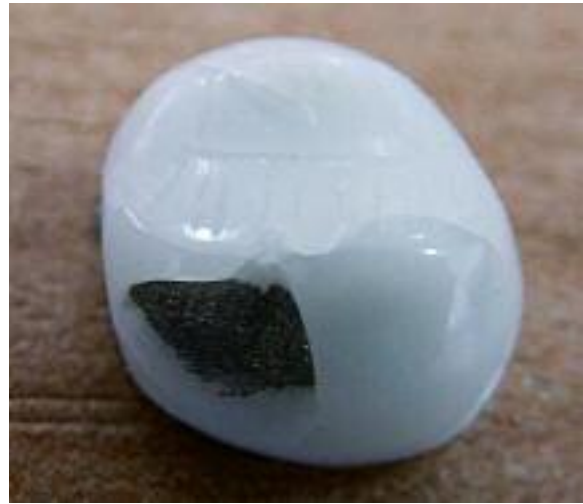
Figure 2. Mixed failure, spalling, loss of a third of the veneer material of upper second primary molar (Original magnification X10)

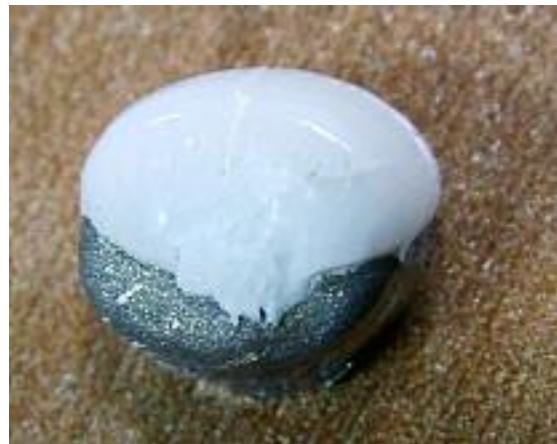
Figure 3. Mixed failure, loss of one second of the veneer material of lower first molar (Original magnification X10)

failure. The probable cause of why adhesive failure was not observed can be due to the fact that the veneer material was bonded to stainless steel base using the sandblasting method. In addition, separation from stainless steel base of veneer material was characterized by a spalling (Fig. 3). These results were agreed with failure modes observed in the previous studies which were used preformed NuSmile crowns^{9,10,20,21}. Perhaps the observed failure types might be due to the fact that veneer material was bonded to stainless steel base using the sandblasting method. Moreover, the extents of fracture of veneer material in the study were cracking, loss of a third or loss of one second of the veneer. These findings are in agreement with that of previous study, in which NuSmile primary anterior crowns were tested²¹.

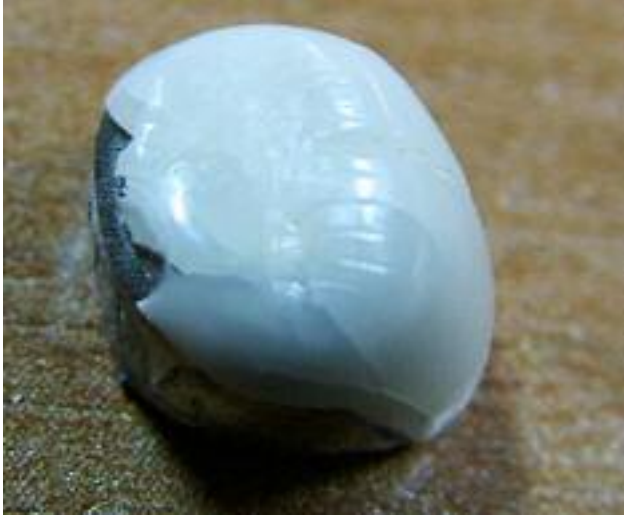
Figure 4. Mixed failure, loss of a third of the veneer material of lower first molar (Original magnification X10)
