TITLE: Effect of Temperature and Strain Rate on the Embrittlement Behavior of Heat-Treated Carbon Steel (UNS) G10180

Effect of Temperature and Strain Rate on the Embrittlement Behavior of Heat-Treated Carbon Steel (UNS) G10180

Abstract: The microstructures of plastically deformed steel was studied to potentially promote ingress of atomic hydrogen raising its susceptibility to embrittlement. The as- received UNS G10180 was heat-treated to about 500oC. The apparent embrittlement of the specimen came after series of controlled pre-stressing by quasi-static loading (fatigue cycling) followed closely by pre-charging of the specimen with hydrogen in an ambient electrochemical environment of hydrochloric acid. Standard tensile test was hydrogenated from 2 to 6 hours, and deformed by cold working to 40%, 50%, 60% and 80%. The mechanical and laboratory tests on the dissolution and dissociation mechanism of the ions were also carried. The crack length and time of failure at low strain were also evaluated under the simulated conditions. The results showed that by calculation, pre-charging with hydrochloric acid raised the susceptibility of embrittlement of hydrogen specie by 25%. It was fou

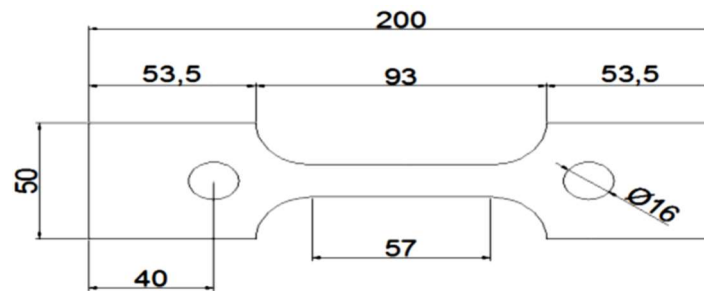
Figure 1: ASTM E8 based fracture pre-stress sample design

- ii. The test specimens were designed out of the UNS grade of carbon steel by carefully controlled lathe machining process. Thirty out of the fifty-four samples machined out for this work were dented heavily to a concentrated stress, forming the fracture stress specimen. The final geometry of the samples was such that will promote embrittlement upon pre-stressing and the cathodic hydrogen charging by the acid in accordance to American Society of Testing and Materials E8 standard [5]. The machined notches were carefully investigated microscopically for fracture phenomenon after thirty minutes' interval.

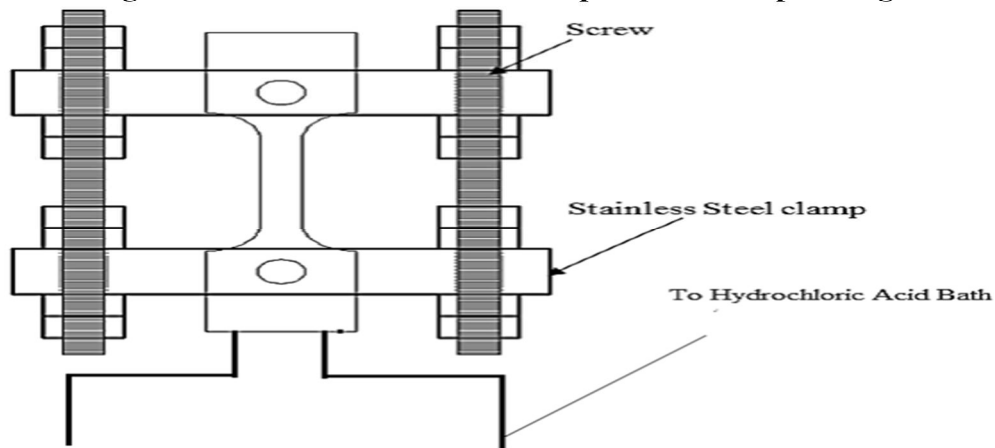
Figure 2: Jig-clamp system linked to hydrochloric acid bath for the experiment

- iv. The experimental setup is comprised of an integrated arrangement of a Jig-clamp system connected firmly to the specimen submerged into an electrochemical bath of hydrochloric acid of the stated concentration. It serves the dual purpose of hydrogen charging (ASTM G148-97) and pre-stressing simultaneously. The Jig-clamp system used comprises 1600mm by 45mm by 20mm grade 904 stainless steel with four high tensile bolts. The pre-stressing of the mild carbon steel is delivered by the gripping effect of the chuck of the clamp with the Jig bolt actuated carefully to apply stepwise progressive pressure at about 35% of the ultimate yield strength of the steel which is below the threshold of cracking or blistering. The extended sections of the jig- clamp system likely to be exposed to the Acid are epoxy coated to discourage local galvanic action. The electrochemical part of the experimental circuit fitted with a sensitive current measuring ammeter picks the flow of hydrogen electrons (current) into the steel at 25, 30, 35, 40, 45, 50 and 60°C as they are allowed to age for 0 hours, 50, 100, 150, 200, 250, 300, and 350 hours consecutively in the acid under plastic loading. To further concentrate the hydrogen, a barnacle cell setup based on ASTM recommendations embedded into the arrangement isolates part of the metal as the hydrogen anode, the remainder as the cathodic half. The system measures the oxidation current when the proton reacts with the hydroxyl ions. The strain rate was obtained by a clip-on extensometer with a 25mm gauge length or a 45°C strain gauge rosette. The hydrogen concentration value adsorbed in the matrix of the steel is given by equation 1.

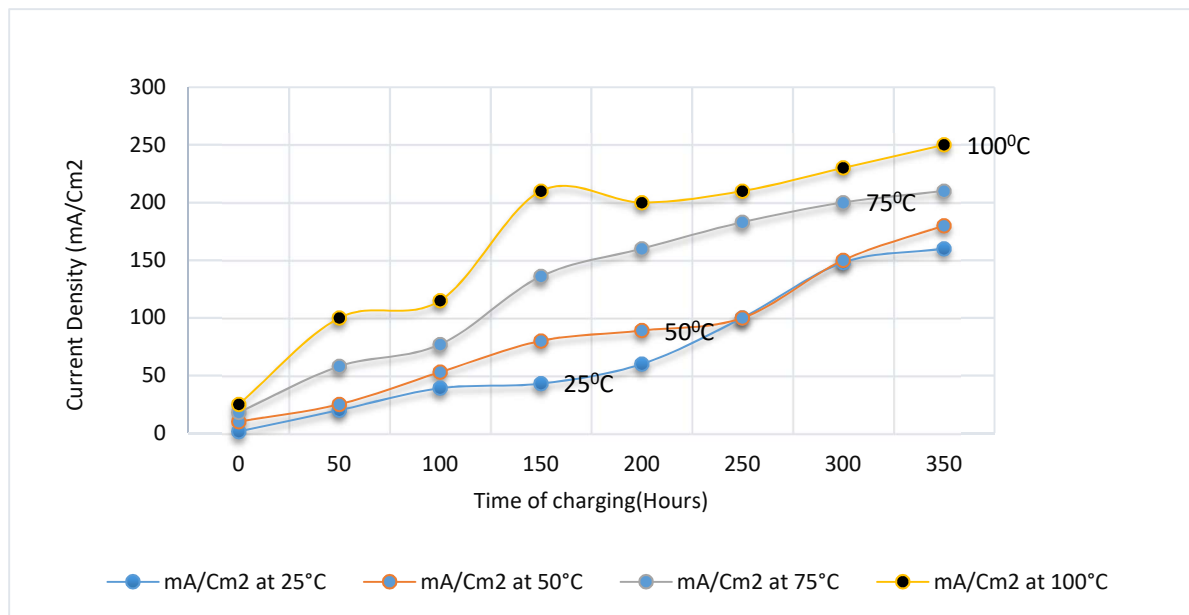
Figure 3: A graph of current against Times of charging

The UNS steel specimen used during the course of the plastic loading in the media maintained at 25°C showed an increase in the electrons leaving the surface as captured by the increasing value of the current density. When the aging process was kept at 350 hours with samples immersed as shown by the jig arrangement. It follows that increasing the experimental temperature alongside time of charging led to increase in the current density. The samples failed in almost an embrittling manner with the increase in pre stressing coupled with the pre charging. As shown in Figure 4, observation of the graphical trend showed decreasing tensile strength as the recharging period increases. However, in Figure 5, the strain varied sinusoidally with time. The strain rate was

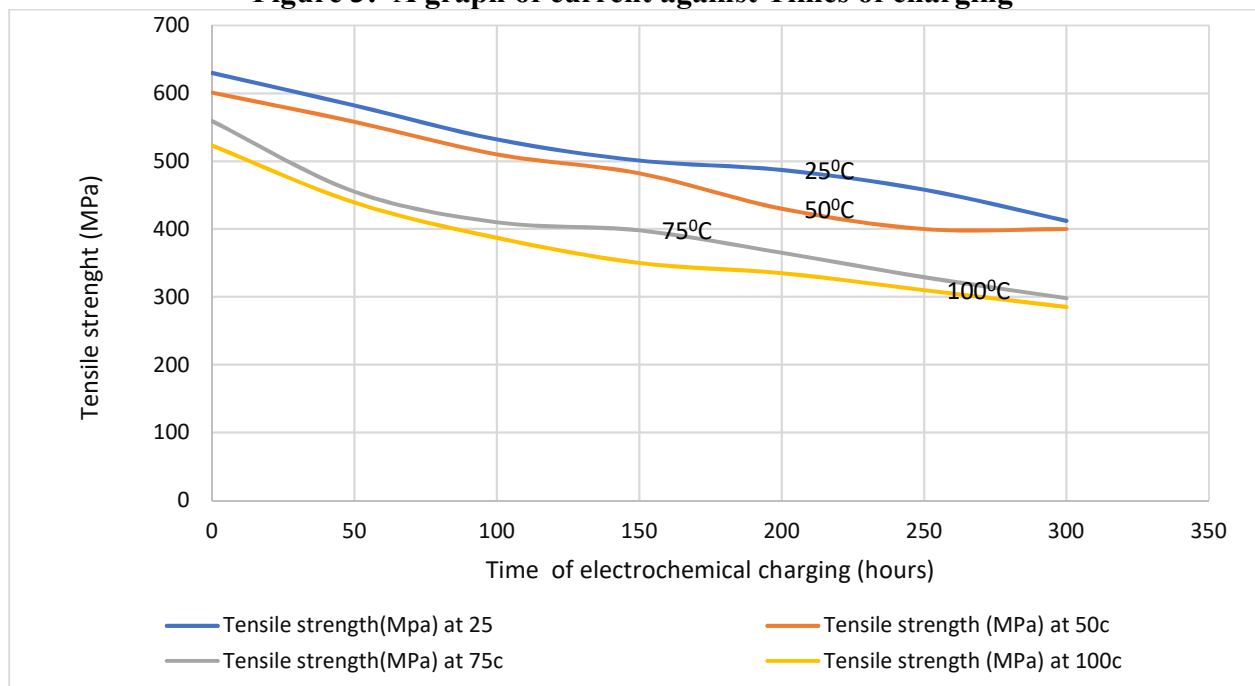
Figure 4: A graph of Tensile versus Time of Charging

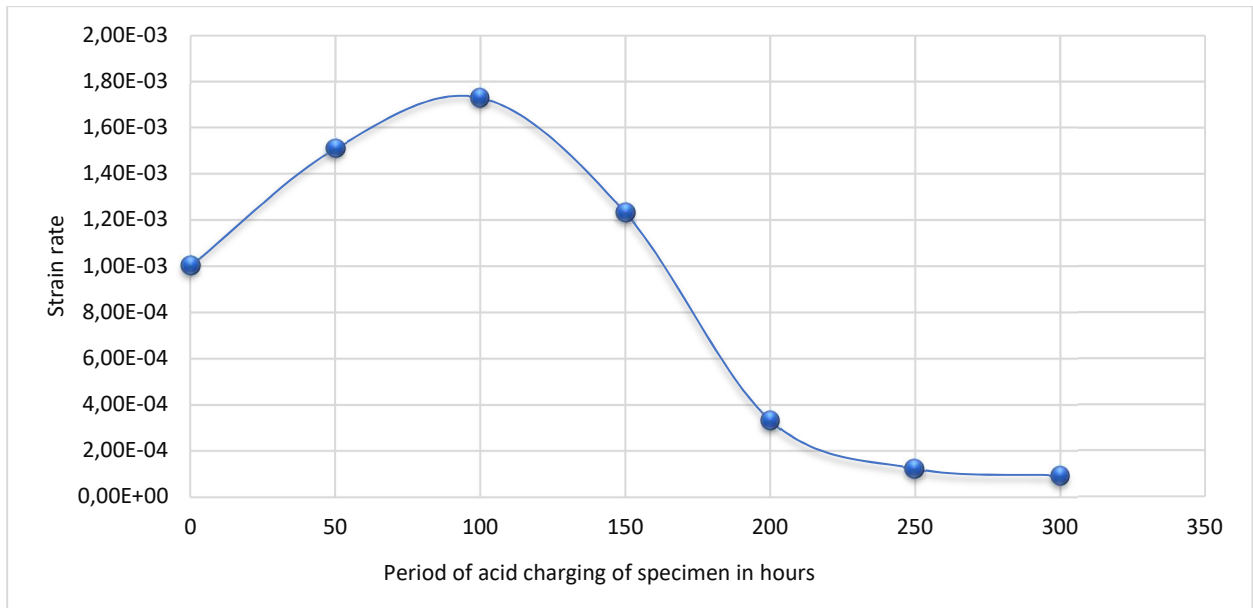
Figure 5: A graph of Strain rate versus period of charging of specimen in hours

critically reduced because of plastic loading was affected by the acid pre-charging leading to a compromise on the mechanical strength. It can be deduced that:

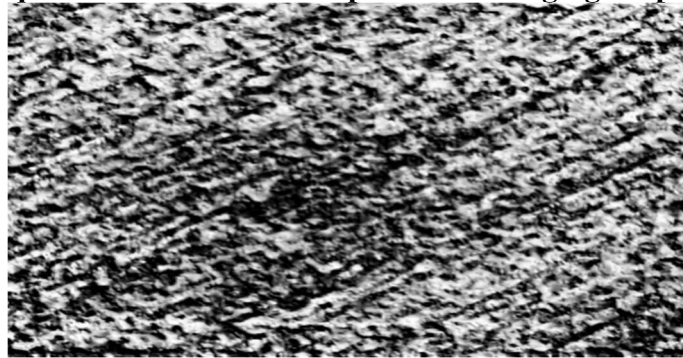
Plate 1: Fracture Surface of Control Sample

As shown in Plate 1, it is observed that fractured surface of the control specimen contains a large population of small and shallow dimples which is indicative of its relatively high tensile strength and ductility [6].

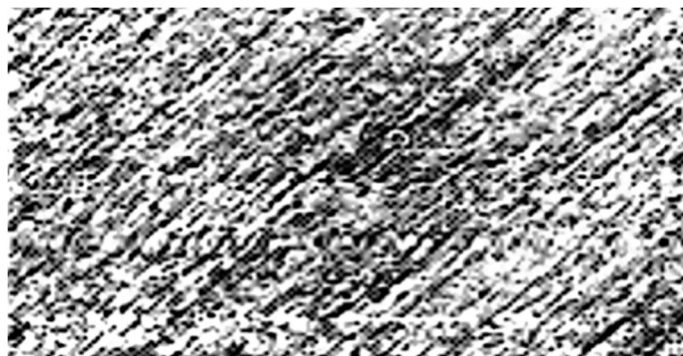
Plate 2: Fracture surface of the Sample at 25°C

Fracture surface observed showed that hydrogen triggered the fracture along the grain boundaries as shown in Plate 2 [7].

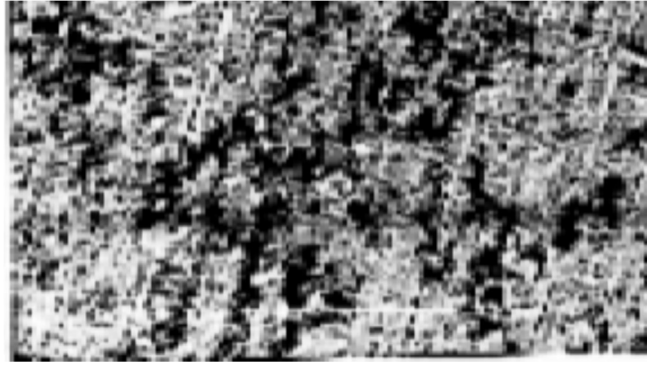
Plate 3: Fracture surface of the Sample at 50°C

Plate 3 showed Transgranular quasi-cleavage type of fracture appeared, which indicates brittle failure.

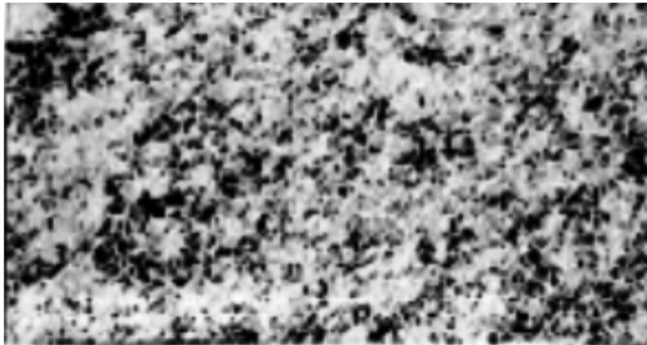
Plate 4: Fracture surface of the Sample at 75°C

The result in Plate 4 indicates that with increased hydrogen gas pressure, i.e. hydrogen content inside the material, enhances the propensity for intergranular cracking [7].

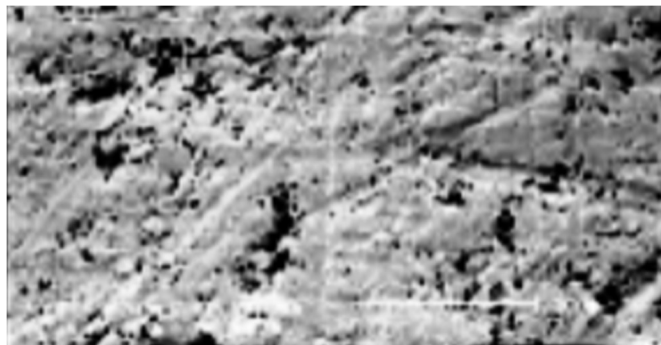
Plate 5: Fracture surface of the Sample at 100°C

Plate 5 shows microvoiding along the grain boundaries near the propagation tips, indicating hydrogen modified dislocation behavior and its interaction with grain boundaries and plays a crucial role in triggered the intergranular cracking [7].
