TITLE: Discovery Process of the Zeytinburnu Mosaics Outside the City Walls

## Discovery Process of the Zeytinburnu Mosaics Outside the City Walls

**Citation:** Aydemir, O. & Hattap, E. S. (2023). Discovery process of the Zeytinburnu Mosaics outside the city walls. *Journal of Architectural Sciences and Applications*, 8 (2), 926-934.

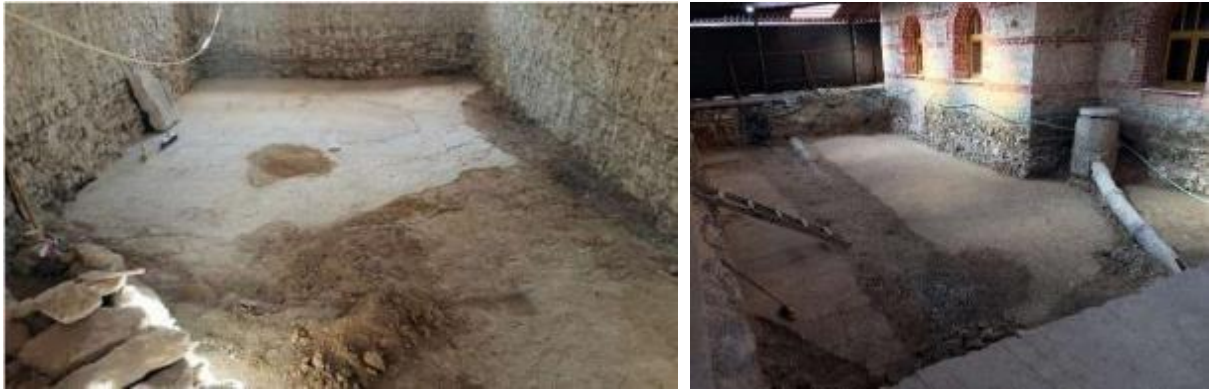
**Figure 2.** Revealed mosaics from excavations in Zeytinburnu, 2017-2019 (Zeytinburnu Municipalit Archives, 2019)

The excavation process started with the discovery of some partial mosaics during the reinforcement of foundations of the corner room southwest of the Old Municipality Building from the Ottoman Era and was completed under the inspection of the Directorate of Archeological Museums of Istanbul

depending on the permission taken from the Directorate of Conservation Board by Zeytinburnu Municipality (Figure 2).

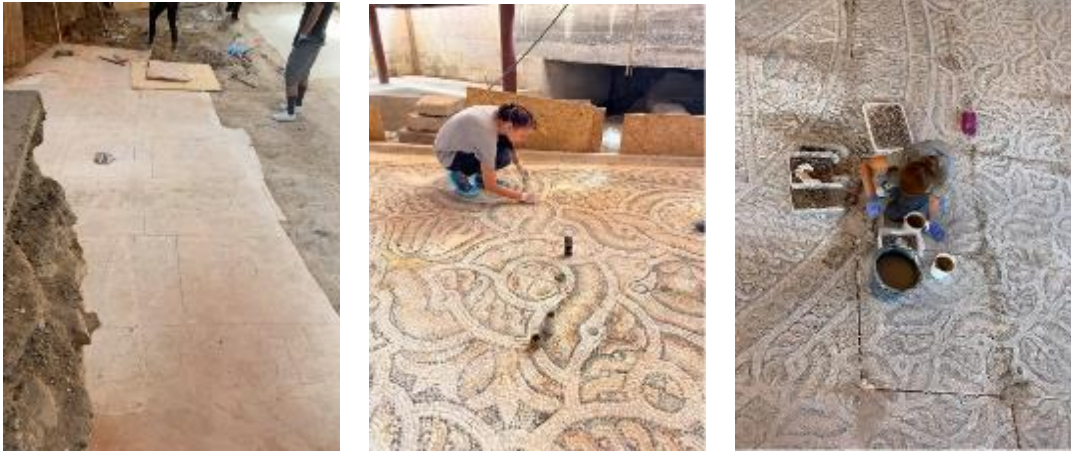
**Figure 3.** Conservation steps of Zeytinburnu Mosaics (Olca Aydemir Archives, 2019)

The conservation process of Zeytinburnu mosaics was completed following the steps of removing the soil on top (10-20 m depth of sand and gravel layers) (Çömlekçi & Kahraman, 2022), designing the grid system of the plates, implementing of facing, moving, conservation methods and re-placement of the mosaics to the original locations. All conservation steps were taken according to the critiques

of the conservation report of the Directorate Central and Regional Restoration and Conservation Laboratory of Istanbul (Figure 3, 4, 5).

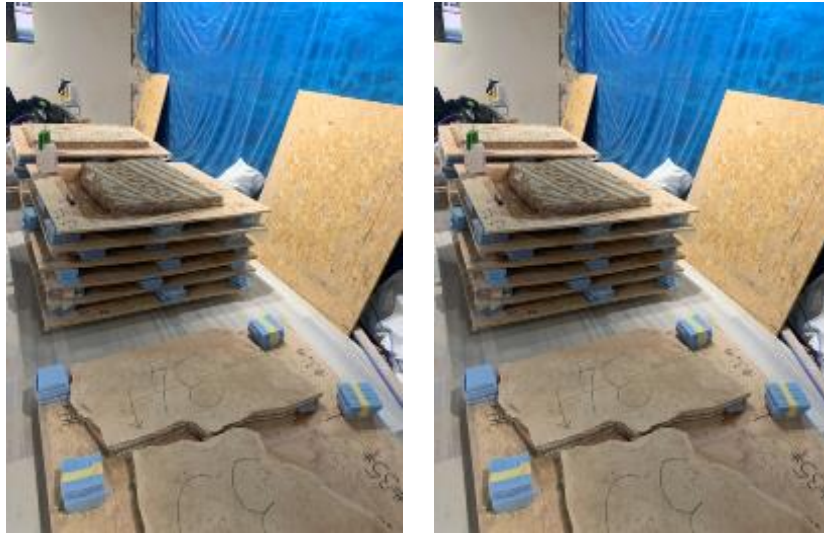
**Figure 4.** Moving the mosaics after reinforcement and numeration to store them under protection during the conservation implementations (Olca Aydemir Archives, 2019)

Before the inspection of mortar and movement of the cut plates, a pre-reinforcement way of fixing the parts under risk with the help of cloth was carried out, avoiding any damage to the mosaics.

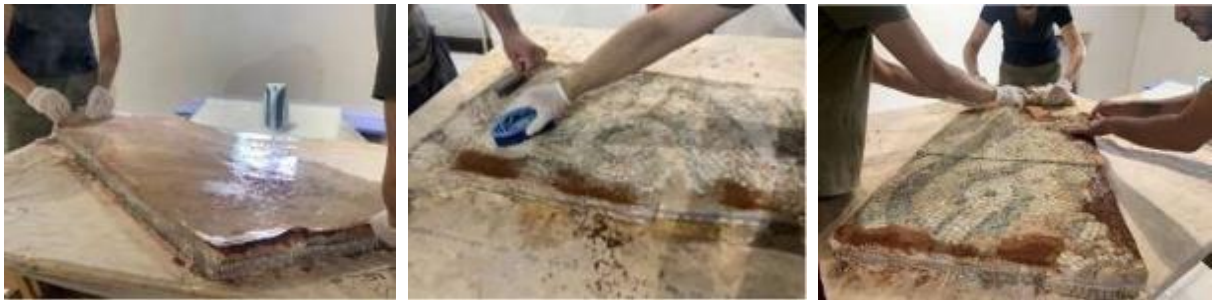
**Figure 5.** Conservation steps of Zeytinburnu Mosaics (Olca Aydemir Archives, 2019)

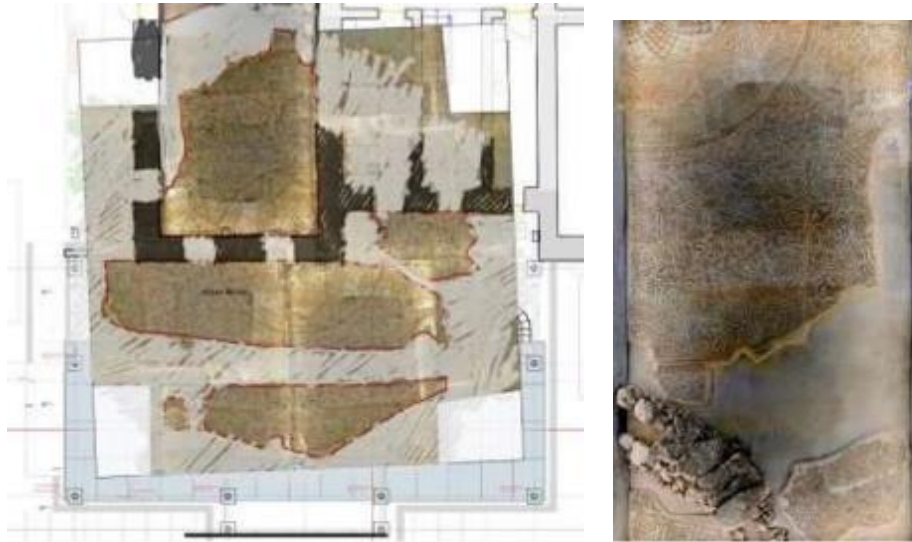
**Figure 6.** Interiors of Zeytinburnu Mosaics (Zeytinburnu Municipality Archives & Sketches of Celalettin Çelik, 2019)

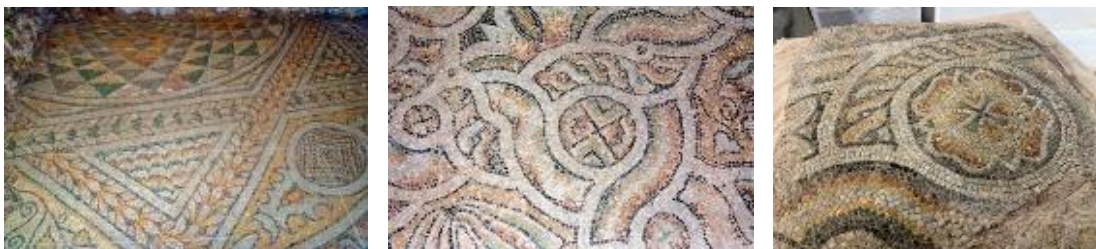
**Figure 7.** View of vivid colored tessera modules after the cleaning (Zeytinburnu Municipality Archives, 2022)

Zeytinburnu Mosaics are formed of geometric patterns on a mortar layer (of which analysis process is completed) which are an arrangement of triangles colored white, green, yellow, black, brown, orange, and red. Besides the assumption of the 5th-century date in terms of technical observation, it was understood that they belonged to the 5th-6th century during the excavations and depending on the coin of the 5th century found inside the foundation walls (Figure 7). In the following process, the floor mosaic plate was dated to the 4th century AD. The floor mosaics of Istanbul are dated from the 2nd century till the 6th century which are rarely discovered (Yalçın, 2022).

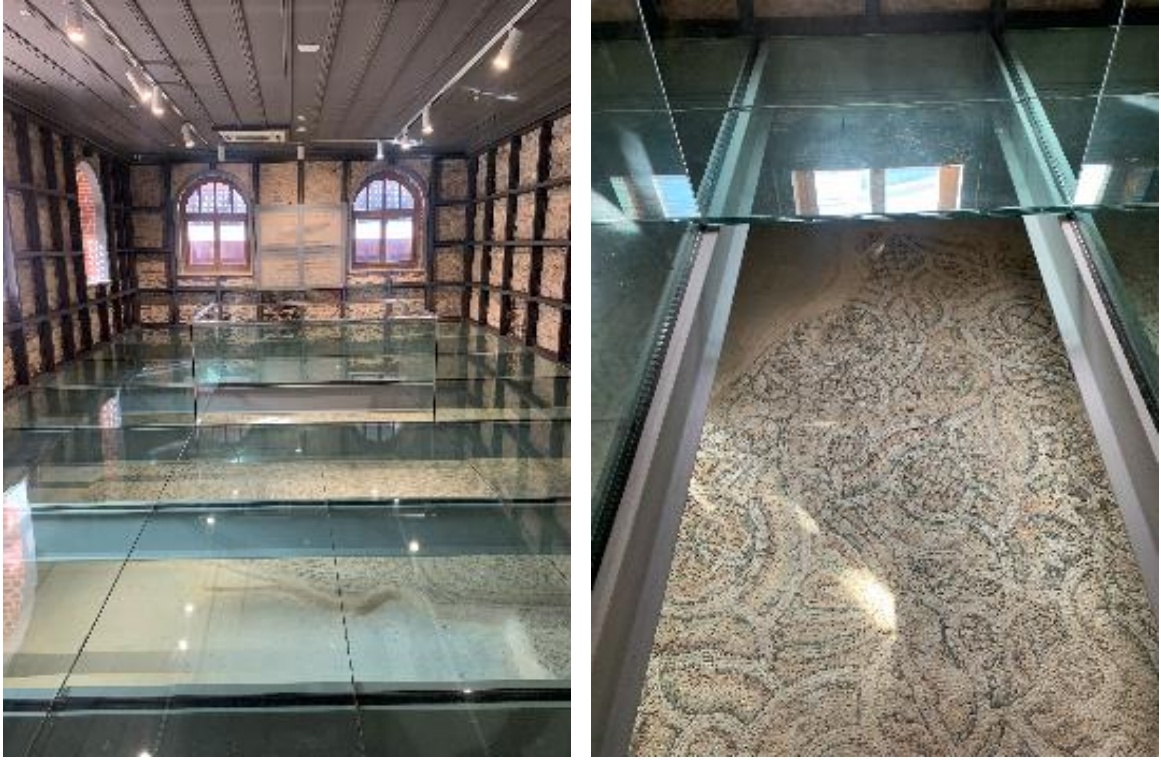
**Figure 8.** The completed and exhibited part of the mosaics (Sibel Hattap Archives, 2022)

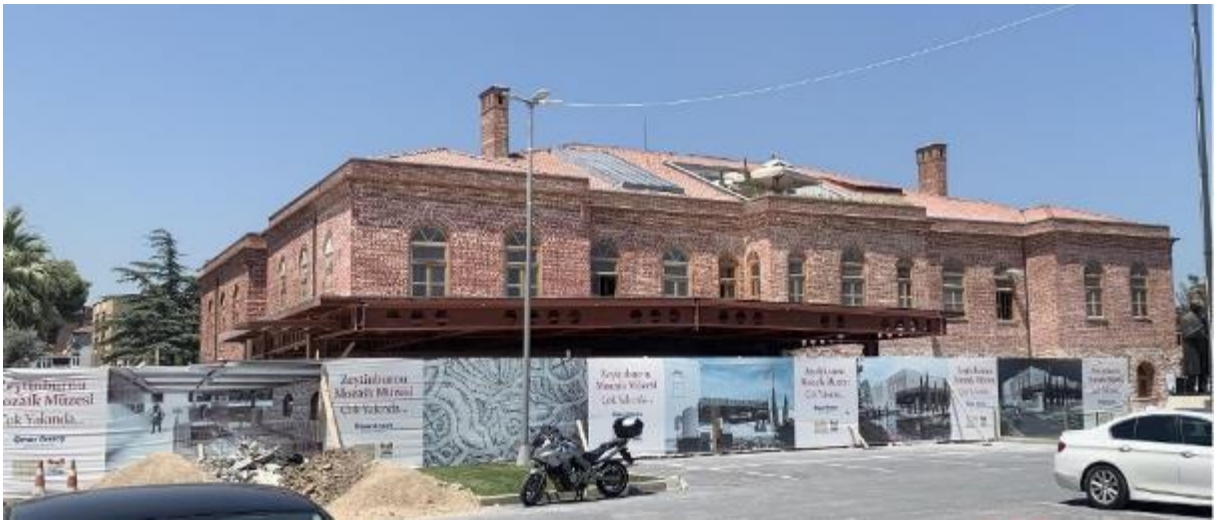
**Figure 9.** Exterior exhibition works of mosaics at Kazlıçeşme Art Center (Sibel Hattap Archives, 2022)

After completion of the excavations, the cleaning and conservation works were carried out and the mosaics were replaced for the exhibition and that part of the building was arranged as a museum (Figure 10, 11).

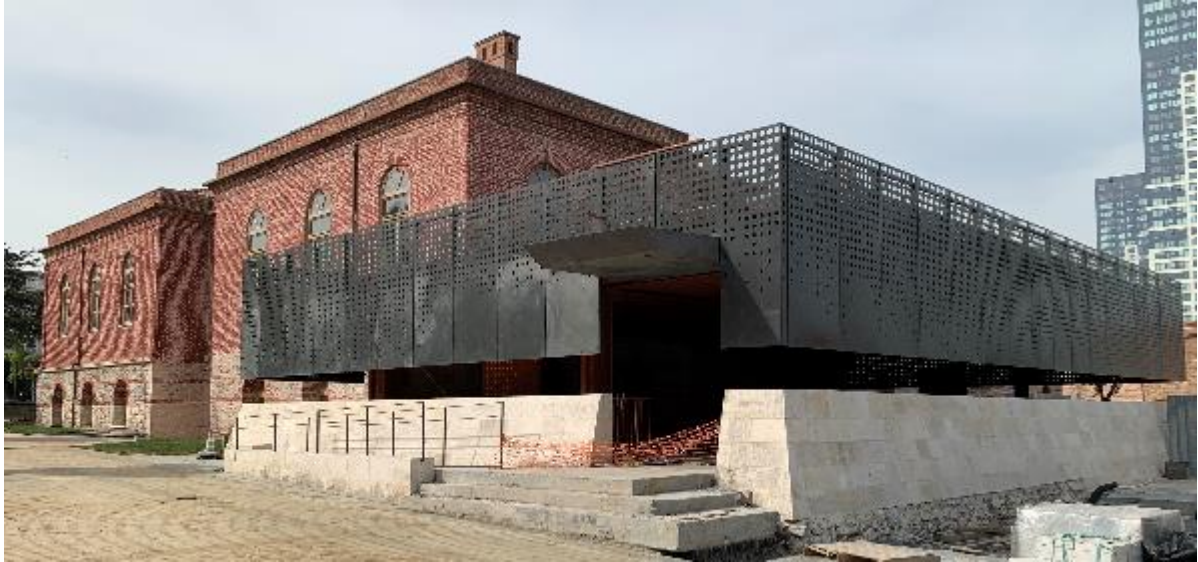
**Figure 10.** Current view of Kazlıçeşme Art Center (the exterior exhibition part) where the mosaics are exhibited (Sibel Hattap Archives, 2023)

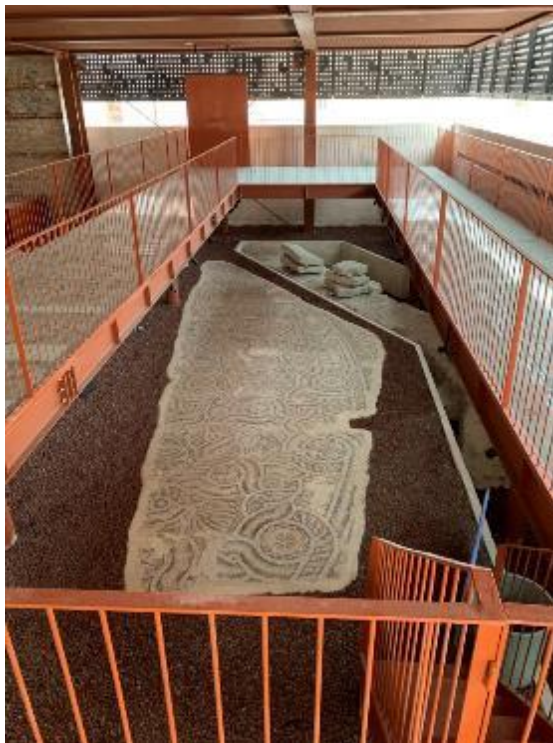
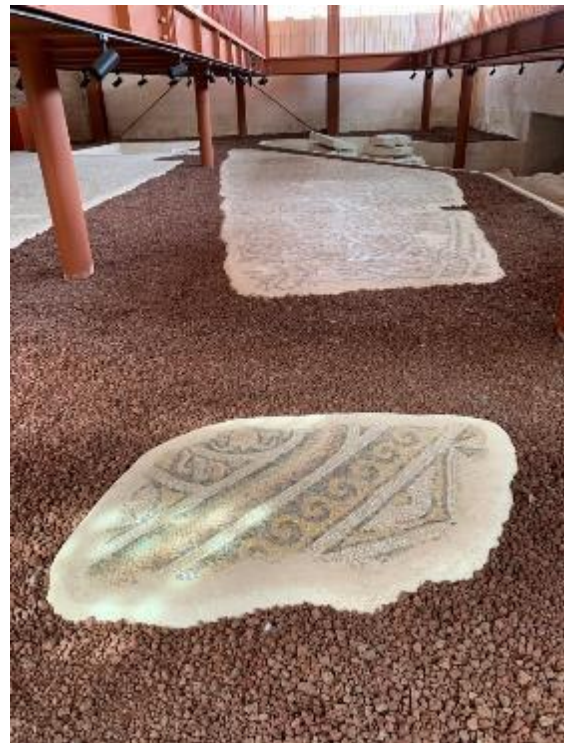
**Figure 11.** Exhibition of the rest of the mosaics at semi-open part of the building (the exterior exhibition part) (Sibel Hattap Archives, 2023)

The rest part of the mosaics was also revealed and after the conservation steps, they were exhibited in a semi-open area. It is very precious and remarkable that some of the mosaics revealed in Zeytinburnu are exhibited in In-Situ at Kazlıçeşme Art Center which served as a military hospital and then as Zeytinburnu Municipality Building while the rest are exhibited under a semi-open structure outside the building as continuity of the interior ones.

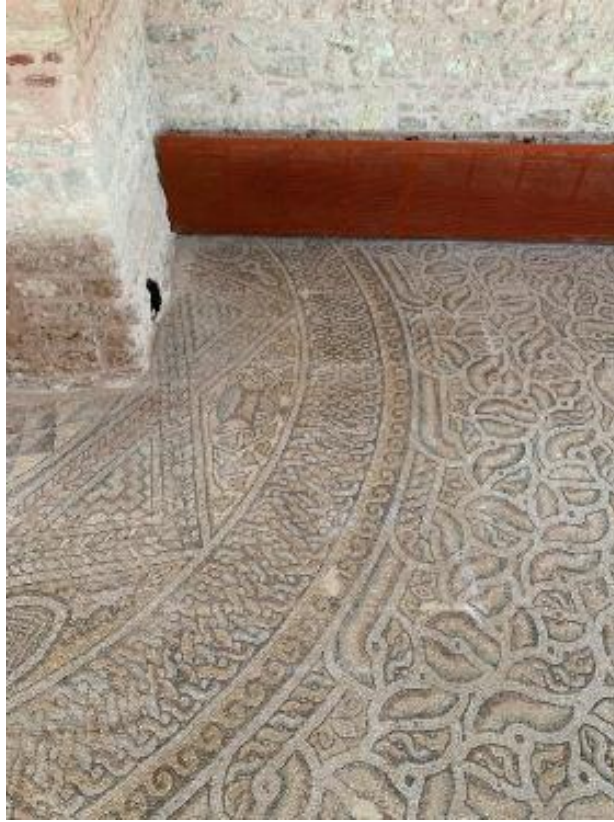
**Figure 12.** Exhibition of the circular forms of the mosaics at semi-open part of the building (the exterior exhibition part) (Sibel Hattap Archives, 2023)
