TITLE: Seismic Damages in Masonry Structural Walls and Solution Suggestions

Academic Platform Journal of Natural Hazards and Disaster Management

4(2) 2023: 49-64, DOI: 10.52114/apjhad.1400644

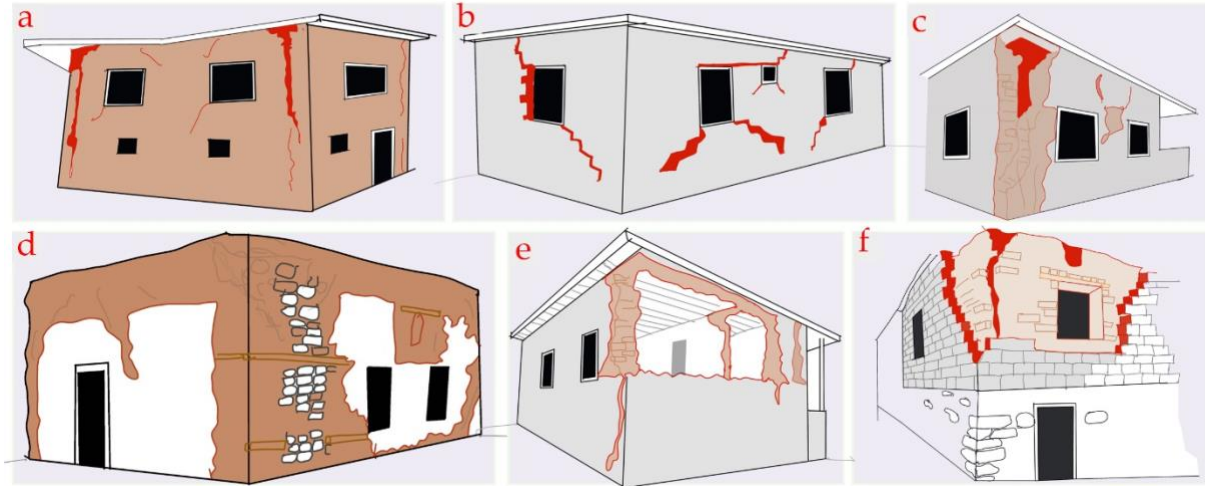
The Kahramanmaraş earthquakes of February 6, 2023, called the disaster of the century for Türkiye, caused great destruction in a very large region. Significant damage has occurred in buildings with different structural systems. Various levels of damage have occurred in masonry structures, which are widely used especially in rural areas. This study focused on the damages occurring in masonry walls located in the earthquake zone and the damages occurring in load-bearing walls, which are the most important elements of masonry structures. As a result of field observations, the damages occurring on these walls were evaluated. It is thought that photographs taken from the region provide an important resource to provide a general understanding of these damages. Damages have been observed in various forms such as out-of-plane deformations at corner points, irregular use of wall materials, low or insufficient strength

of the wall materials used, and out-of-plane movements on the walls. These results emphasize the importance of measures to be taken to improve the earthquake resistance of masonry structures in rural areas exposed to earthquakes and to make them durable after the earthquake. Schematic representations of the structural damages resulting from the evaluations are shown in Figure 113.

**Figure 13.** Schematic representation of load-bearing wall damages in masonry structures a) separation at corners b) window corners damages c) out-of-plane wall corner damages d) Falling of exterior materials e) out-of-plane movement f) inadequate connections
