TITLE: Investigation of Failure Mechanism of a DCI Engine Connecting Rod

In reciprocating engines, connecting rod cap and connecting bolts are critical as they are exposed to varying loads under different operating conditions. This paper focuses on the failure of the connecting rod of a 1.5 dci K9K diesel engine. As a result of the engine operating for approximately 378400 km, the connecting rod was broken, and the reasons for the failure of the connecting rod cap and connecting bolt were investigated. The connecting rod of the K9K engine was designed in accordance with the dimensions by using SolidWorks software, and then exported to ANSYS software for stress and fatigue analysis. Also, the macrostructure of the broken connecting rod cap and bolt was investigated. We knew that the mechanic who fixed the engine about two years ago tightened the connecting rod bolts without using a torque meter. Therefore, stress and fatigue analyses were performed to determine the effect of different tightening torques (ranging from 22.5 to 52.5 Nm) at 2000 rpm. According to the numerical analysis results, with increasing tightening torque, the maximum equivalent stress and alternating stress valu

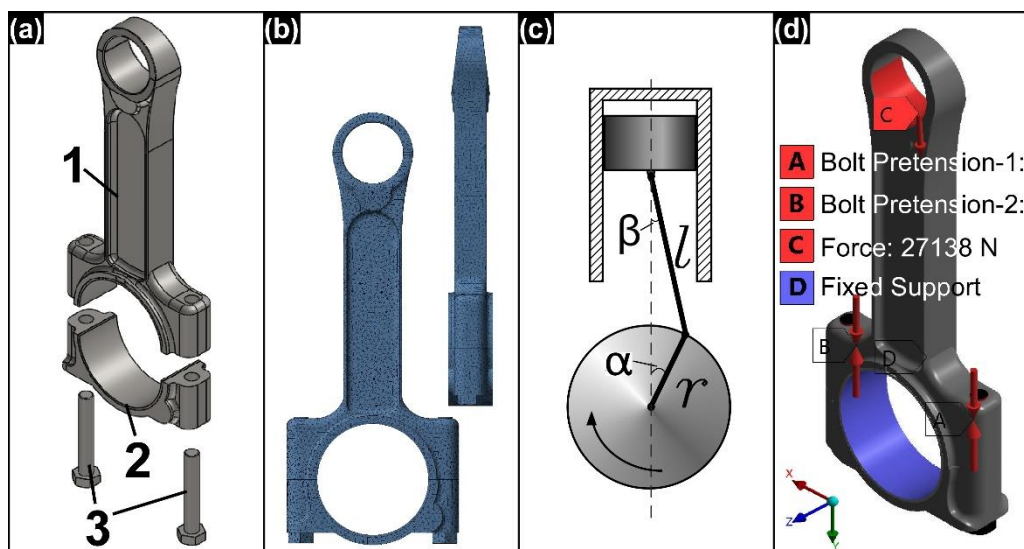
Figure 2. (a) Main parts of connecting rod, (b) finite element model showing meshes, (c) angles of crankshaft and connecting rod at the maximum in cylinder pressure, (d) loading conditions.

To understand the mechanism of connecting rod failure, first, the geometric model of the connecting rod was created using SolidWorks software. As seen in Figure 2 (a), the connecting rod consisted of three basic components. Part 1, 2 and 3 were the connecting rod shank, lower cap and bolts, respectively. Then, the created model was exported to the ANSYS Workbench software for numerical analysis. AISI 4140 low alloy steel was defined as the material with linear-elastic properties [13]. The maximum young's modulus, yield strength, ultimate strength and poisson ratio of 4140 steel were 210 GPa, 1540 MPa, 2073 MPa and 0.29 %, respectively. In the next step the contact definitions between neighboring components were carried out. The friction coefficients of bolts and all other parts were defined as 0.15 and 0.1  $\mu$ , respectively [24]. Tetrahedron meshes were used to divide the connecting rod into finite elements (Figure 2 (b)). The average mesh quality value was tried to be 0.85 and above to obtain more accurate results. To achieve this, different operations such as patch independent, patch conforming and mesh sizing were applied. The model was occurred with 160994 nodes and 104508 elements.
