TITLE: Analysis of Deterioration on Stone Surfaces: The Case of Kasimiye Madrasah

Analysis of Deterioration on Stone Surfaces: The Case of Kasımiye Madrasah

Citation: Biçen Çelik, A., Ergin, Ş., Dal, M. & Ay, İ. (2023). Analysis of Stone Deterioration on the Facades of the Kasımiye Madrasah. *Journal of Architectural Sciences and Applications*, 8 (2), 696-712.

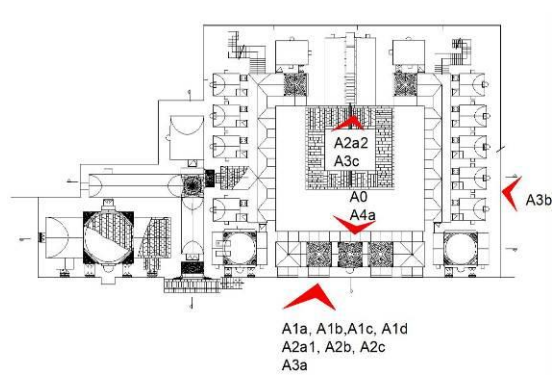
Figure 9. The plan representation of the stones selected for the use of XRF chemical method for the deterioration of the Kasımiye Madrasah

All types of deterioration occurring in the Kasımiye Madrasah were analysed with the codes determined by X-Ray Fluorescence Spectroscopy (XRF chemical analysis method). The codes determined (Table 6), the representations of the selected stones on the plan (Figure 9) and on the facade (Figure 10) are given below. The main purpose of analysing the materials of historical buildings is to obtain information about the production technology as well as the physical and chemical composition of the materials (Karataş, Alptekin & Yakar, 2022).
