TITLE: The Restitution of "Çifte Hamam" in Ahlat According to Final Excavation Outcomes

# The Restitution of “Çifte Hamam” in Ahlat According to Final Excavation Outcomes

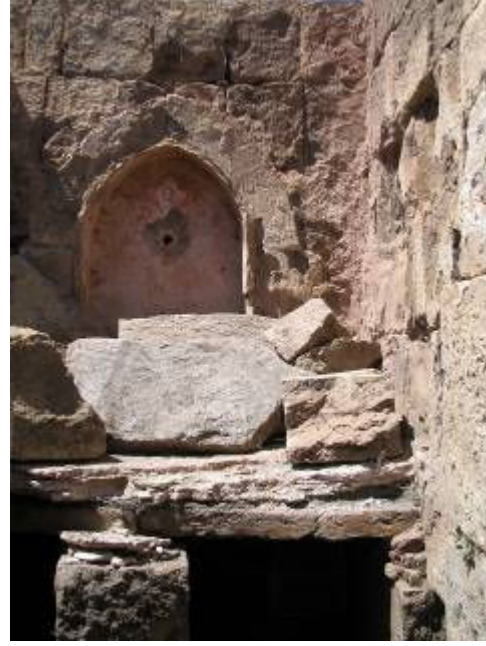
Figure 3. The water pipe and halvet niche

Having been under the ground as a whole when excavation thereof was commenced by Prof. Dr. Prof.Dr. Haluk Karamağaralı in 1970's, it is situated right outside the bastion remains at the northeastern side of the wall. The structure is positioned as *Çifte Hamam* on the north-south axis. As a result of the excavations led by Prof.Dr. Haluk Karamağaralı, men's section, water depot, and the wall separating the men's section from the women's section have been unearthed. At the southeastern corner of the unearthed area, *sıcaklık* (caldarium) section with the *göbek taşı* (central platform) at the center, the iwans surrounding it, as being located at the reciprocal axes, and the *halvets* (private rooms) at the corners are appertained to the men's section. At the relatively better-sustained men's section, while the walls and vaults were found to have been built by cut-stone, the domes and the transitions elements were found to have been built by brick. It is understood from the remnants that, all spaces, including the floors, were plastered with mortar. Bath basins, emplaced inside the pointed arc niches at the *halvets*, are seated on the plastered floor. It is understood from the water drains visible inside the walls, and from the single tap holes, that these bath basins were drained only with water warmed enough to take bath. (Figure 3).

<sup>6</sup>See: Figure 3; Men's section is at the *halvet*, located at the southeastern corner; base, conveying feet, *sal* stones, plasters and wall junction.

<sup>10</sup> See: Figure 3, the same information is available in the excavation report, dated 17.08.1972.

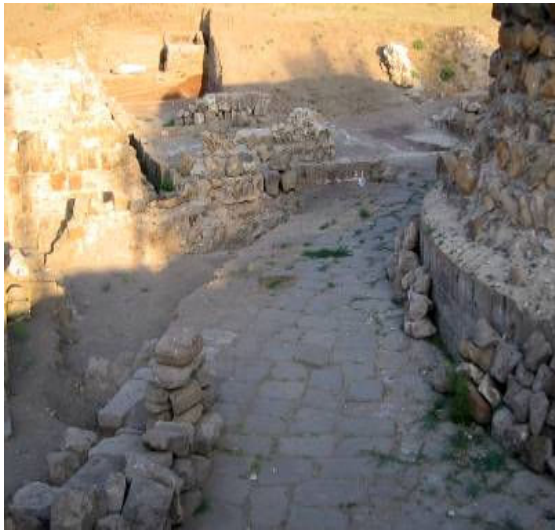
Figure 4. The Street near the Bath

Having the bath excavation restarted in the year 2009, the original street, curving along the part of the city wall at the southwest of the bath, was tidied out with its floorings unearthed; it was thereby clarified how the units of the bath, understood to have been built later, had been shaped in connection with the street.<sup>3</sup> (Figure 4)

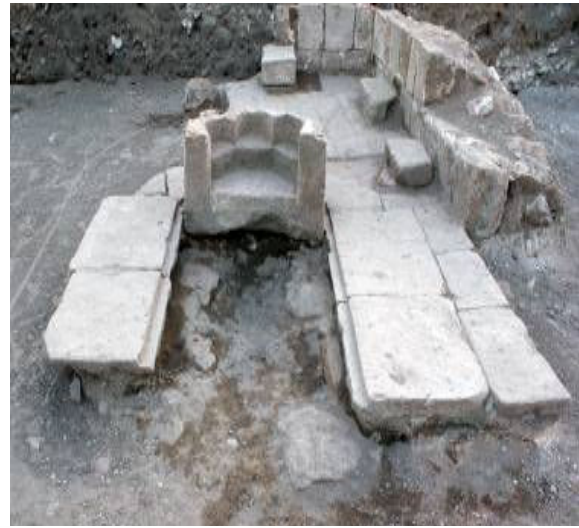
Figure 5. The wall remnant and the şadırvan (pool)

During the excavation works carried on at the northeast of the building, it was ascertained that, cut-stones were used as the construction material, and Horasan mortar as the binding material at the bottom level. At the west part of the bath, a fountain basin in trefoil form was unearthed as being situated on the stone cladding in the middle of the soyunmalık part of the women's section<sup>4</sup>. Besides, a wall remnant, put up by well-trimmed stone, was found at the north of the şadırvan (pool) (Figure 5) Paving stones in varying dimensions were found at the soyunmalık part of the women's section. On the floor of the location, pipe drains, belonging to the water installation of the bath, were also found; and two separate pipe drain networks were found to get connected with a larger pipe drain at the east of the location.

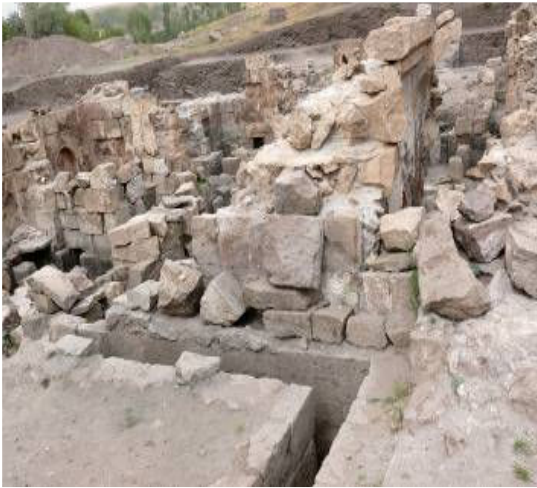
Figure 6. the waste water network of the bath

In front of the wall at the north of the soyunmalık part, under the flooring, a channel system (with 0.20 m of width, and 0.20 to 0.90 m of depth, and with 9 m length towards south-north, and 5 m length towards east-west direction), upper parts of which were made of cut-stone, having been identified through the main rock belonging to the waste water network of the bath, was identified<sup>5</sup>. (Figure 6)

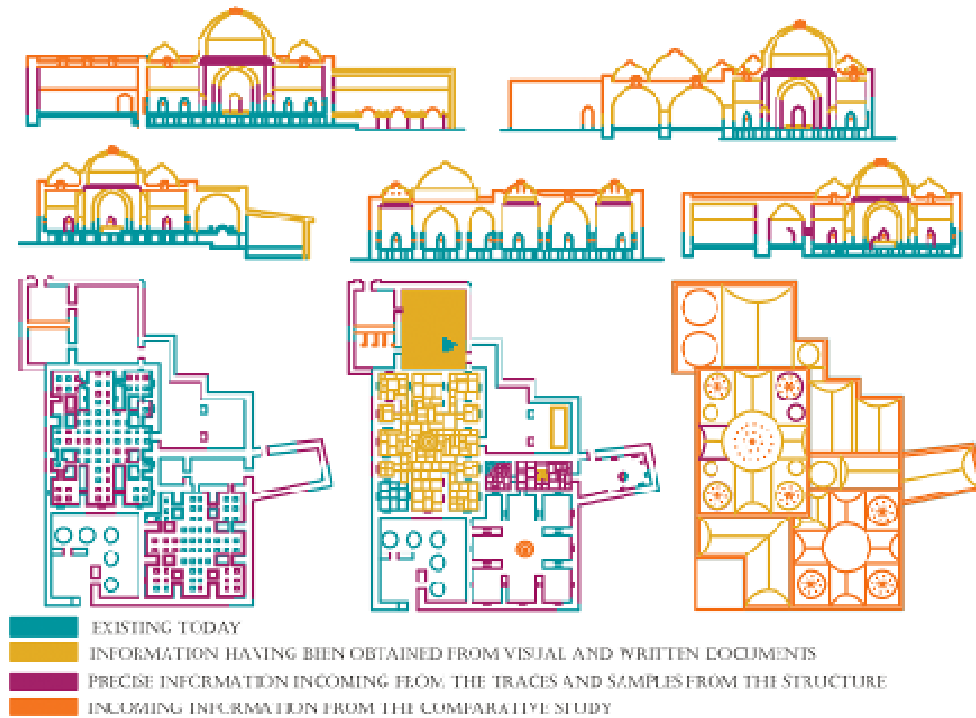
Figure 8. Restitution stages

While the available parts of the structure have formed a substantial source of data throughout the restitution study, visual and written documents, and comparative works done with the structures revealing periodic characteristics have played substantial part in the completion of the restitution. In this context, restitution stages have been assessed in the following three consecutive titles ( Figure 8).

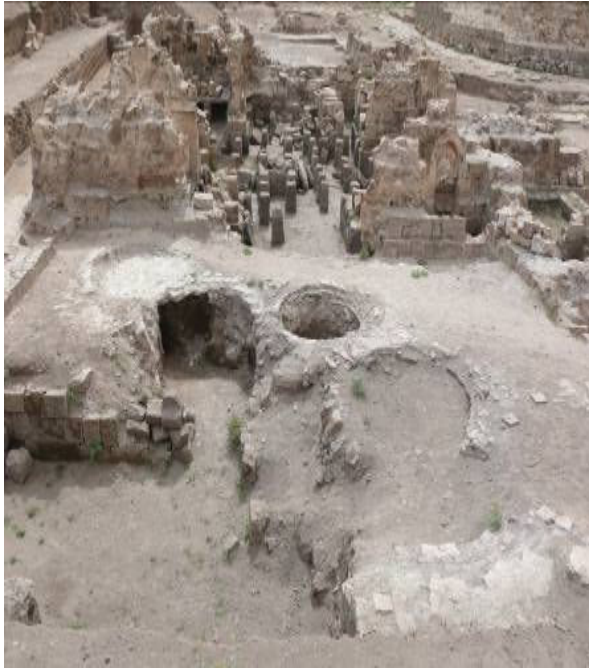
Figure 9. The 'Külhan'

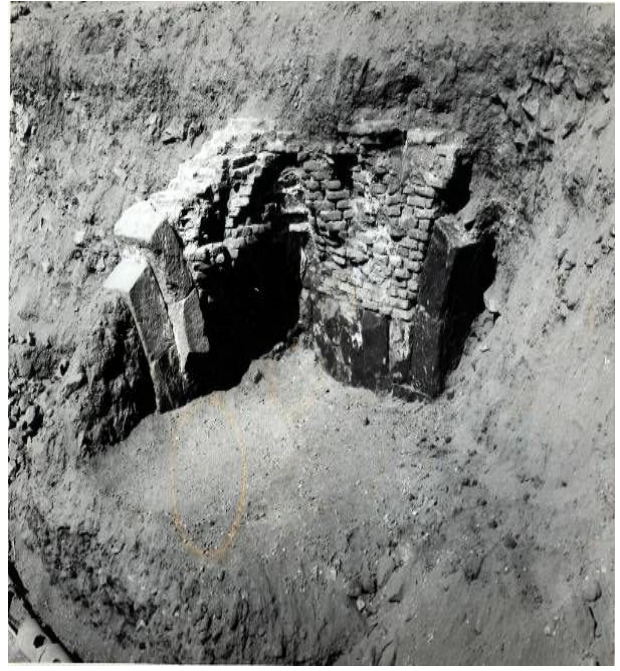
Figure 10. The squinch and the bricks which annihilated because of atmospheric conditions [5].

The photos, having been taken every year within the scope of the excavations throughout the past years, the elements, which are seen in these photos, but have been annihilated in the course of time due to either atmospheric conditions, or due to the acts of vandalism, have been identified, and completed with primary reliability<sup>8</sup> (Figure 10).

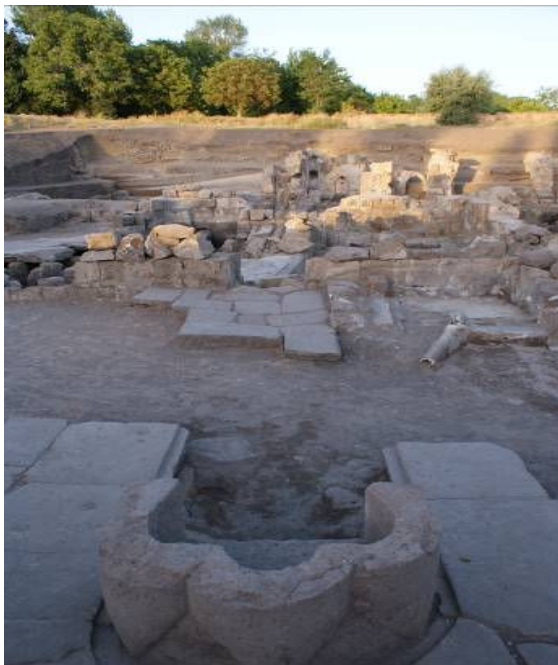
Figure 11. The Şadırvan (pool) pool and paving stones

Disregarding our lack of information regarding the fronts, despite there is no trace having survived up to the present day, the probability of the presence of windows at the *Soğukluk* section is quite high on the basis of the information incoming from the comparative study. According to the reviews, in the *soğukluk* locale, while there is no space at the fronts of the women's section, there is so at those of the men's section. Furthermore, just like the *şadırvan* (pool), having been unearthed at the *soğukluk* section of the women's bath, pipe drains were found running towards the middle of the *soğukluk* section of the men's bath, and it has become possible to mention of the presence of a *şadırvan* (pool) pool in this section, too. ( Figure 11.)

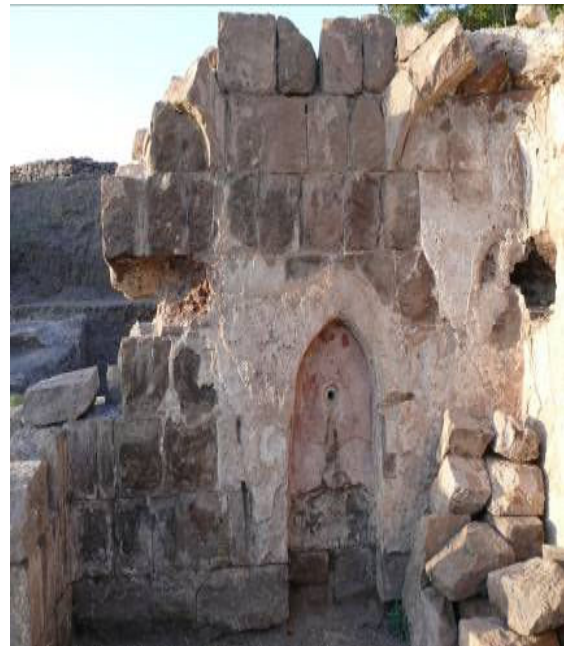
Figure 12. The concave stones and the pink plaster at the halvet.

Whole of the *sıcaklık*s of both women's and men's sections of the structure had been plastered by a pink colored plaster uninterruptedly, including the floors and walls. This plaster could have survived as preserved up to the present day<sup>10</sup>(Figure 12). Plaster remnants have been determined also at various layers over the wall parts at certain sections. As a result of the tests, having been conducted by Ankara University, the plaster has been found to be *Horasan* mortar. Besides, the wall, floor, and ceiling of the water depot had also been plastered by *Horasan* plaster, and the information regarding thereto is available in the excavation report, dated 09.08.1972.

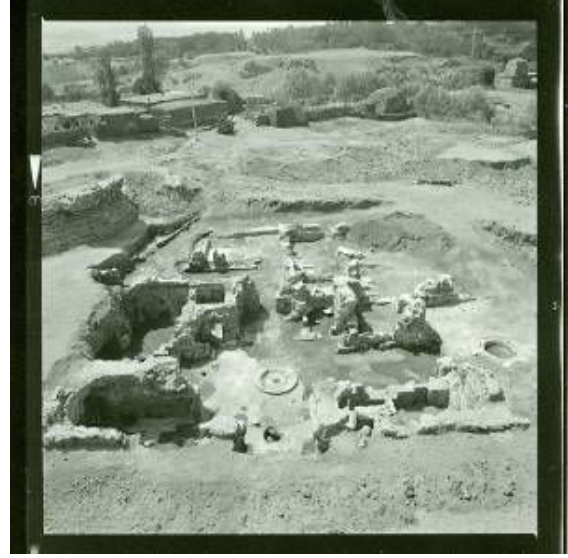
Figure 14. "Göbek taşı (central platform) [4]."

Presence of the *göbek taşı* (central platform) with sprinkler is clearly seen at the photos, having been taken in the years 1975 and 1977, and the excavation reports, dated 21.08.1975, and 01.08.1977. The presence of the pipe drains, which are headed to the sprinkler, also reinforces this characteristic (Figure 14).
