TITLE: REHABILITATION OF HIGH STRENGTH REINFORCED CONCRETE CORBELS USING  
BASALT FIBER FABRIC

# REHABILITATION OF HIGH STRENGTH REINFORCED CONCRETE CORBELS USING BASALT FIBER FABRIC

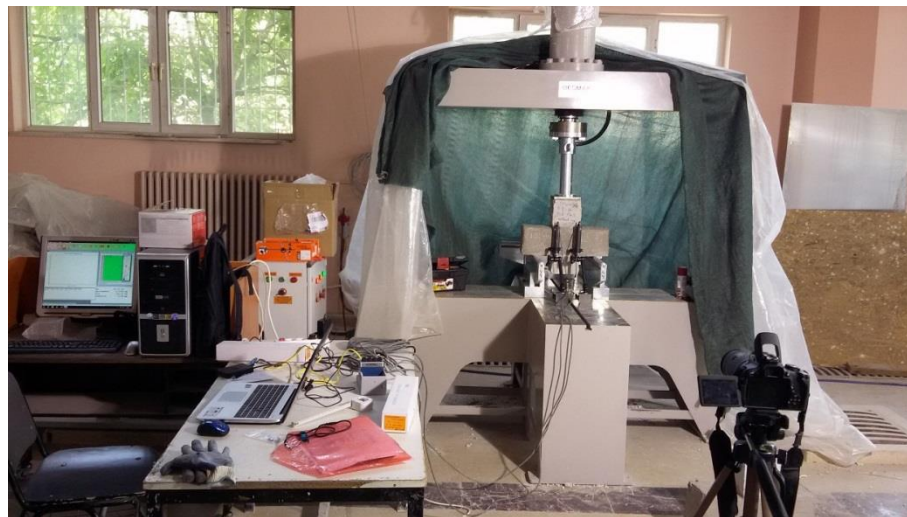
Figure 4. Corbel Specimen Setup

All corbels were tested before and after the rehabilitation process under three-point loading tests Figure 4. Tests were carried out via 500 kN capacity displacement-controlled loading machine. The corbels were loaded with rate of 0.3 mm/min. Deflection of corbels was measured by two linear-variable-displacement-transducers (LVTDs). Load and displacement values were recorded at every 0.2seconds.

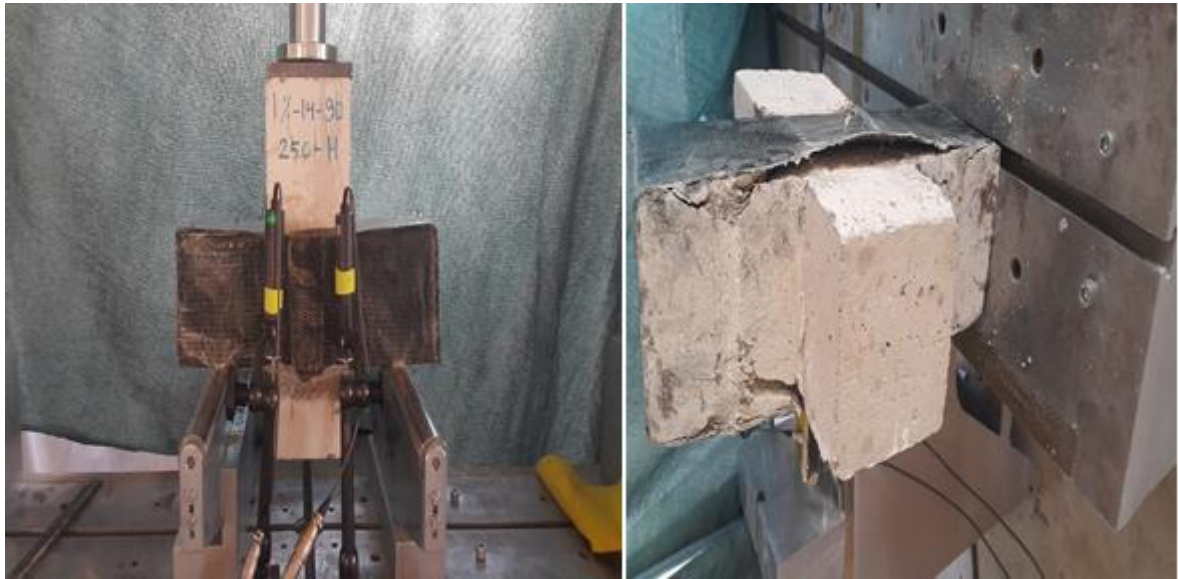
Figure 5. Specimen with De-bonding failure

number of the specimen and the remain terms represent compressive strength, steel fiber ratio, main bar diameter, degree of heating before initial failure, and shear span length, respectively. As a result of tests, it was concluded that load capacity of the high strength reinforced concrete corbels increased an amount of 50% averagely as compared to the corresponding values before rehabilitation. Moreover, strengthening with basalt fiber fabric enhanced the ductility of corbels noticeably. Therefore, a preferable seismic performance of reinforced concrete corbels can be achieved with basalt fiber fabric even they are damaged due to both fire and overloading. Besides, the failure modes of the corbels before and after rehabilitation are summarized in Table 4. All of the corbels have the same failure pattern after repairing which is debonding between the basalt fiber fabric and the surface of corbels as shown in Fig. 5. Even different failure modes had been observed in the initial failure of the corbels, failure modes of all corbels after rehabilitation were debonding failure. This result can be attributed to the placement of the fabric in two directions which makes the fabric much more powerful leading to prevention of the tearing of the fabric.
