TITLE: The Cross-section Variations in Red Pine (*Pinus brutia* Ten.) Needles as an Indicator of Atmospheric Pollution: Gökova Thermal Power Plants

AUTHORS: Yasar NUHOGLU, Yilmaz YILDIRIM, Murat DÜNDAR

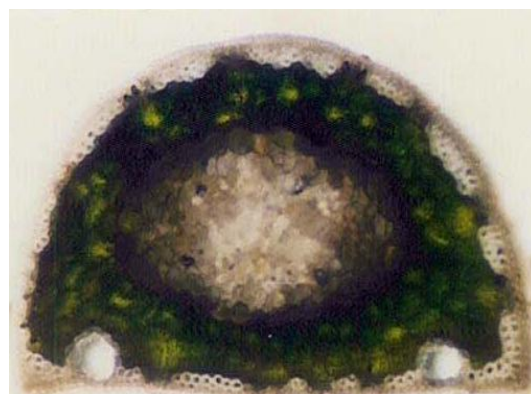
Fig. 2. Cross-section of one-year-old needle taken from the control point (x 80).

emitted from KTPP can be seen in Figs. 3, 4 and 5 are compared with Fig. 2. The areas effected by the KTPP, dilation in resin canals and anomalies on resin canal positions, thinning in epidermis and hypodermis layers were observed in cross-sections of Turkish pine needles. In these sections, it was observed that especially subordinate resin canal diameters have dilated too much.

The dilation in resin canals can be clearly observed when Fig. 2 are compared with Figs. 2 and 5. Fig. 2 shows the cross-section of a one-year-old needle taken from the control point. The diameters of the main and subordinate resin canals in the cross-sections of those needles were calculated $37.05 \pm 15.73 \mu\text{m}$ by finding the average score of 100 samples. Figs. 3 and 5 show two samples of the cross-section of one-year-old and two-year-old needles respectively taken from the areas under the harmful effects of SO_2 , NO_x and fly ash released into the atmosphere from the chimney of KTPP. What is observed in this cross-section is that subordinate resin canals' diameters have been as large as those of main canals and that resin canals' diameters have dilated too much. In the measurements performed on 100 of one-year-old needle samples in the 1st research point, the diameters of resin canals were found to be $55.95 \pm 15.87 \mu\text{m}$. These increases found especially on two-year-old needles belong to the polluted points such as the 1st, the 2nd and the 7th research points (see Figure 5). The less the pollution is, the more normal the diameters of resin canals are. This occurrence may be by two reasons. Firstly, the Turkish pine injuries air pollutants of the TPP, and pathogens or insects attaches towards this sensitive (injured) plants (Krupa and Manning 1988). Thus, the Turkish pine exudes most resin to protect of its vitality and it increases the amount of resin released and thus cause dilation in resin canals. Secondly, during the photosynthesis, sulfur dioxide and hydrogen fluoride turn into sulfuric and hydrofluoric acid as a result of various reactions within the needle texture after they have passively been taken into the needle with polluted air. Because sulfuric acid is a resin-exude agent, by these ways it is augmented the amount of resin-released and excessive released resin has pressed in the internal resin canal surfaces, thus cause dilation in the resin canals. The more the resin exudation is, the more the resin canal volume and diameter are. Figs. 3 and 4 show that a cross-section of Turkish pine needle injured by air pollutants emitted from the chimney of KTPP. In addition, certain metals found in the fly ash such as

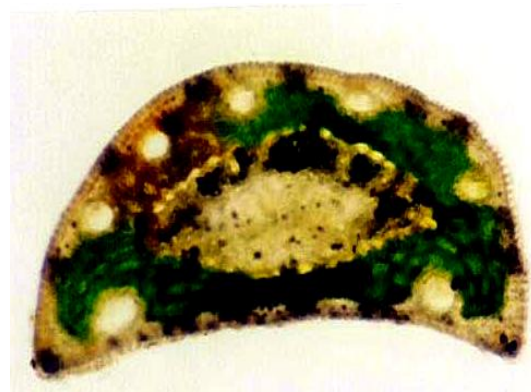
Fig. 3. Cross-section of one-year-old needle taken from the 1st research point (x 80).

Normally, there are two main and five subordinate resin canals in the cross-section of a needle; however, there are 2 main and 6-9 subordinate resin canals in the cross-sections of the needle in polluted points (see Figs. 3 and 5). That is, air pollutants increase the number of resin canals and main and especially subordinate resin canal diameters in time. It was performed statistical analysis between the resin canal diameters of one-year-old needles taken from control and all of the research points in order to prove this expression.

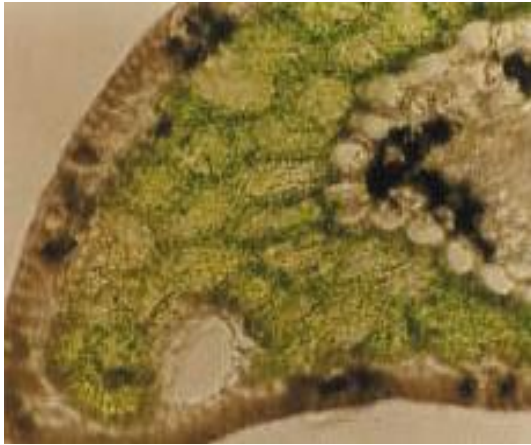
Fig. 4. Cross-section of one-year-old needle taken from the 1st research point (x150).

Air pollutants do not only injury the anatomical and morphological structure of the needle, they also injury transmission corymbs. Fig. 4 show the corymbs in the cross-sections of the needles taken from polluted points. From them, it is clearly observed in the needle that the endodermis layers and transfusion tissue cells have lost their characteristics and have been deformed, gaps have occurred within the cells after the intra-cellular material has disappeared and that the cells have lost their vitality. In addition, the cytoplasmic material in the parenchyma cells found in the needles in the polluted points has lost its natural density and structure.

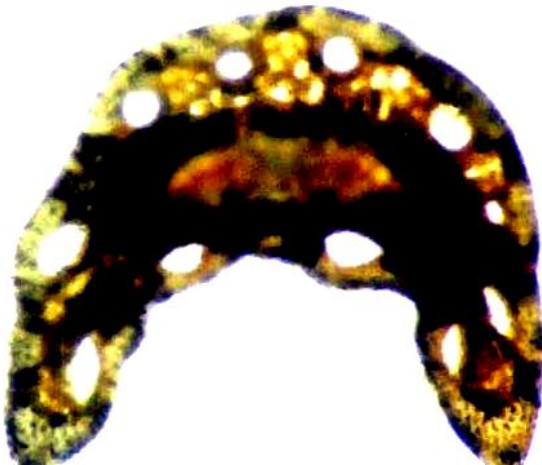
Fig. 5. Cross-section of two-year-old needle taken from the 1st research point (x 80).

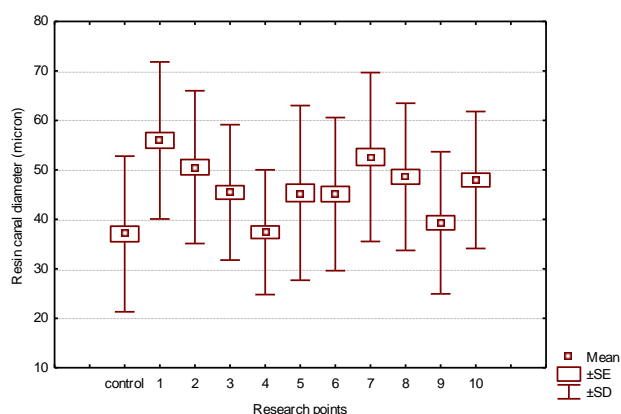
At the same time, 'The Box and whisker plot' were performed by descriptive statistics (as non-parametric statistic) in order to fit the difference of resin canal diameter in all of the research points as visual. 'The Box and whisker plot' is indicated the difference of resin canal diameter in all of the research points as perfectly shown in Fig. 6.

Fig.6. The differences of resin canal diameter in all of the research points as 'The Box and whisker plot for all variables'.

When evaluated together Table 1 and Fig. 6, it is seen that the resin canal diameters in the 1st, the 2nd, the 7th and the 10th research points are the most effected by air pollutants. The reason of this occurrence attribute to the air pollutants are carried towards the north-east direction because of south-west winds. The resin canal diameters in the other research points such as the 3rd, the 5th, the 6th and the 8th are more effected.
