TITLE: Degradation Effect of Different Environments on Characteristics of Calcium Carbonate Reinforced Polyethylene

Alpay Tamer ERTÜRK<sup>1,\*</sup>, Tülin ŞAHİN<sup>2</sup>

### Abstract

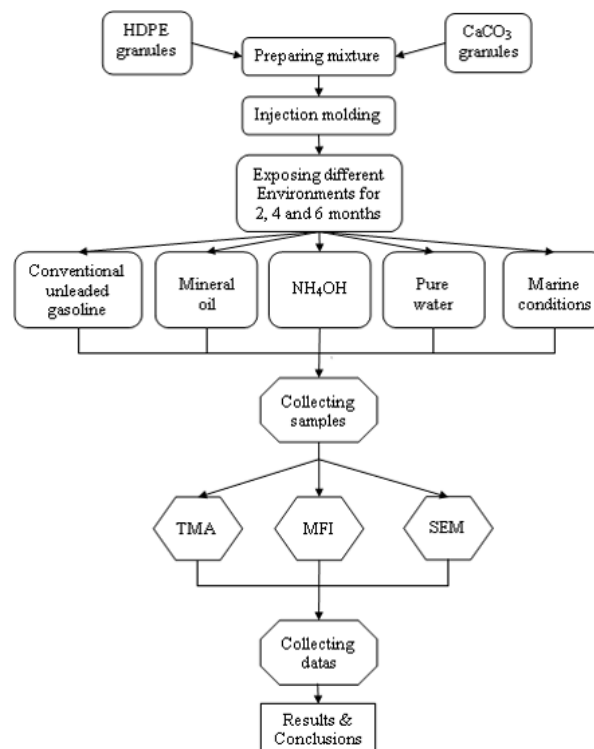
**Figure 1.** Flow chart of the study

Type of polyethylene used in this study is manufactured by Solvay SA. This product is called ELTEXTUB172 commercially. ELTEXTUB172 which is a type of high-density polyethylene has been developed for use in the production of natural gas pipe by Solvay S.A. Calcium carbonate minerals used in this study are manufactured by Omya A.G. This mineral is called Omyalane 10 2M-OG commercially. Omyalane 10 2M-OG is used as reinforcement. Its grain size is 2 µm. This reinforcement can be used directly with polyolefins. HS-5430 sensitive balance manufactured by Hana Electronics Systems was used for preparing mixture ratios. Before injection molding of samples, calcium carbonate and HDPE granules were mixed properly. Neat HDPE and 5-50wt% CaCO<sub>3</sub> reinforced HDPE materials were produced. Samples containing different weight proportions of calcium carbonate were studied. Flow chart of the study can be seen in Fig 1.

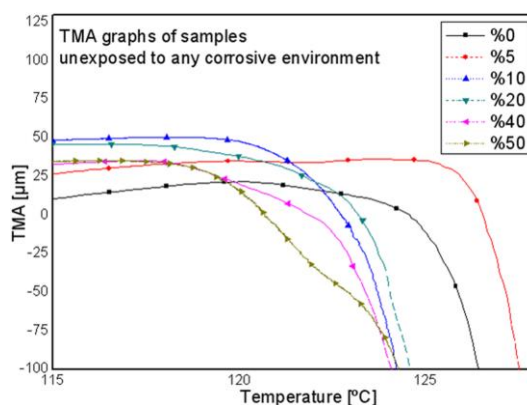
**Figure 2.** TMA graphs of samples unexposed to any corrosive environment

The results of the TMA give very good tips about degradation mechanisms of polymers. In fact, unique degradation characteristics of each polymer can be revealed by TMA test analysis. Information about degradation characteristics of a polymer is useful in determining working conditions [30]. Therefore, the properties of neat HDPE and HDPE/CaCO<sub>3</sub> composites were analyzed through TMA tests. TMA graphs related to a sample which is unexposed to any corrosive environment are indicated in Fig. 2. According to the TMA curves given in Fig. 2, neat HDPE reinforced with 5 wt% CaCO<sub>3</sub> shows very good mechanical properties. The base material mixed with more than 5 wt% CaCO<sub>3</sub> shows adversely effects on mechanical properties of the HDPE composites.

After have completed the comparison process of Figs. 2 and 3, it has been detected that the best results on improving of mechanical properties has been got from the samples which are prepared by 5 wt%  $\text{CaCO}_3$ .

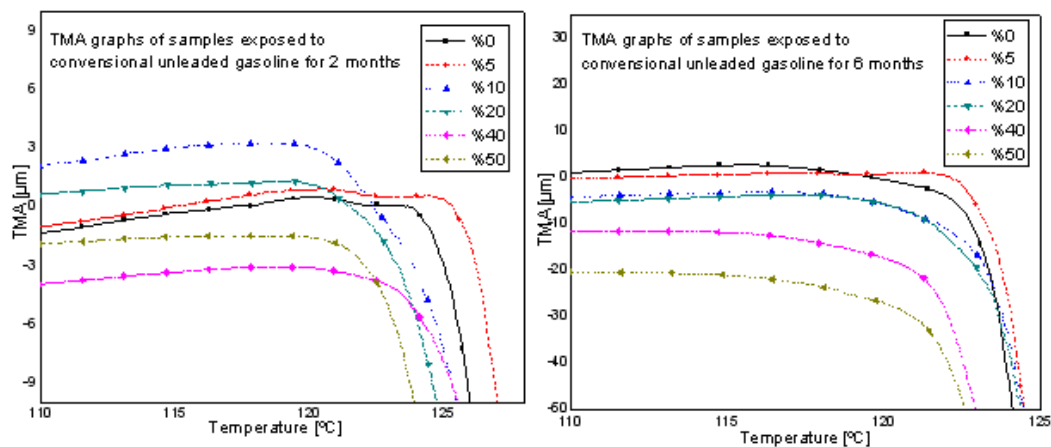
TMA graphs of the samples taken from the environment which is prepared by exposing to unleaded gasoline are presented in Figs. 3-a, b by considering their exposing time as 2 and 6 months, respectively.

**Figure 3.** TMA graphs of samples exposed to conventional unleaded gasoline

On contrast that, the poor mechanical parameters were measured from the samples which are reinforced 50 wt%  $\text{CaCO}_3$ . The other curves keeping between upper and lower limits of the addition  $\text{CaCO}_3$  such as 5 and 50 wt% shows some fluctuations but these can be accepted as generally no radical change on mechanical properties. The other interpretation has been performed by taking results of the samples unexposed and exposed to unleaded gasoline environment indicated in Figs. 2 and 3. Comparing of the curves shows that unleaded gasoline does not degraded mechanical properties of the samples.

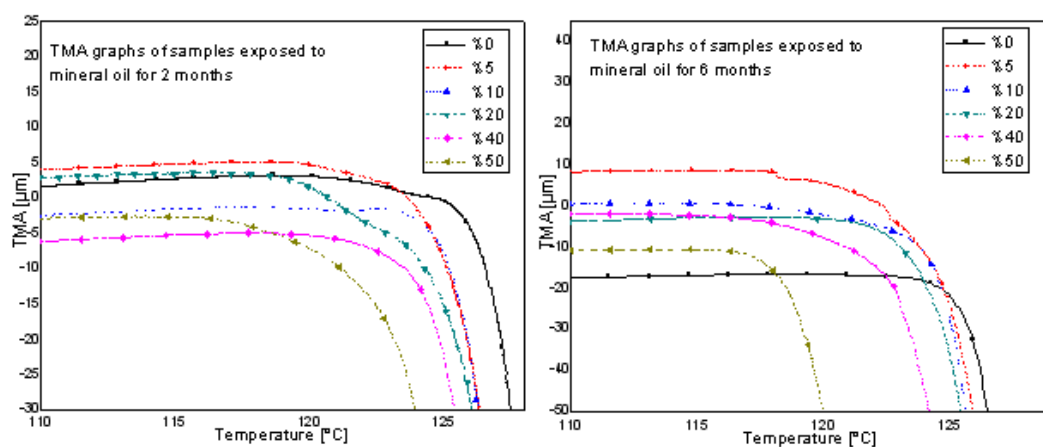
**Figure 4.** TMA graphs of samples exposed to mineral oil

The TMA graphs of the samples exposed to mineral oil, ammonium hydroxide, marine conditions and pure water environments are shown in Figs. 4, 5, 6 and 7, respectively. These graphs have been compared with TMA graphs of samples not exposed to any environment in Fig. 2. As a result of the comparison, addition of 5 wt%  $\text{CaCO}_3$  has no positive effect on mechanical properties except unleaded gasoline environment. Moreover, additions of  $\text{CaCO}_3$  in higher rates into HDPE have negative effects on the  $T_g$  values of the samples taken from the planned exposing environments.

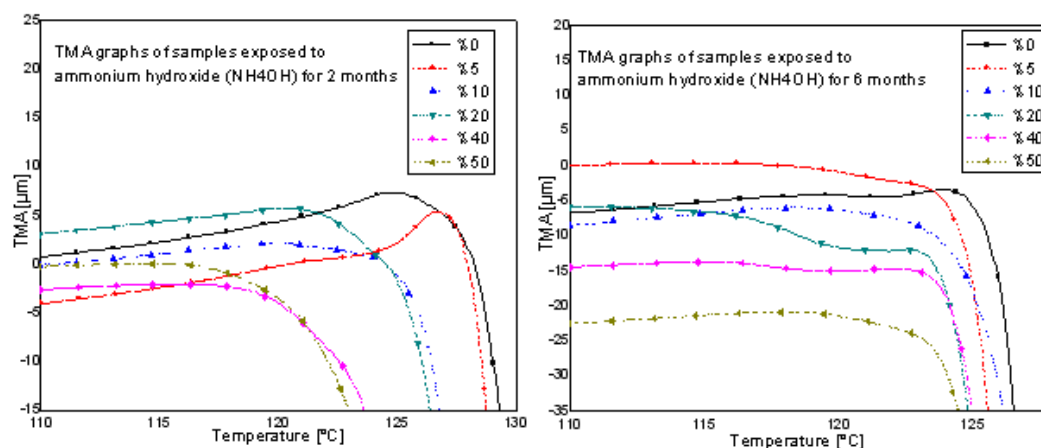
Figure 5. TMA graphs of samples exposed to  $\text{NH}_4\text{OH}$

The data collected from the samples exposed to mineral-oil and pure water given in Table 2, shows no significant increase or decrease of Tg values. Moreover, ammonium hydroxide and sea water environment have caused a significant increase in Tg values as also shown in Fig. 5 and Fig. 7. This increasing is around 3% of Tg values. The results of TMA test indicate dimensional stability of the all samples prepared from HDPE/CaCO<sub>3</sub> material. As a conclusion of TMA research, the findings indicate very good conformity with the earlier results presented in ref 13. On the other hand, the parameter of thermal expansion coefficient shows increasing regularly up to the glass transition temperature as seen in TMA Figs. 2–7.

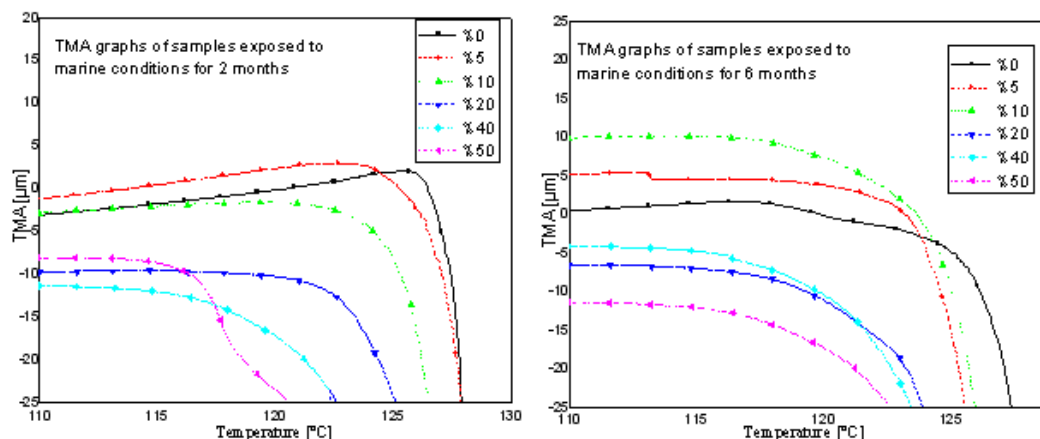
**Figure 7.** TMA graphs of samples exposed to marine conditions

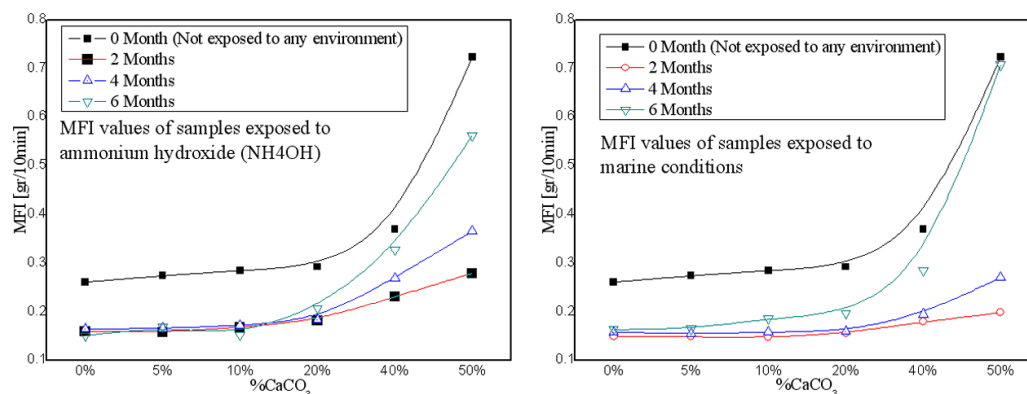
The MFI results were examined according to the different environments and additive quantity of  $\text{CaCO}_3$ . The MFI results of samples exposed to  $\text{NH}_4\text{OH}$  and marine conditions are shown in Fig. 8. These figures indicate that the MFI values of samples containing 0–5 and 10 wt%  $\text{CaCO}_3$  show smooth horizontal trend for different exposing times 2, 4 and 6 months up to 20 wt%. After examination of curves it can be seen easily that addition rate of  $\text{CaCO}_3$  up to 20 wt% has no affectivity on MFI parameter. Nevertheless, after passing wt% 20 the radical increasing of the parameter MFI has been observed.

**Figure 8.** MFI values of samples exposed to ammonium hydroxide ( $\text{NH}_4\text{OH}$ ) and marine conditions

After having completed the analysis of Fig. 9 and then comparing with Fig. 8, a similar trend has been detected easily. However, the data for Figs. 8 and 9 were collected from the samples exposed to different environments.

Finally, MFI parameters have increased independent on both environment conditions and the exposure time as shown in Figs. 8, 9 and 10. The reason of MFI increases are the chain scissions that have taken place because of degradation effects of environments. In conclusion, flow resistance decreases with higher  $\text{CaCO}_3$  weight rates. For this reason, MFI parameters of higher  $\text{CaCO}_3$  rates have the highest values compared to other rates.

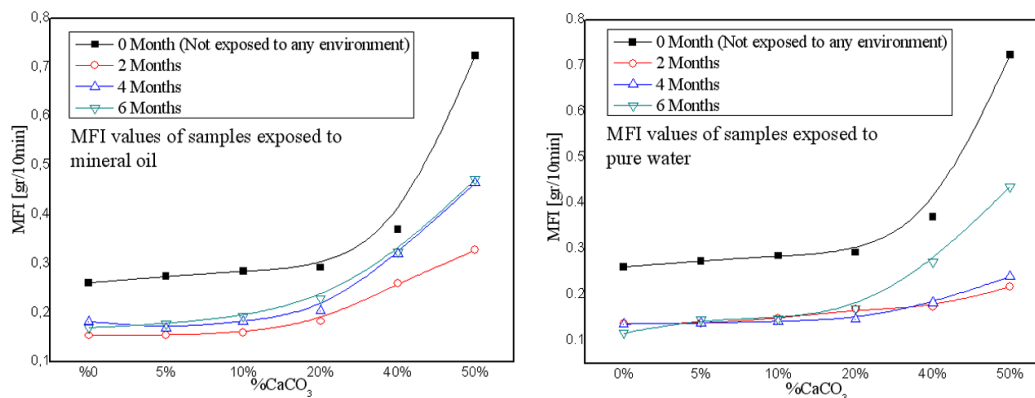
**Figure 9.** MFI values of samples exposed to mineral oil and pure water

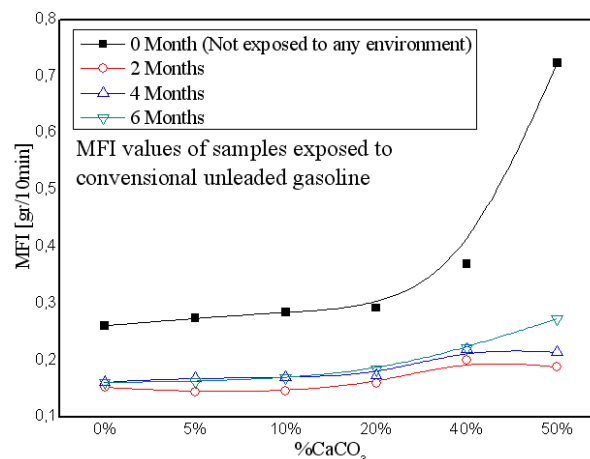
**Figure 10.** MFI values of samples exposed to conventional unleaded gasoline

Smooth regular increasing of MFI parameters for the samples exposed to  $\text{NH}_4\text{OH}$ , pure water, marine conditions and mineral oil environments show time-depended trend. According to the values presented in Fig. 10, MFI values of samples exposed to unleaded gasoline have little effects on the parameters with exposing time. Changes are independent of the amount of  $\text{CaCO}_3$ . Content of 40 and 50 wt%  $\text{CaCO}_3$  additives have been exposed to unleaded gasoline, which haven't shown a radical increase on the MFI parameters unlike the other environments. According to MFI results, addition of  $\text{CaCO}_3$  in HDPE composites should be used up to 10 wt% for using different environments other than unleaded gasoline.

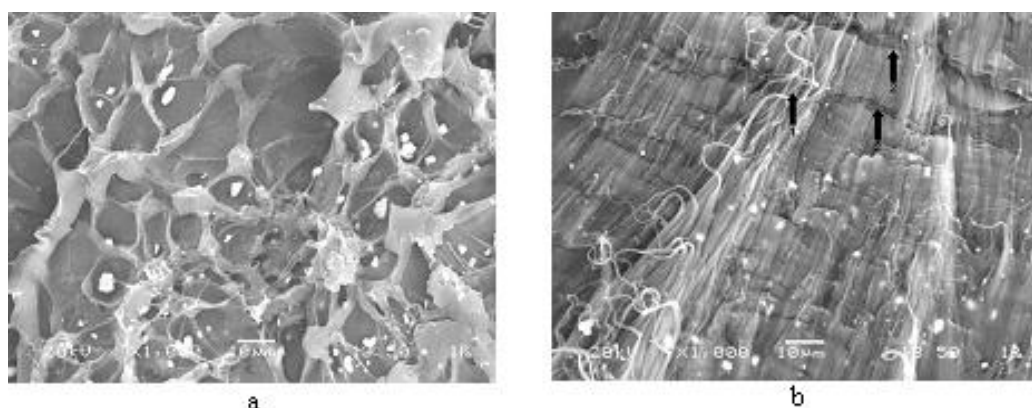
**Figure 11.** Inner (a) and surface (b) section images of 5 wt% content of  $\text{CaCO}_3$  in HDPE/ $\text{CaCO}_3$  samples exposed to mineral oil at 1000x magnification

Moreover, chain branching and micro-cracks were observed in Figs. 11-13. Chain scissions are precursor to formation of micro cracks. These micro-cracks detected in the samples shows time dependency related

to the exposing time. Degradation types defined above are shown in the micrographs with the help of the black arrows. Chain branching and micro-cracks were indicated with number 1 and 2, respectively.

Images taken from the inner (a) and outer section of the samples (b) which have content of  $\text{CaCO}_3$  with 5 wt% in HDPE/ $\text{CaCO}_3$  exposed to mineral oil are shown in Fig. 11. This image clearly explains that deterioration of the material has occurred on the outer surface of the samples due to direct contact with the exposing medium.

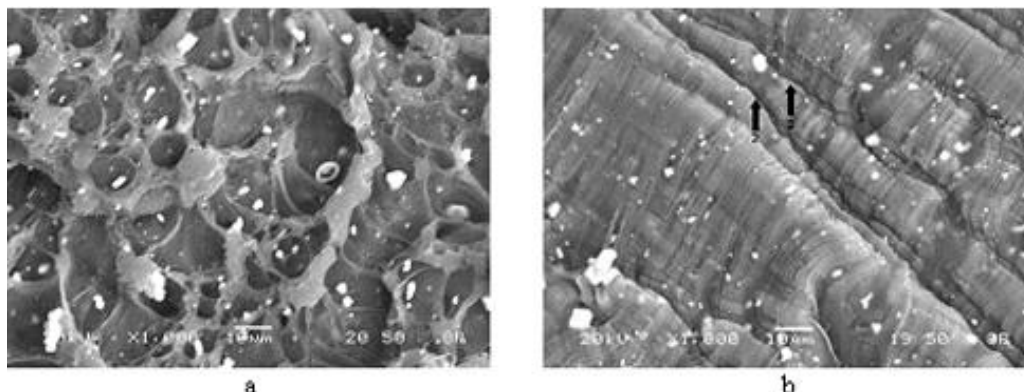
**Figure 12.** Inner (a) and surface (b) section images of 10 wt% content of  $\text{CaCO}_3$  in HDPE/ $\text{CaCO}_3$  samples exposed to ammonium hydroxide ( $\text{NH}_4\text{OH}$ ) at 1000x magnification

On contrast that the analysis for detecting deterioration level in the inner part of the samples do not show any radical indicative evidence such as chain branching and micro-cracks. Images taken from the inner (a) and outer surfaces (b) of the samples which have content of  $\text{CaCO}_3$  with 10 wt% in HDPE/ $\text{CaCO}_3$  exposed to  $\text{NH}_4\text{OH}$  are shown in Fig. 12. In this figure the coding of micro-cracks and chain branching are performed as 1 and 2, respectively.

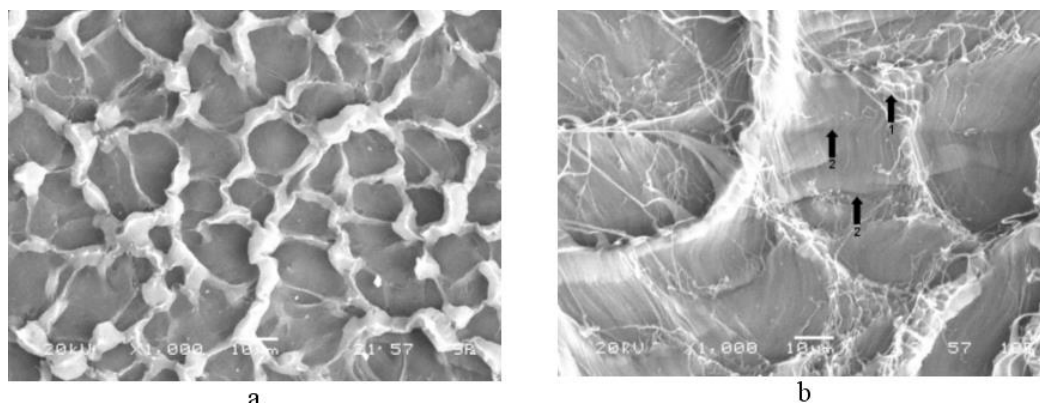
**Figure 13.** Inner (a) and surface (b) section images of 0 wt% content of  $\text{CaCO}_3$  in HDPE/ $\text{CaCO}_3$  samples exposed to conventional unleaded gasoline at 1000x magnification
