TITLE: Investigation of the Sandblasting Pressure Effect on the Wear Properties, Surface Roughness, and Shear Bond Strength of Resin Nanoceramic and Zirconia CAD/CAM Restorative Materials

AUTHORS: Seval Baspinar Alper, Neslihan Tekçe, Elif Sevilay Yildirim, Elif Ilgi Sancak

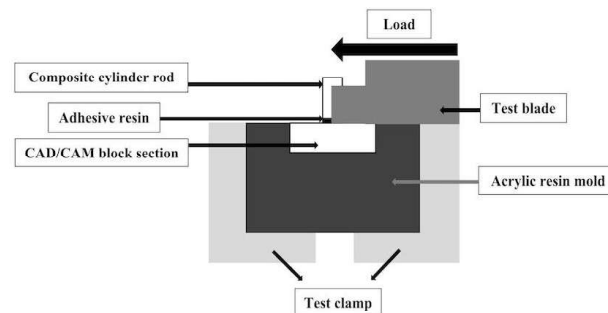
Figure 1. Schematic view of the SBS test.

CAD/CAM block sections to be subjected to the SBS test were embedded in the acrylic molds. Clearfil Majesty Esthetic composite resin was used to fabricate composite cylinder rods. The composite resin material was placed in a Teflon mold (Ultradent Product, Inc., Utah, USA) and polymerized for 40 seconds using the Elipar S10 (3M/ESPE, St. Paul, MN, USA). Eighty composite cylinder rods were obtained. Thereafter, G-Multi Primer was applied to the specimens according to the manufacturer's instructions. The composite cylinder rods were adhered to the ceramic surfaces using G-CEM Link Force dual-cure adhesive resin. A constant force of 10 Newton was applied to standardize the cement thickness.²³ The excess cement was removed then each surface was polymerized for 20 seconds. The samples were stored in distilled water for 24 hours at room temperature. Then, SBS test was performed in Shear Bond Tester (Bisco, Schaumburg IL Inc, USA) at a speed of 0.5 mm/min and the values were recorded in Newton and calculated in MPa. Schematic views of the SBS test were shown in Figure 1. Failure modes were examined with an M3B stereomicroscope (Wild, Heerbrugg, Switzerland) (x30) and assessed as adhesive, cohesive, and mixed. The schematic representation of the test procedure was presented in Figure 2.

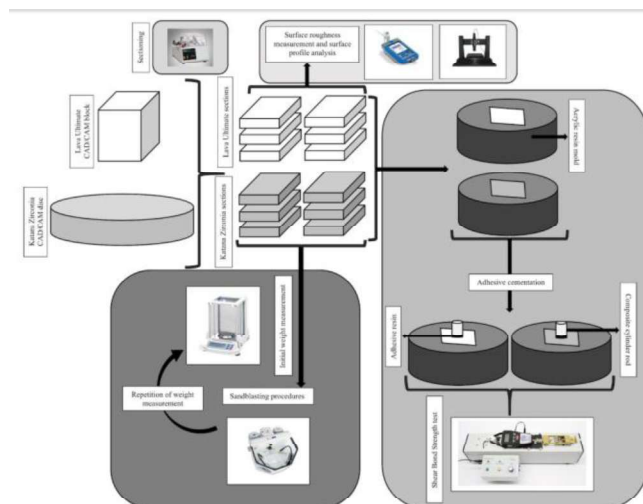
Figure 2. Schematic representation of the test procedures

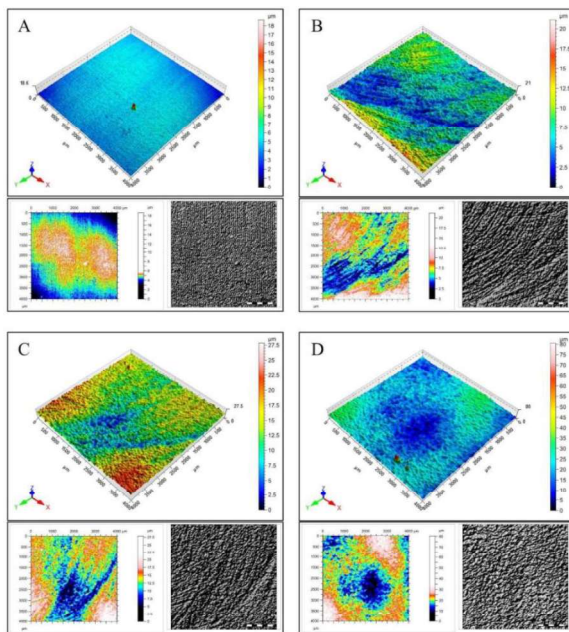
Figure 3. 3D profilometry images of Lava Ultimate samples. (A: Group-0; B: Group-1; C: Group-2; D: Group-3).

The mean and \pm standard deviation values for the volume differences, Ra, and SBS were given in Tables 2-4. The three-dimensional images were shown in Figures 3 and 4. The dispersion of SBS failure modes was shown in Figure 5. The most common failure mode was adhesive and cohesive failure did not occur.

The three-dimensional images showed more craters, grooves, and scattered irregular areas formed as the sandblasting pressure increased in the groups of LU. Rough areas with increasing pits and peaks were determined on the surface of the KZ specimens.

When examining the three-dimensional images in the current study, it was observed that more craters, grooves, and scattered irregular areas formed as the sandblasting pressure were increased in LU groups. Rough areas with increasing pits and peaks were noted in the KZ specimens. When restorative materials were compared, it was found that the presence of irregular areas and grooves on the surface of LU specimens was more pronounced than KZ. The abrasive effect of sandblasting treatment on LU was more effective due to the structural differences among the materials.

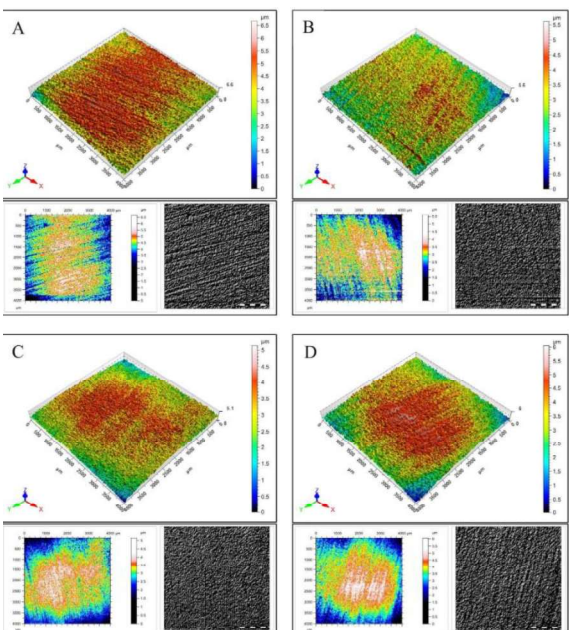
Figure 4. 3D profilometry images of Katana Zirconia samples. (A: Group-0; B: Group-1; C: Group-2; D: Group-3).

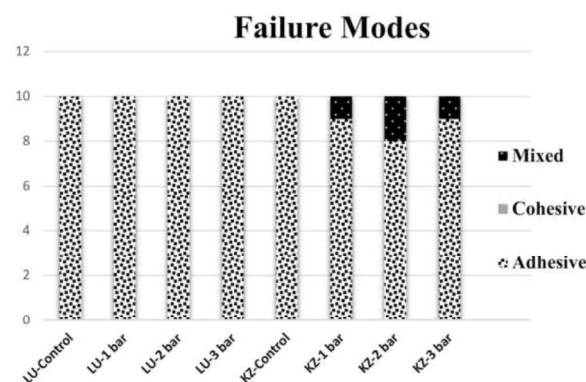
Figure 5. Distribution of failure modes according to experimental groups.

When evaluating failure modes, adhesive failure was observed for all LU specimens. For KZ, adhesive failure occurred mainly. Cohesive failure did not occur for these two materials. The rate of mixed failure was lower than that of adhesive failure in KZ.
