TITLE: Numerical Analysis of Damaged Helical Gear Wheel

Numerical Analysis of Damaged Helical Gear Wheel

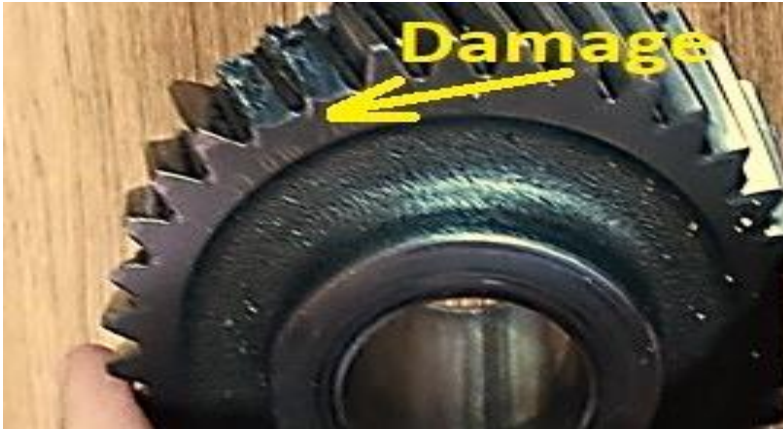
Figure 4. The damaged helical gear wheel.

In this study, a damaged helical gear, which is frequently used in car engines, static stress analysis was performed with the ANSYS Workbench Finite Elements Package program. The drawings of the helical gear wheel were made in the Solidworks program (Solidworks, 2021). In the analysis, the properties of the helical gear made of structural steel were used. A picture of the damaged helical gear wheel is given in Fig. 4.

It was known that the damaged helical gear whose numerical analysis was made was a ductile material. Due to this material structure, it was observed that the damage starting area was broken at an angle of 45 degrees.
